## Arboricultural Impact Assessment

Land off Llandegai Road  
Bangor  
LL57 4HP

Ref: P.1339.20

**Macbryde Homes**

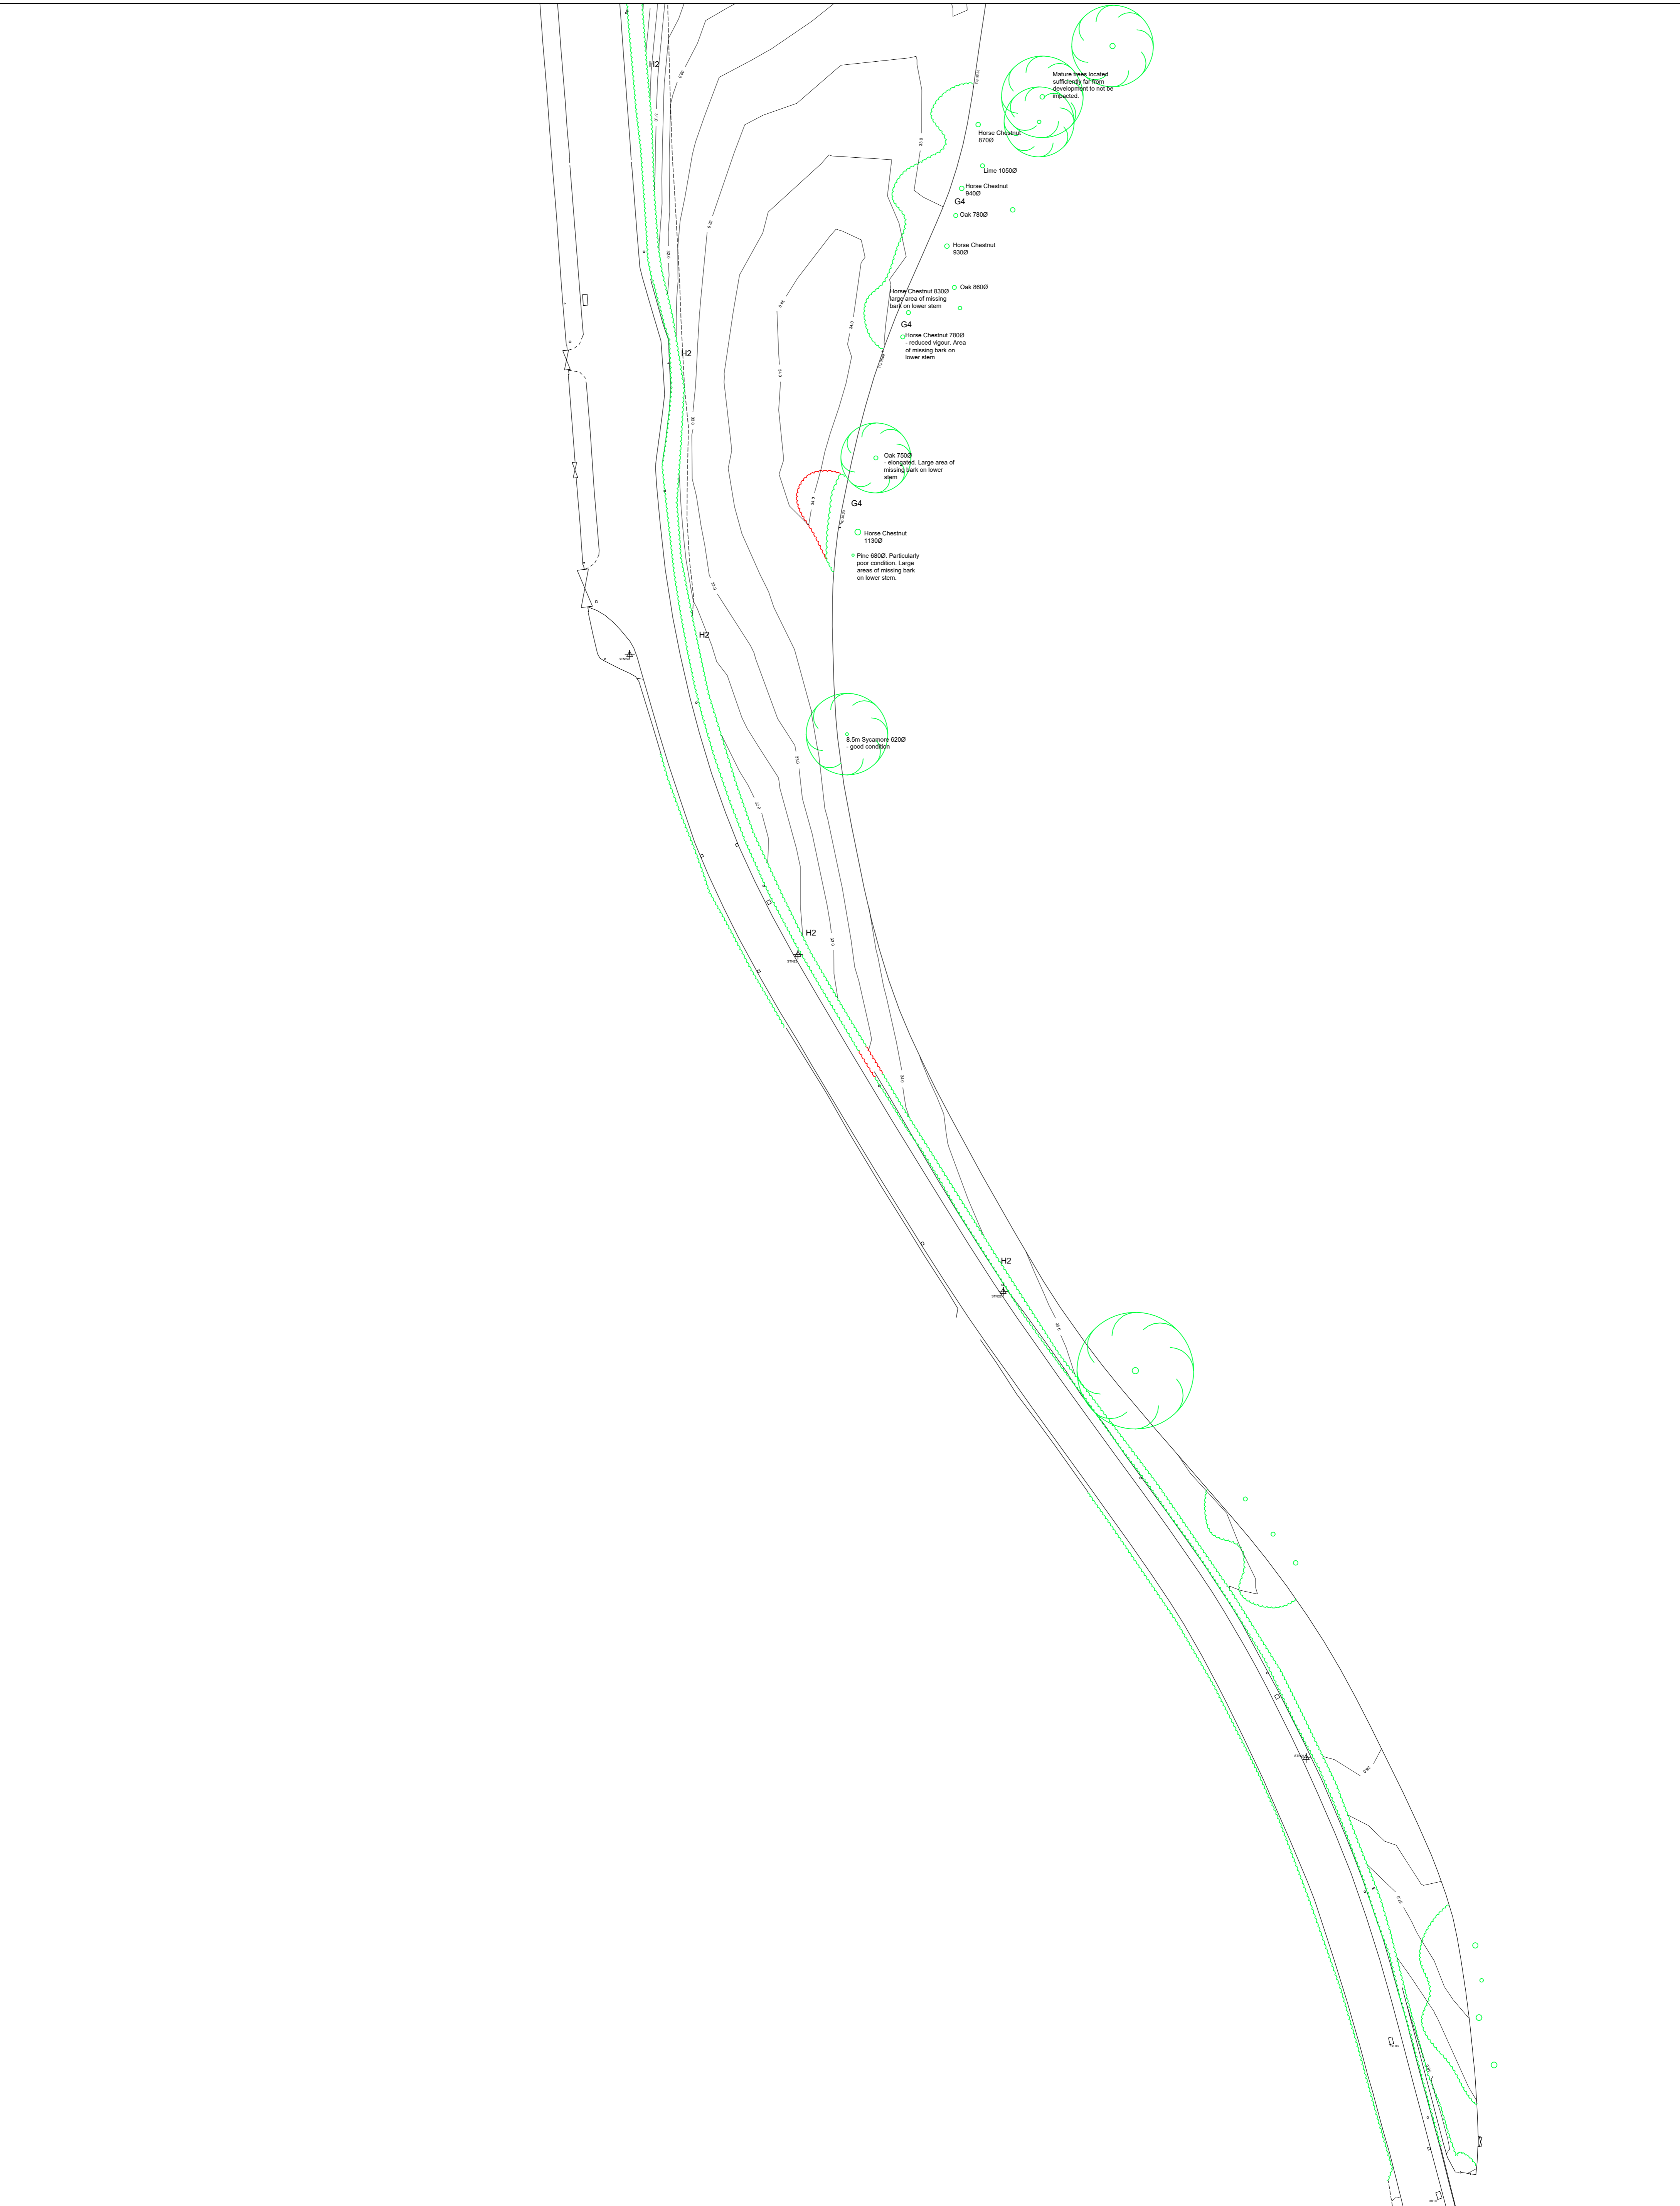
CLIENT: Macbryde Homes Ltd			
PROJECT: Llandegai Road, Bangor LL57 4HP			
DRAWING TITLE: Tree Survey and Tree Removal Plan Sheet 2 of 2			
SCALE: 1:500 @A1	DRAWN BY: CP	DRAWING NO.:	REV:
DATE: 22/06/2020	CHKD BY: RA	P.1339.20.01	-

- 3.2** Sixteen individual trees (T1-T16), five groups of trees (G1-G5) and two hedges (H1-H2) were recorded during our survey, the details of which can be found within Appendix 1 to this report and cross referenced with drawing P.1339.20.01 *Tree Survey and Tree Removal Plan*.

- 6.1** The proposals to develop the site by the construction of sixty-seven residential dwellings will directly require the removal of T1, T2, T3, T7, G3, H2 (in part) and H3 (in part).

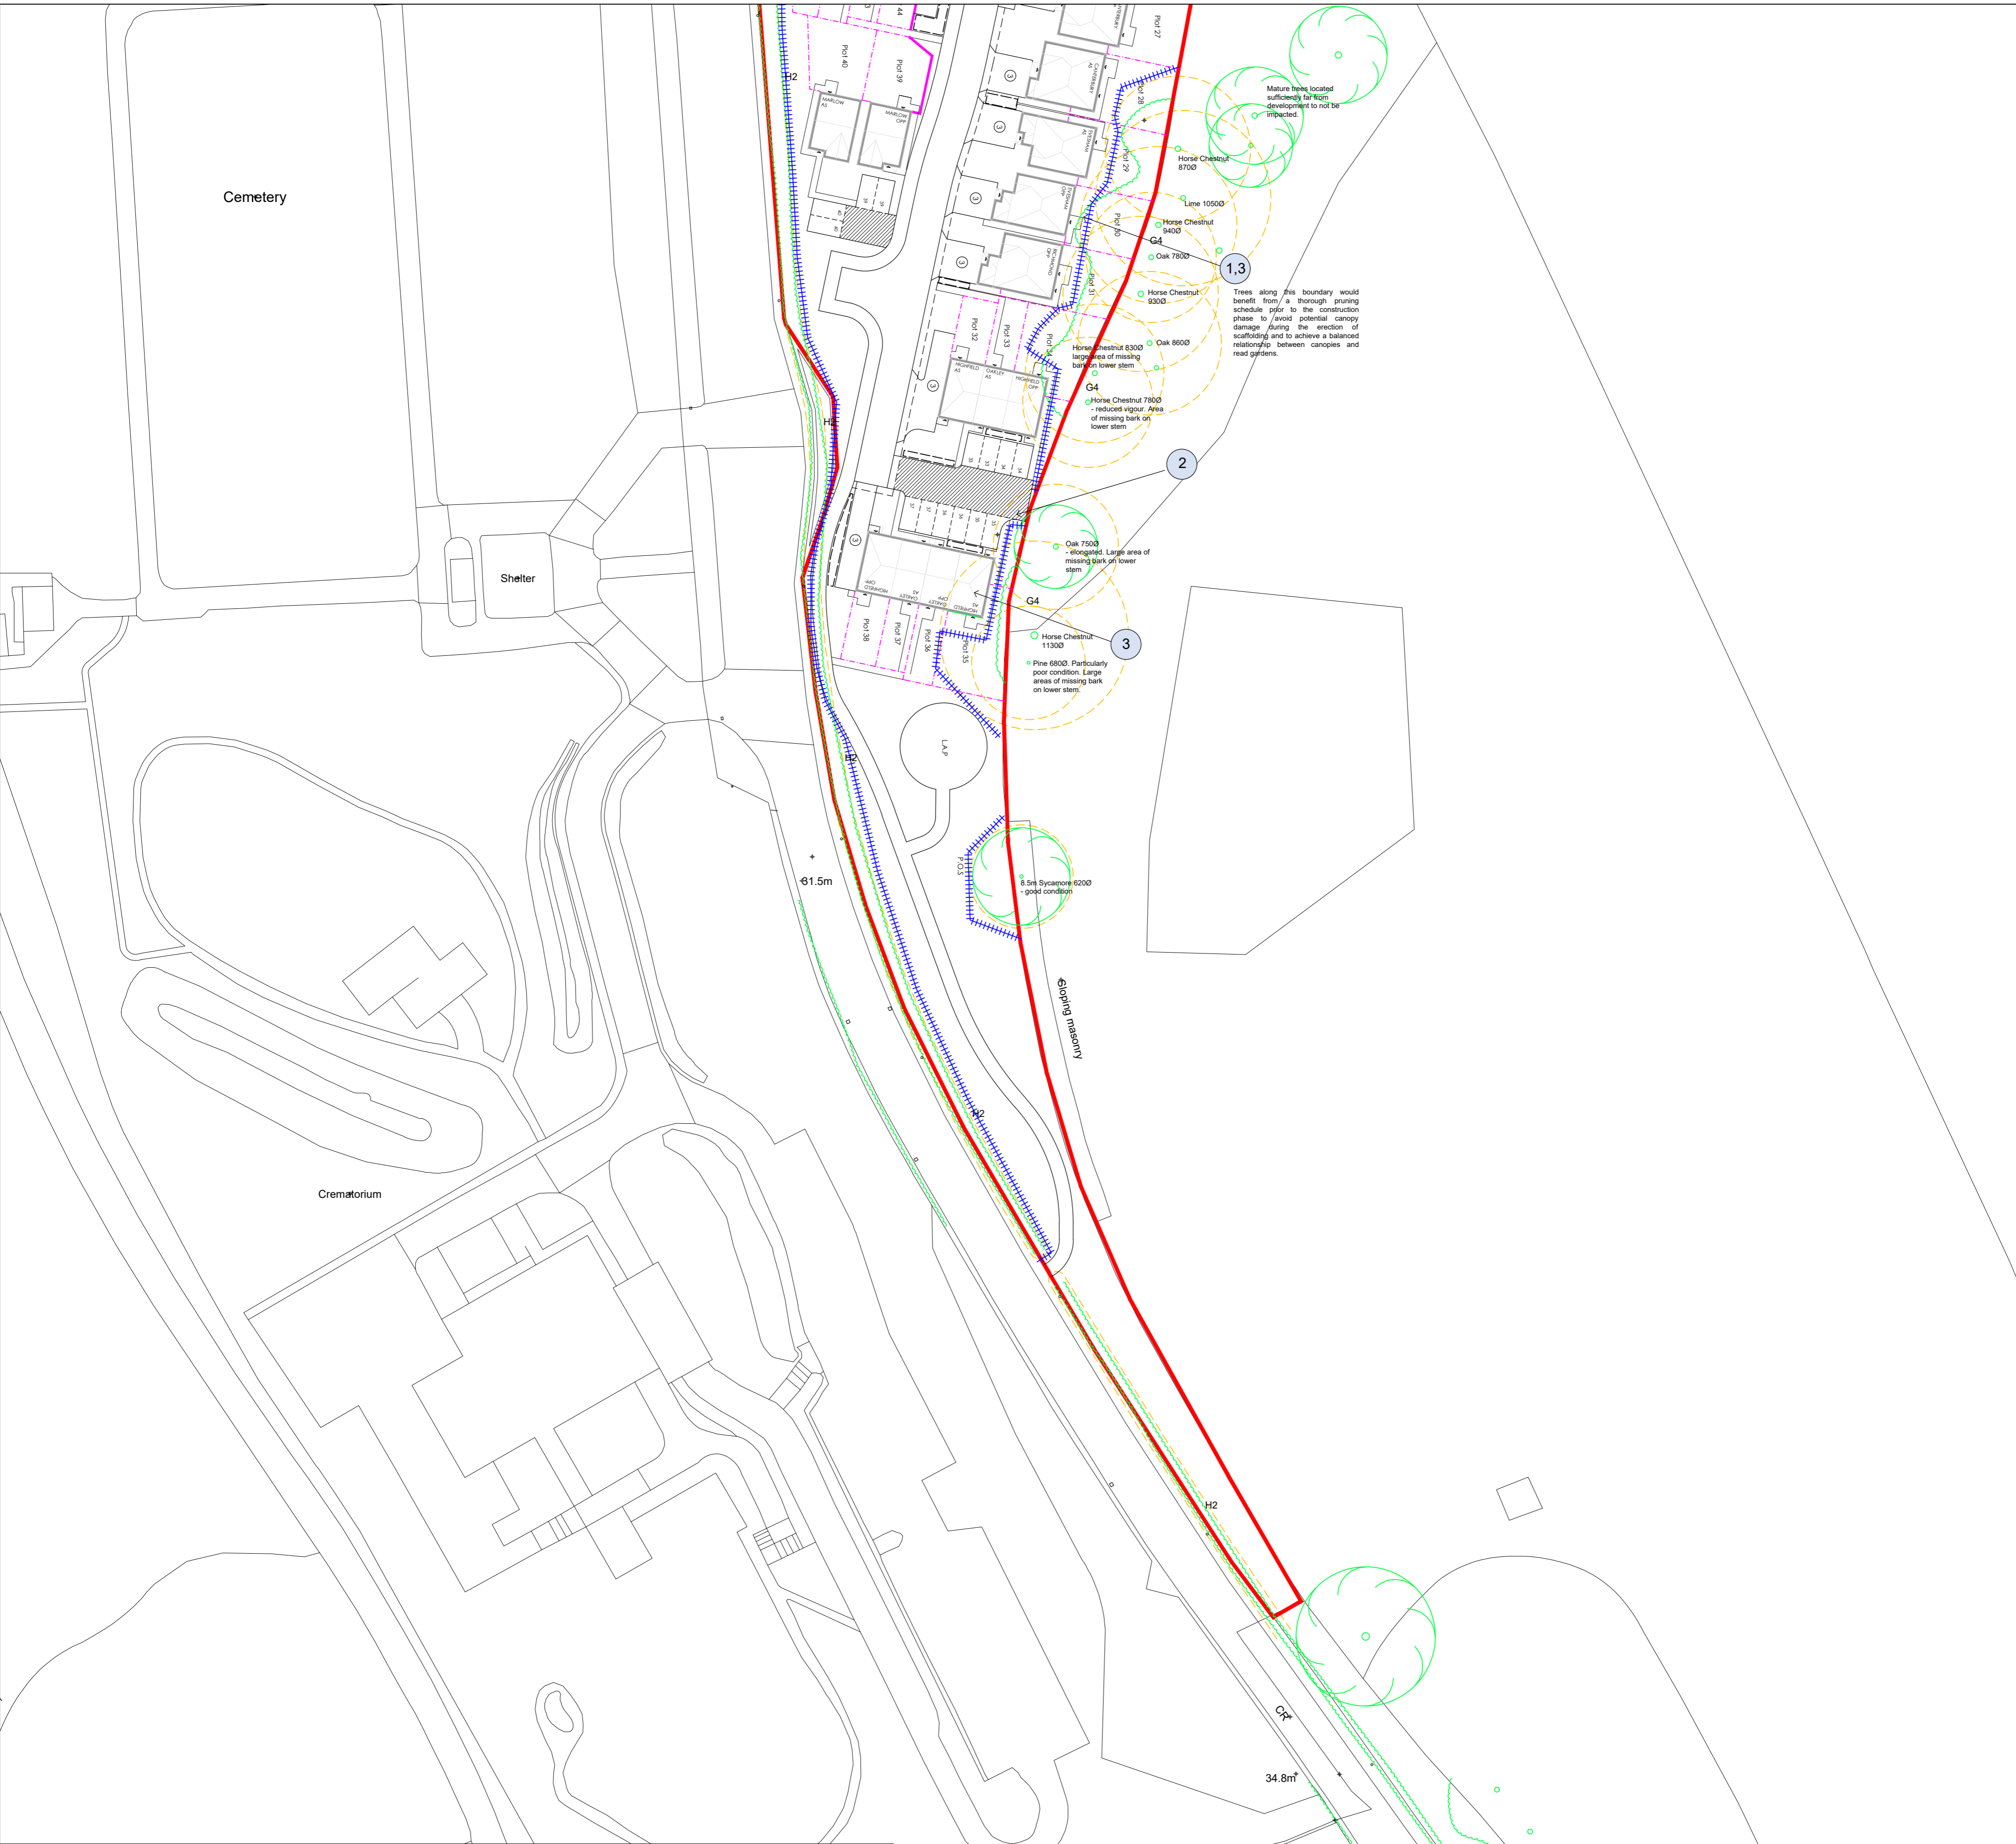
CLIENT: Macbryde Homes Ltd  
PROJECT: Llandegai Road, Bangor LL57 4HP  
DRAWING TITLE: Tree Protection Measures  
Sheet 2 of 2  
SCALE: 1:500 @A1  
DATE: 22/06/2020  
DRAWN BY: CP  
CHECKED BY: RA  
DRAWING NO: P.1339.20.02

- 6.2** In the absence of suitable controls, the development also has the potential to have an indirect impact on G4, T9 and T10 that are proposed for retention as part of the development of the site.

- 6.3** Protection of retained trees from the impacts of the development proposals can be provided by:
- The erection of protective fencing in advance of the commencement of the development in the locations shown;

Potential Impact / Work Stage	Affecting	Protection Measure / Mitigation	Description / Specification and Procedure
<b>Construction Phase</b>			
1	Canopy pruning	Several trees within G4	<ul style="list-style-type: none"> <li>Pruning schedule</li> </ul> Tree specific pruning schedule to be created along this boundary to achieve a suitable clearance from plot scaffolding and to achieve a balanced relationship between canopies and rear garden space.
2	Proposed areas of hard standing	Oak 750mm DBH within G4	<ul style="list-style-type: none"> <li>Root pruning</li> </ul> Significant rooting mass is not considered likely in this location; however, any exposed roots to be pruned cleanly back to the soil surface as promptly as possible to avoid any prolonged exposure, using tools appropriate to the task.
3	Proposed buildings / plots / substations	Several trees within G4	<ul style="list-style-type: none"> <li>Fencing attached to scaffolding</li> </ul> Tree protection fencing to be attached to scaffolding on the eastern elevations of Plots 28-35 to prevent vehicular access along this boundary within root protection areas.

<ul style="list-style-type: none"> <li>Root pruning</li> </ul> Exposed roots <25mm to be pruned cleanly back to the soil surface as promptly as possible to avoid any prolonged exposure. Roots >25mm to be assessed on site by the project arboriculturist as to whether pruning is safe / appropriate.
			<ul style="list-style-type: none"> <li>Supervised excavations</li> </ul> Project arboriculturist to attend site prior to the commencement of any excavations to install the foundations of Plot 35.
4	Proposed substation	T10	<ul style="list-style-type: none"> <li>Root pruning</li> </ul> Significant rooting mass is not considered likely in this location; however, any exposed roots to be pruned cleanly back to the soil surface as promptly as possible to avoid any prolonged exposure, using tools appropriate to the task.
