Arboricultural Impact Assessment

Upper Denbigh Road,
St Asaph

Ref: P.1521.21

September 2021

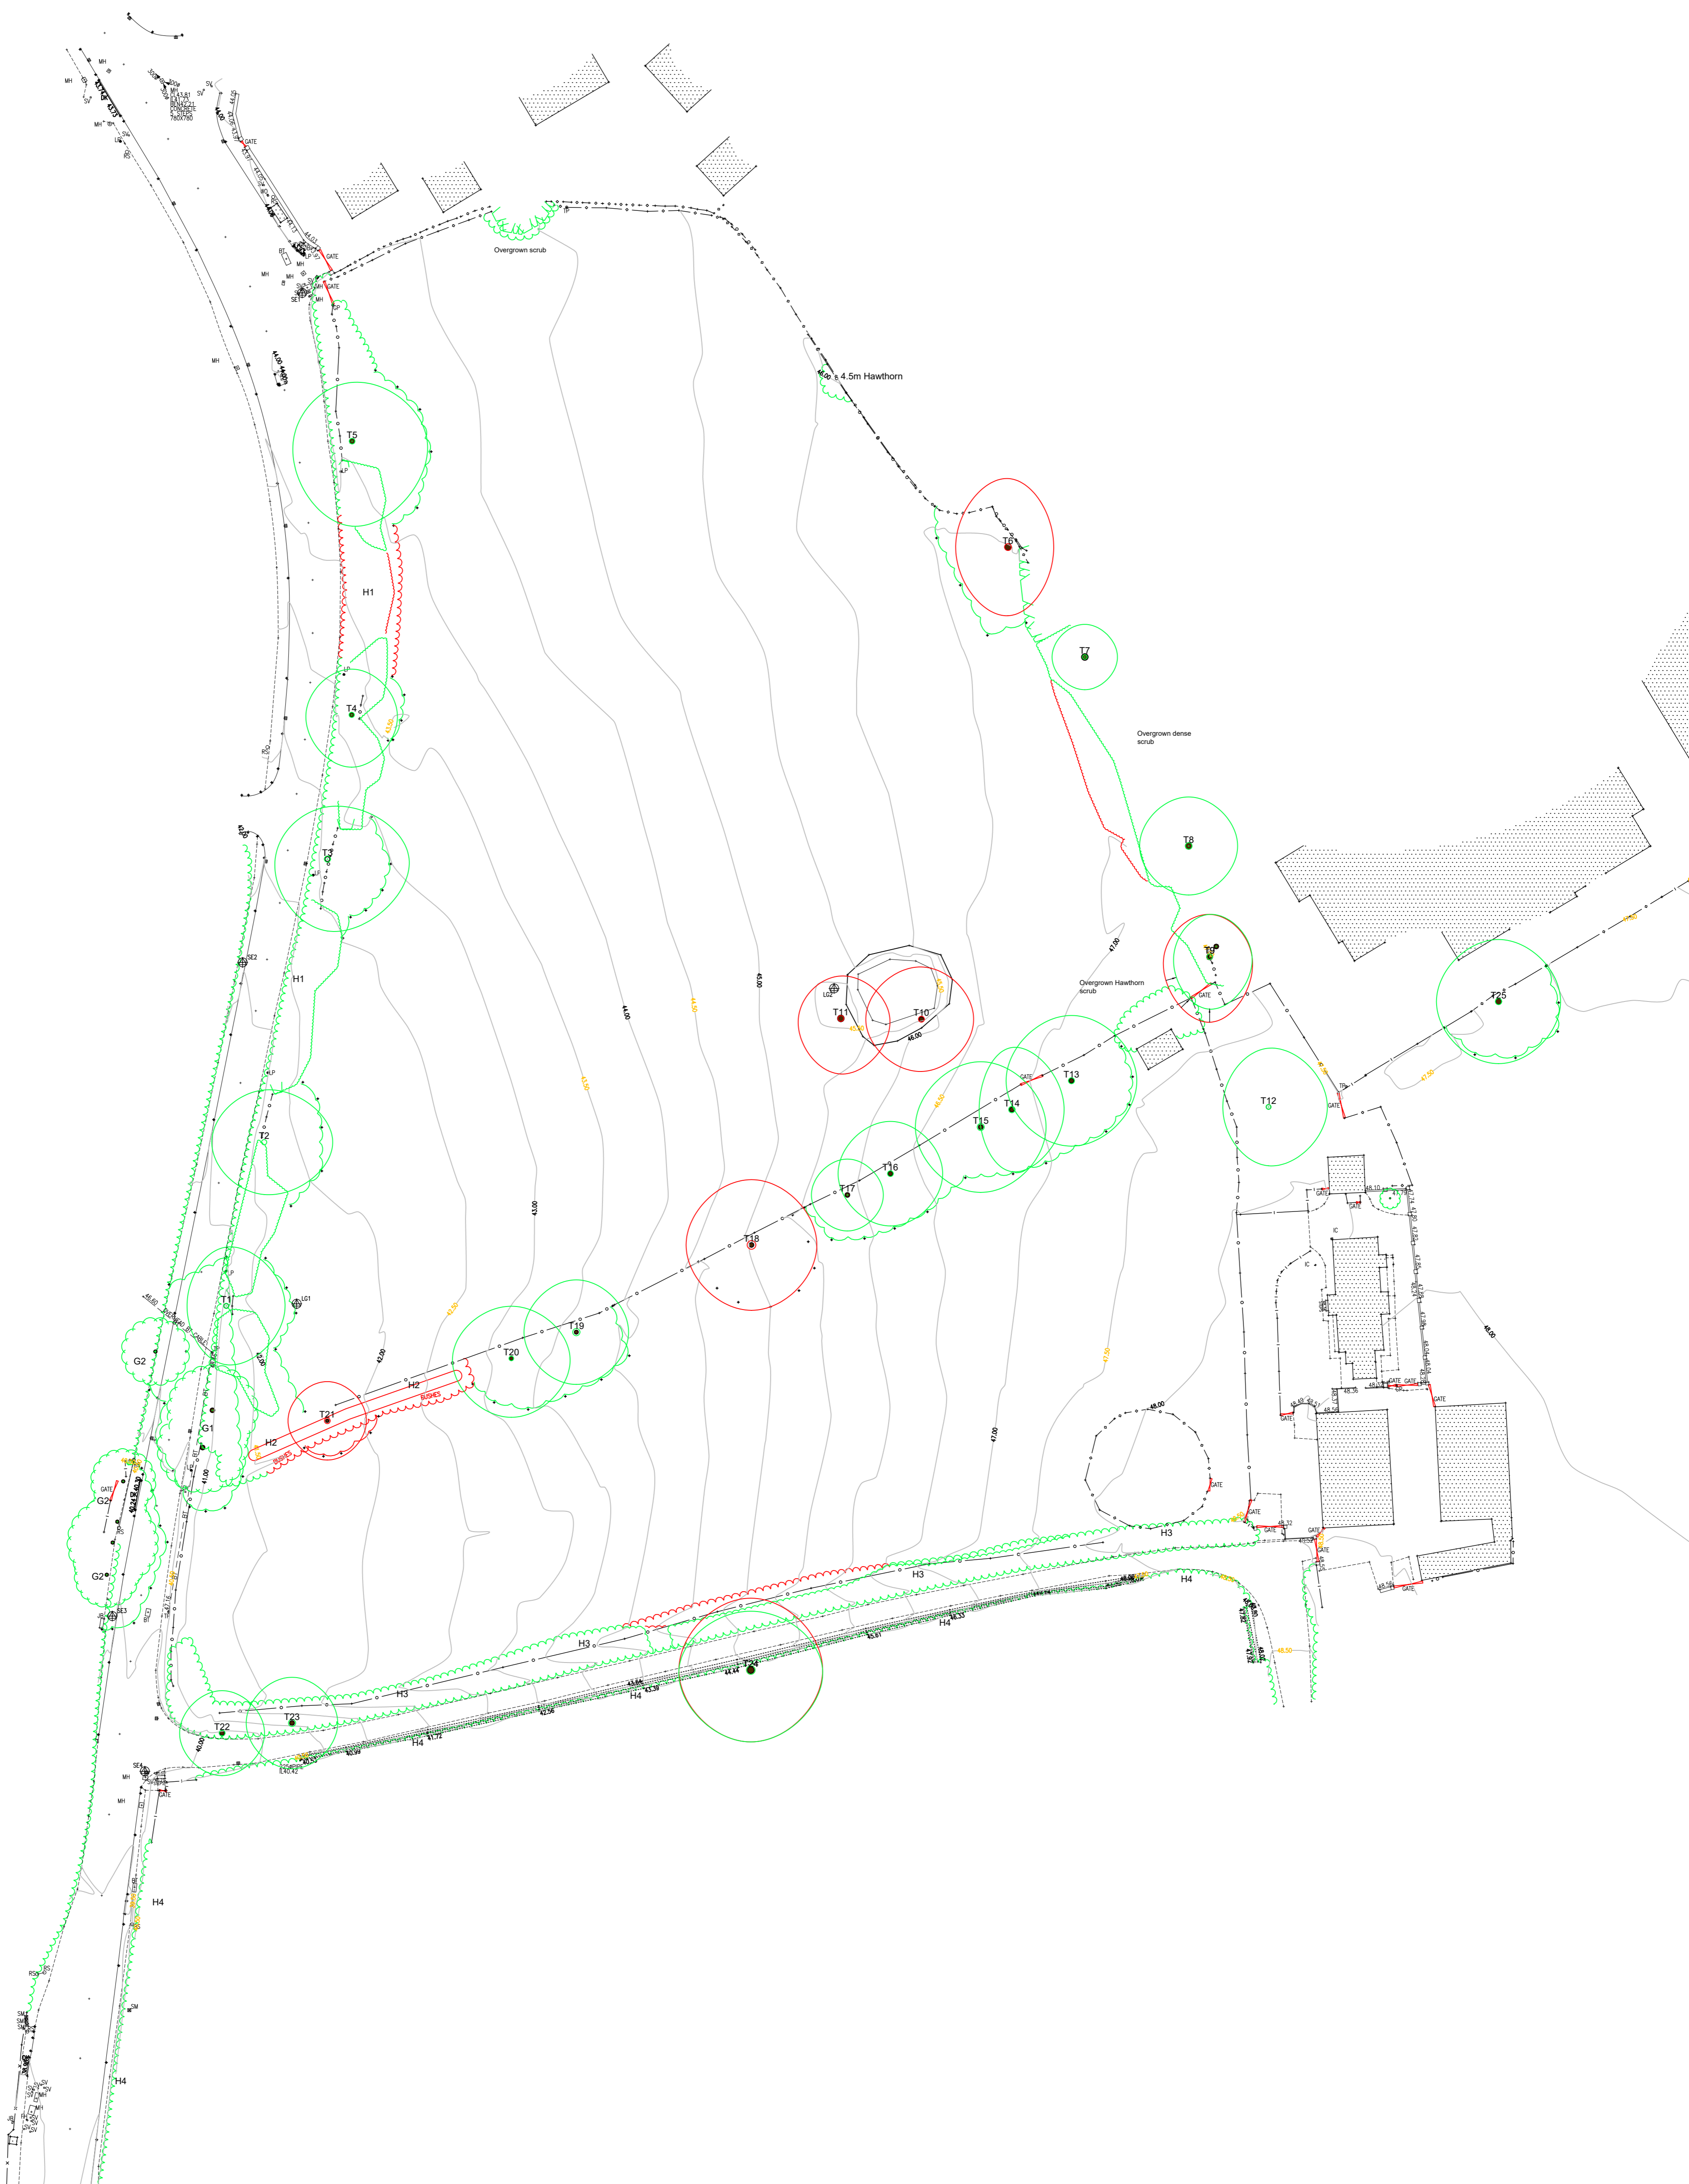
CLIENT:	Castle Green Homes
PROJECT:	Upper Denbigh Road, St Asaph
DRAWING TITLE:	Tree Survey
SHEET:	Sheet 1 of 2
SCALE:	1:500 @A1
DATE:	06/08/2021
DRAWN BY:	KP
CHKD BY:	CP
DRAWING No.:	P.1521.21.01
REV:	-

- 5.1 Existing Tree Cover:** 25 individual and 5 groups of trees and 4 hedges were recorded during our survey, the details of which can be found within Appendix 1 to this report and cross referenced with drawing P.1521.21.01 *Tree Survey*.

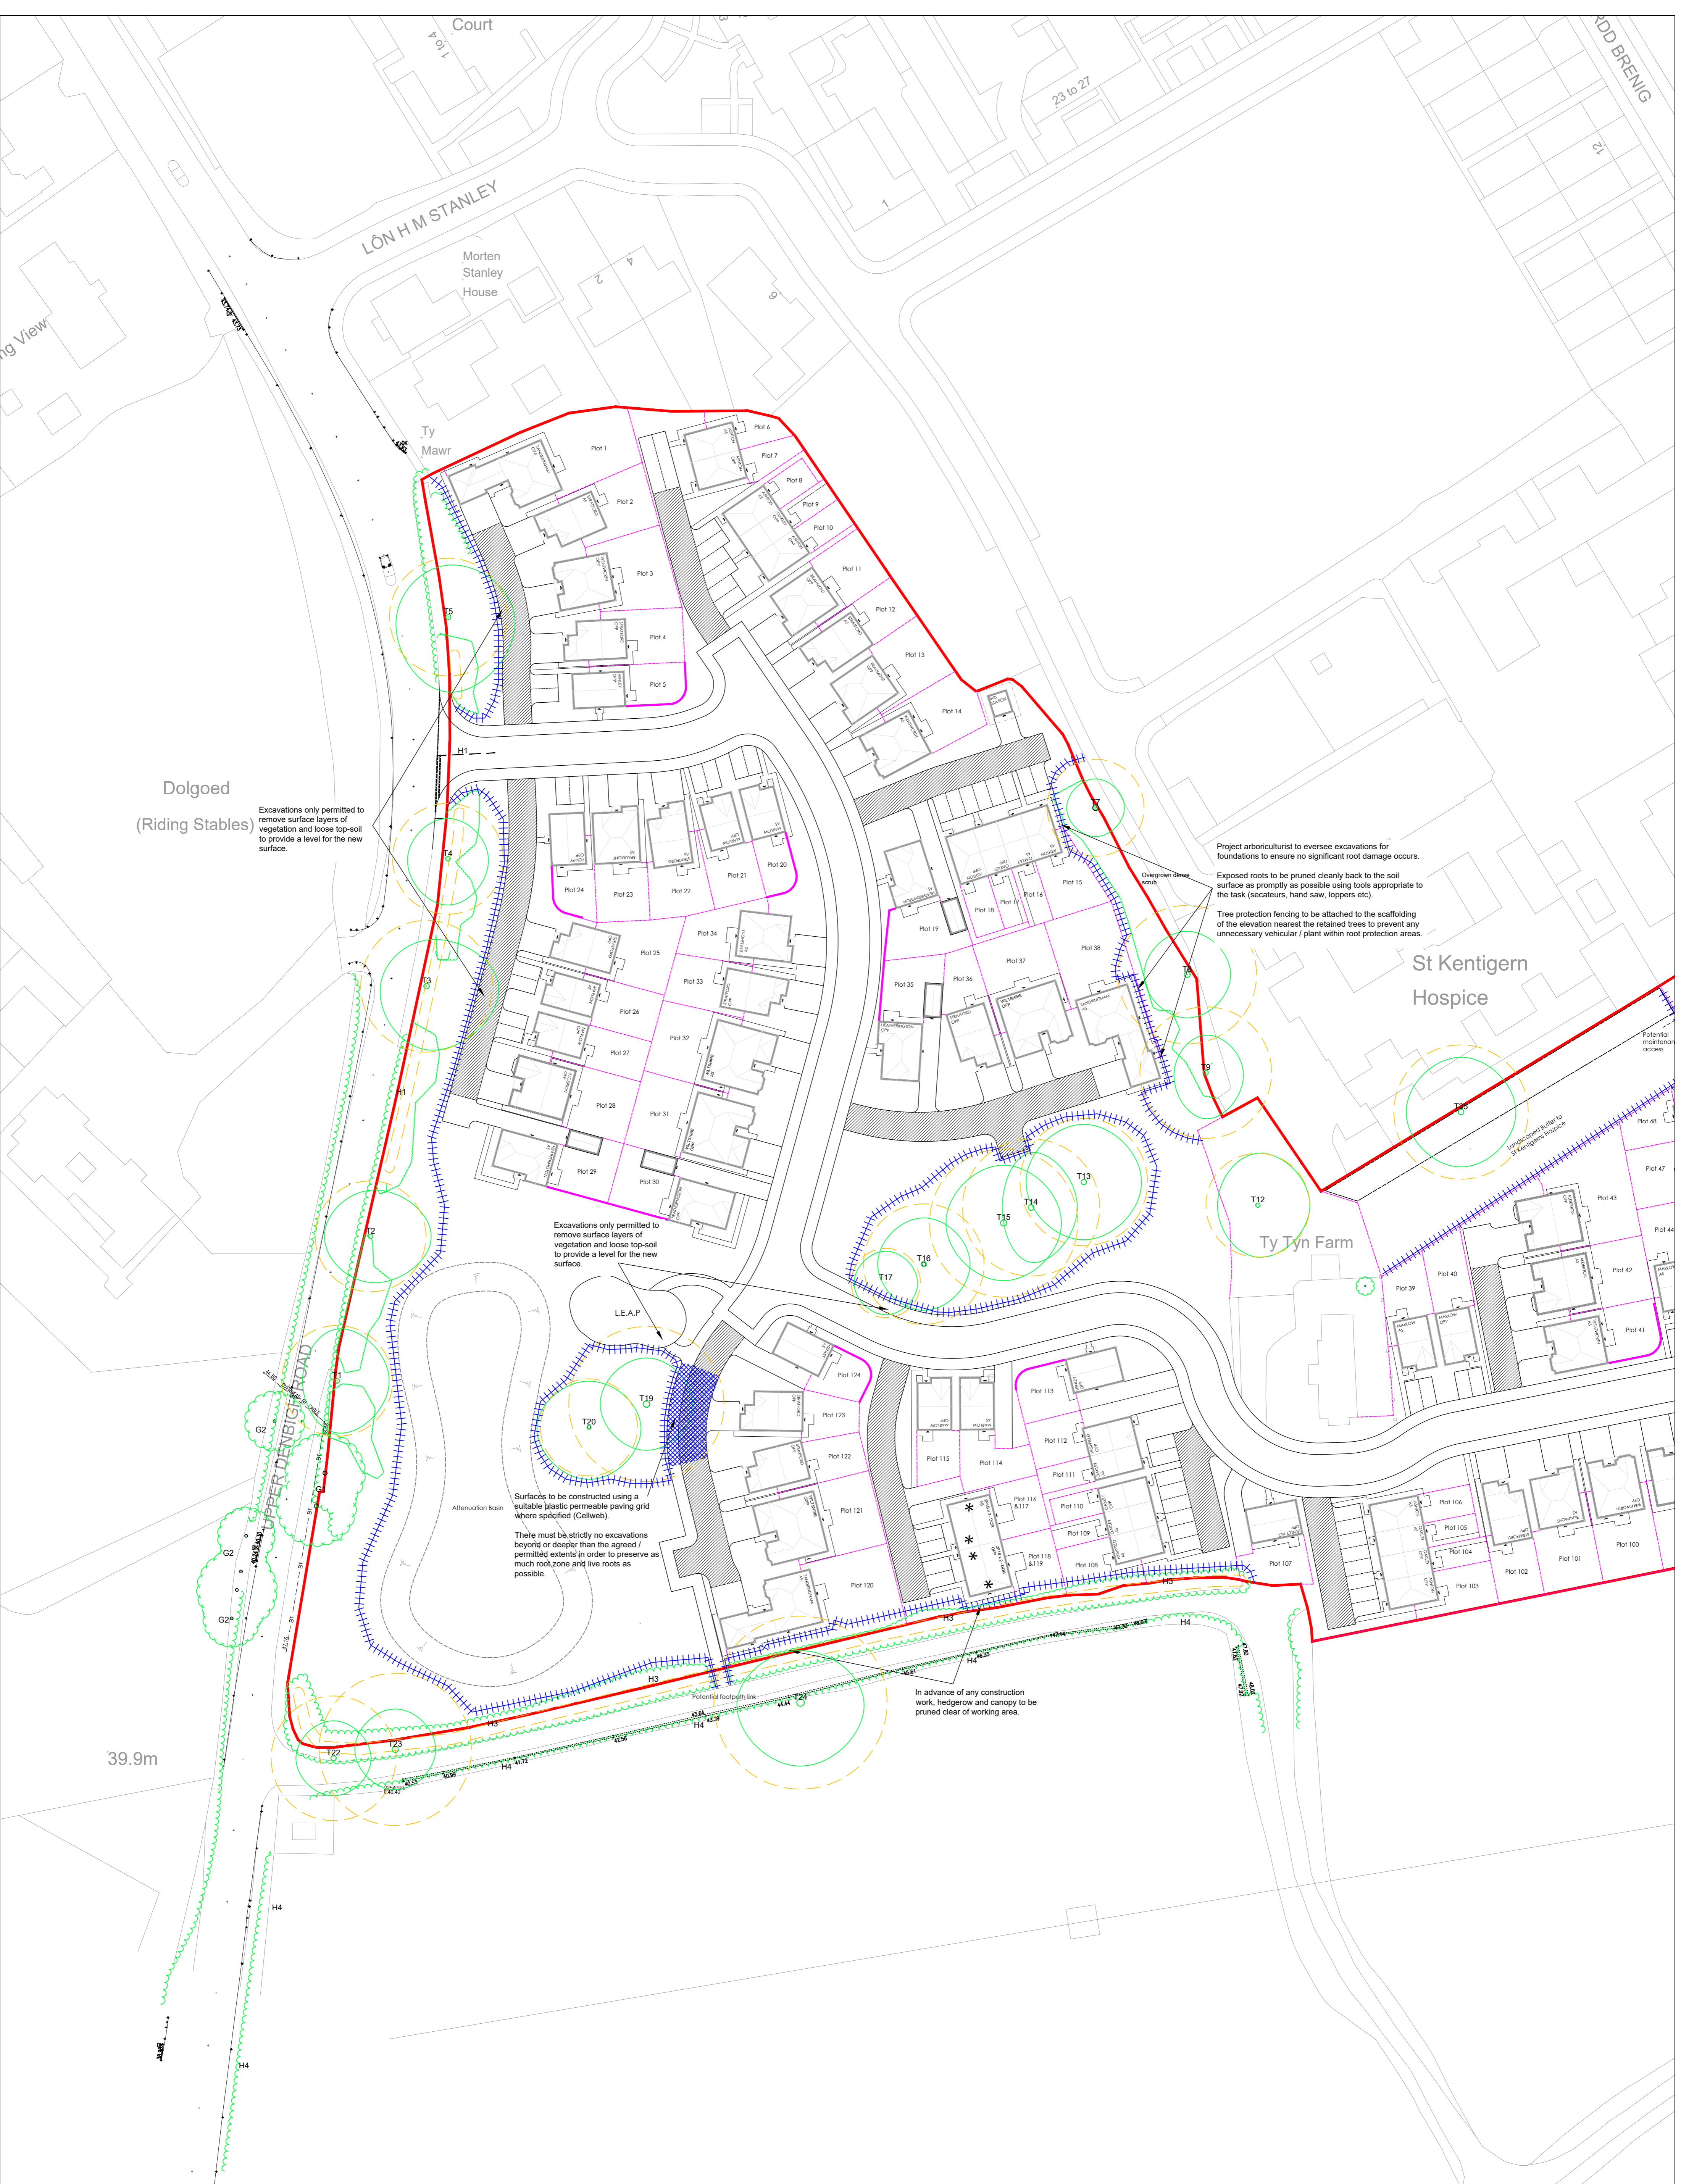
Excavations only permitted to remove surface layers of vegetation and loose top-soil to provide a level for the new surface.

6.1 Based on the proposed layout and those trees proposed for retention, the drawings attached to this report show our preliminary recommendations for the physical protection of retained trees throughout the construction phase. The plans indicate the location of protective barriers, as well as the specification for construction of the protective fencing in accordance with Figures 2 & 3 of the Standard. These barriers will form construction exclusion zones around the retained trees.
