## Arboricultural Impact Assessment

Tan Y Bont  
Main Road  
Rhosrobin  
Wrexham

Ref: P.1421.21

**Castle Green Homes**

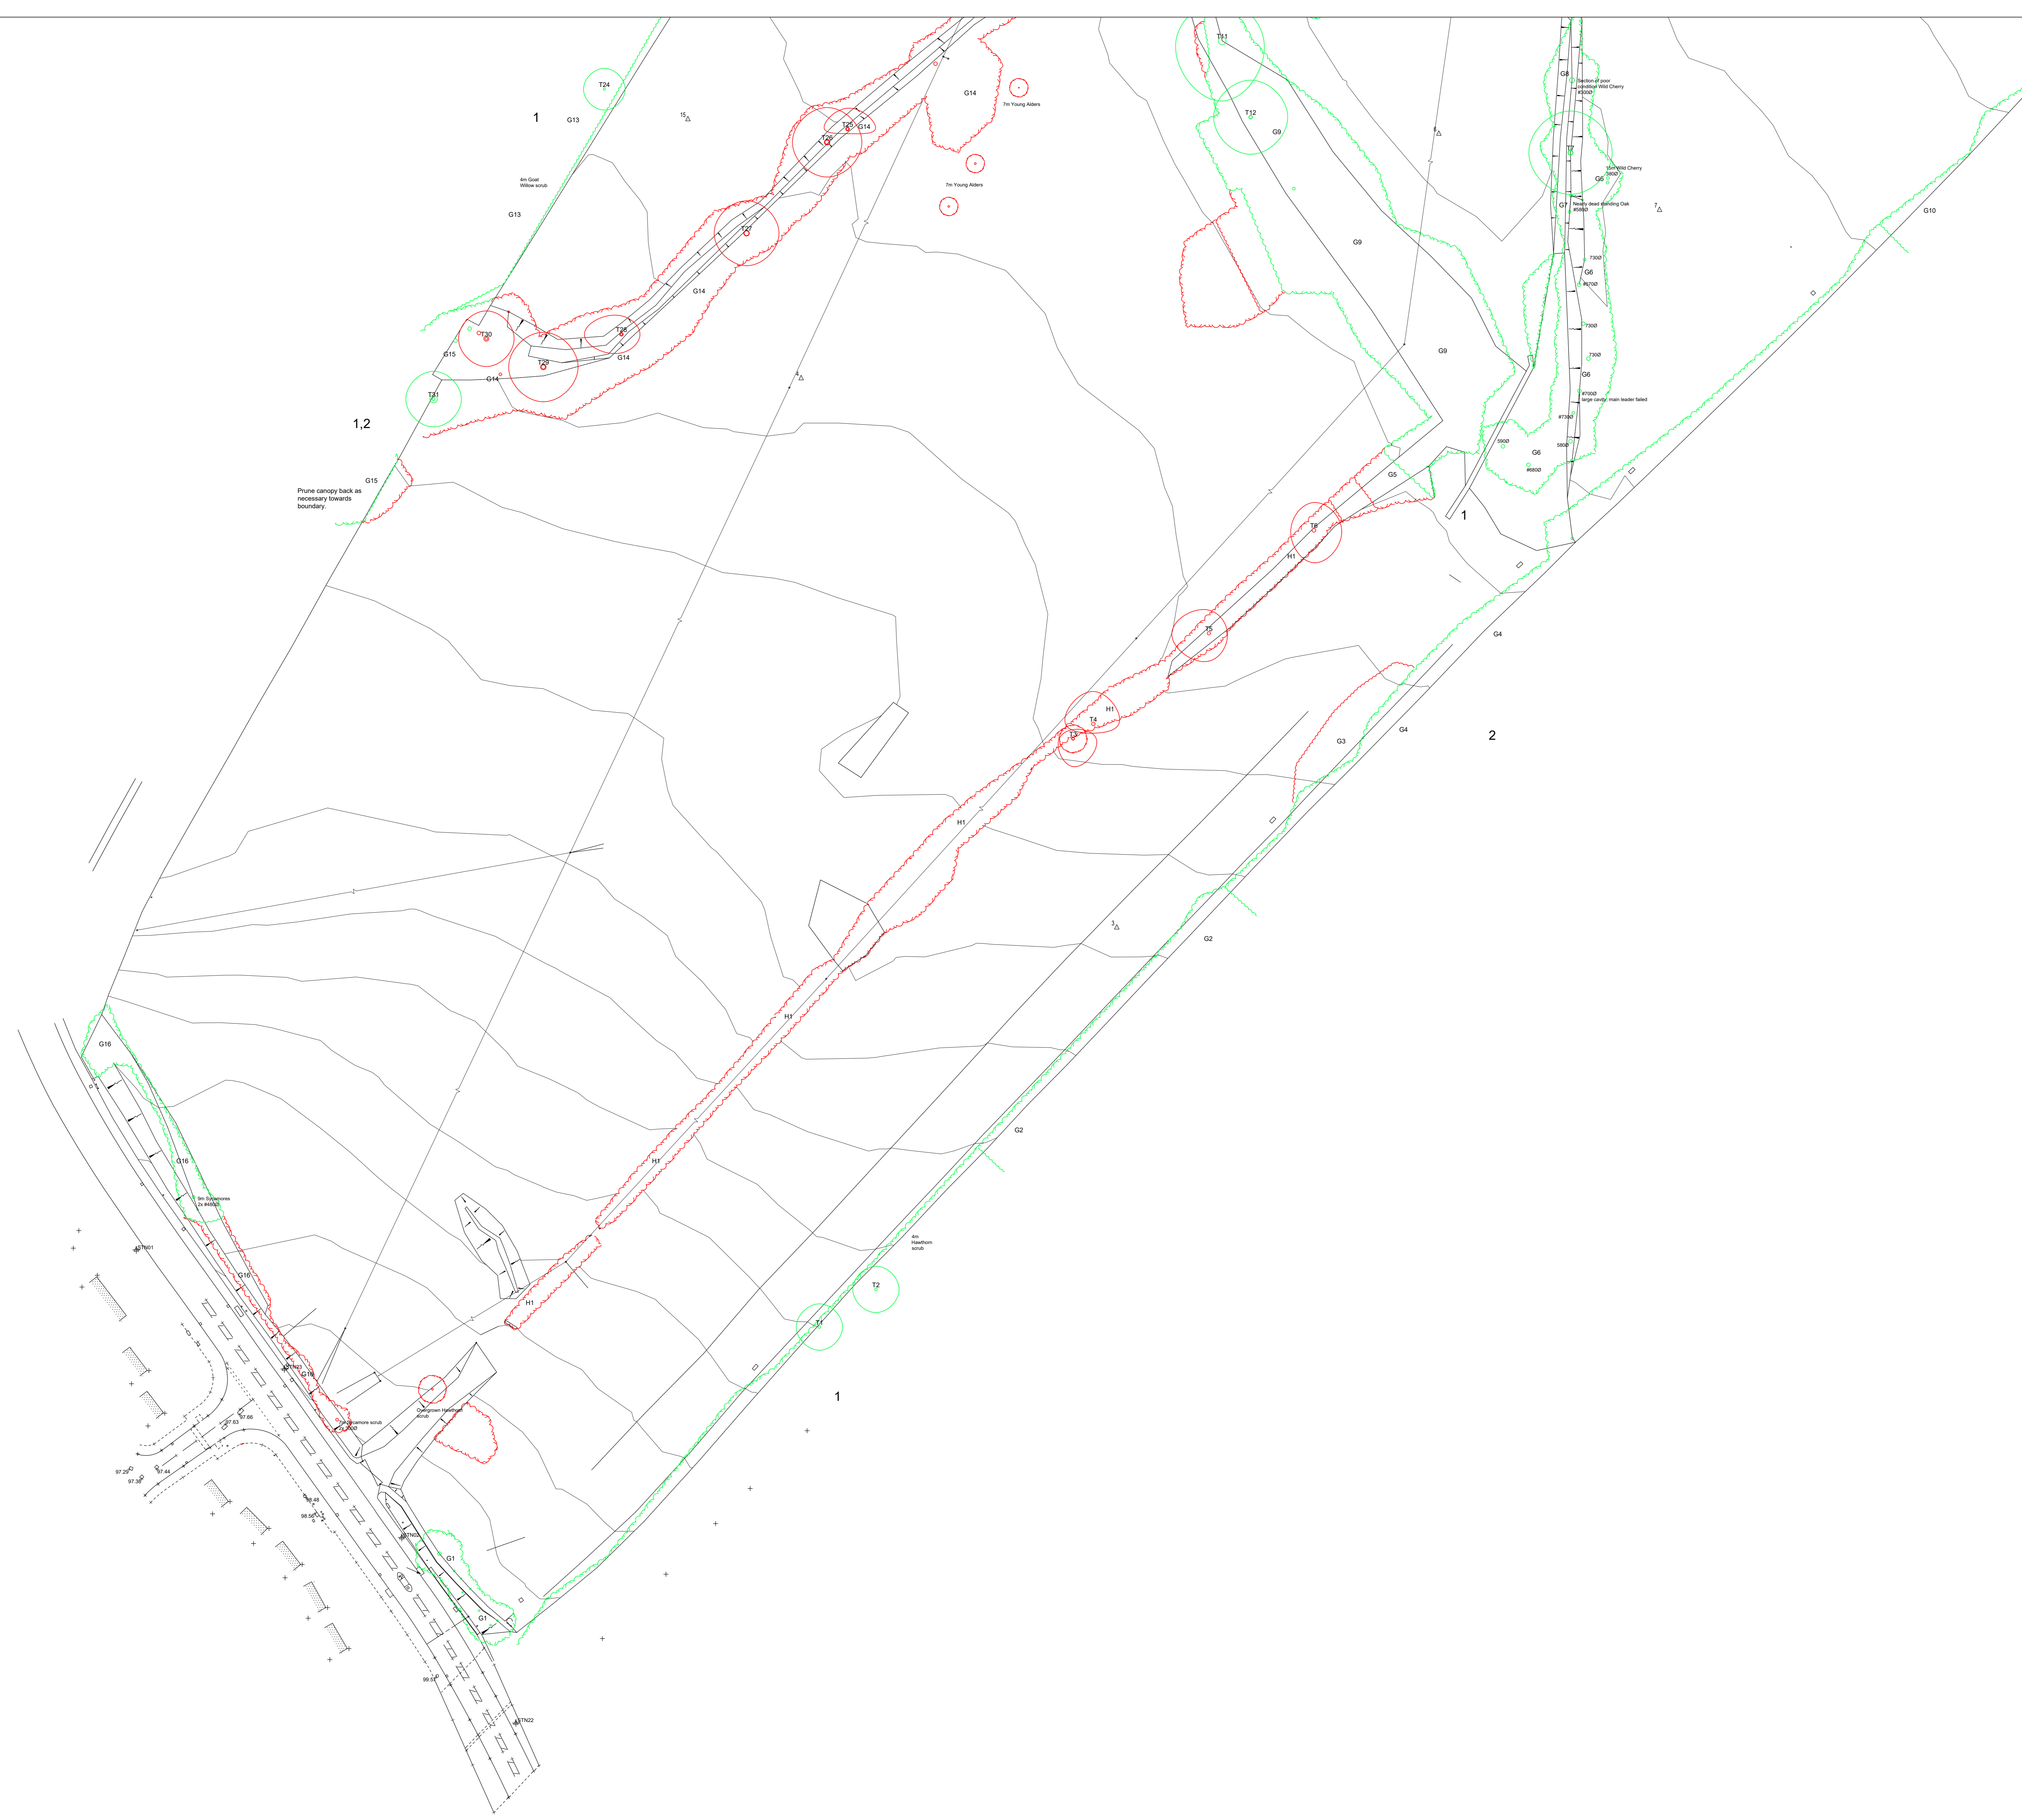
CLIENT: Castle Green Homes  
 PROJECT: Tan Y Bont, Main Road, Rhosrobin, Wrexham  
 DRAWING TITLE: Tree Survey and Tree Removal Plan  
 Sheet 1 of 2  
 SCALE: 1:500 @ A0 DRAWING No: REV  
 DRAWN BY: CP CHD BY: RA DATE: 27/01/2021 P: 1421.21.01 E

- 3.2** Thirty-one individual trees, sixteen groups of trees and six hedges were recorded during our survey, the details of which can be found within Appendix 1 to this report and cross referenced with drawing P.1421.21.01 *Tree Survey and Tree Removal Plan*.

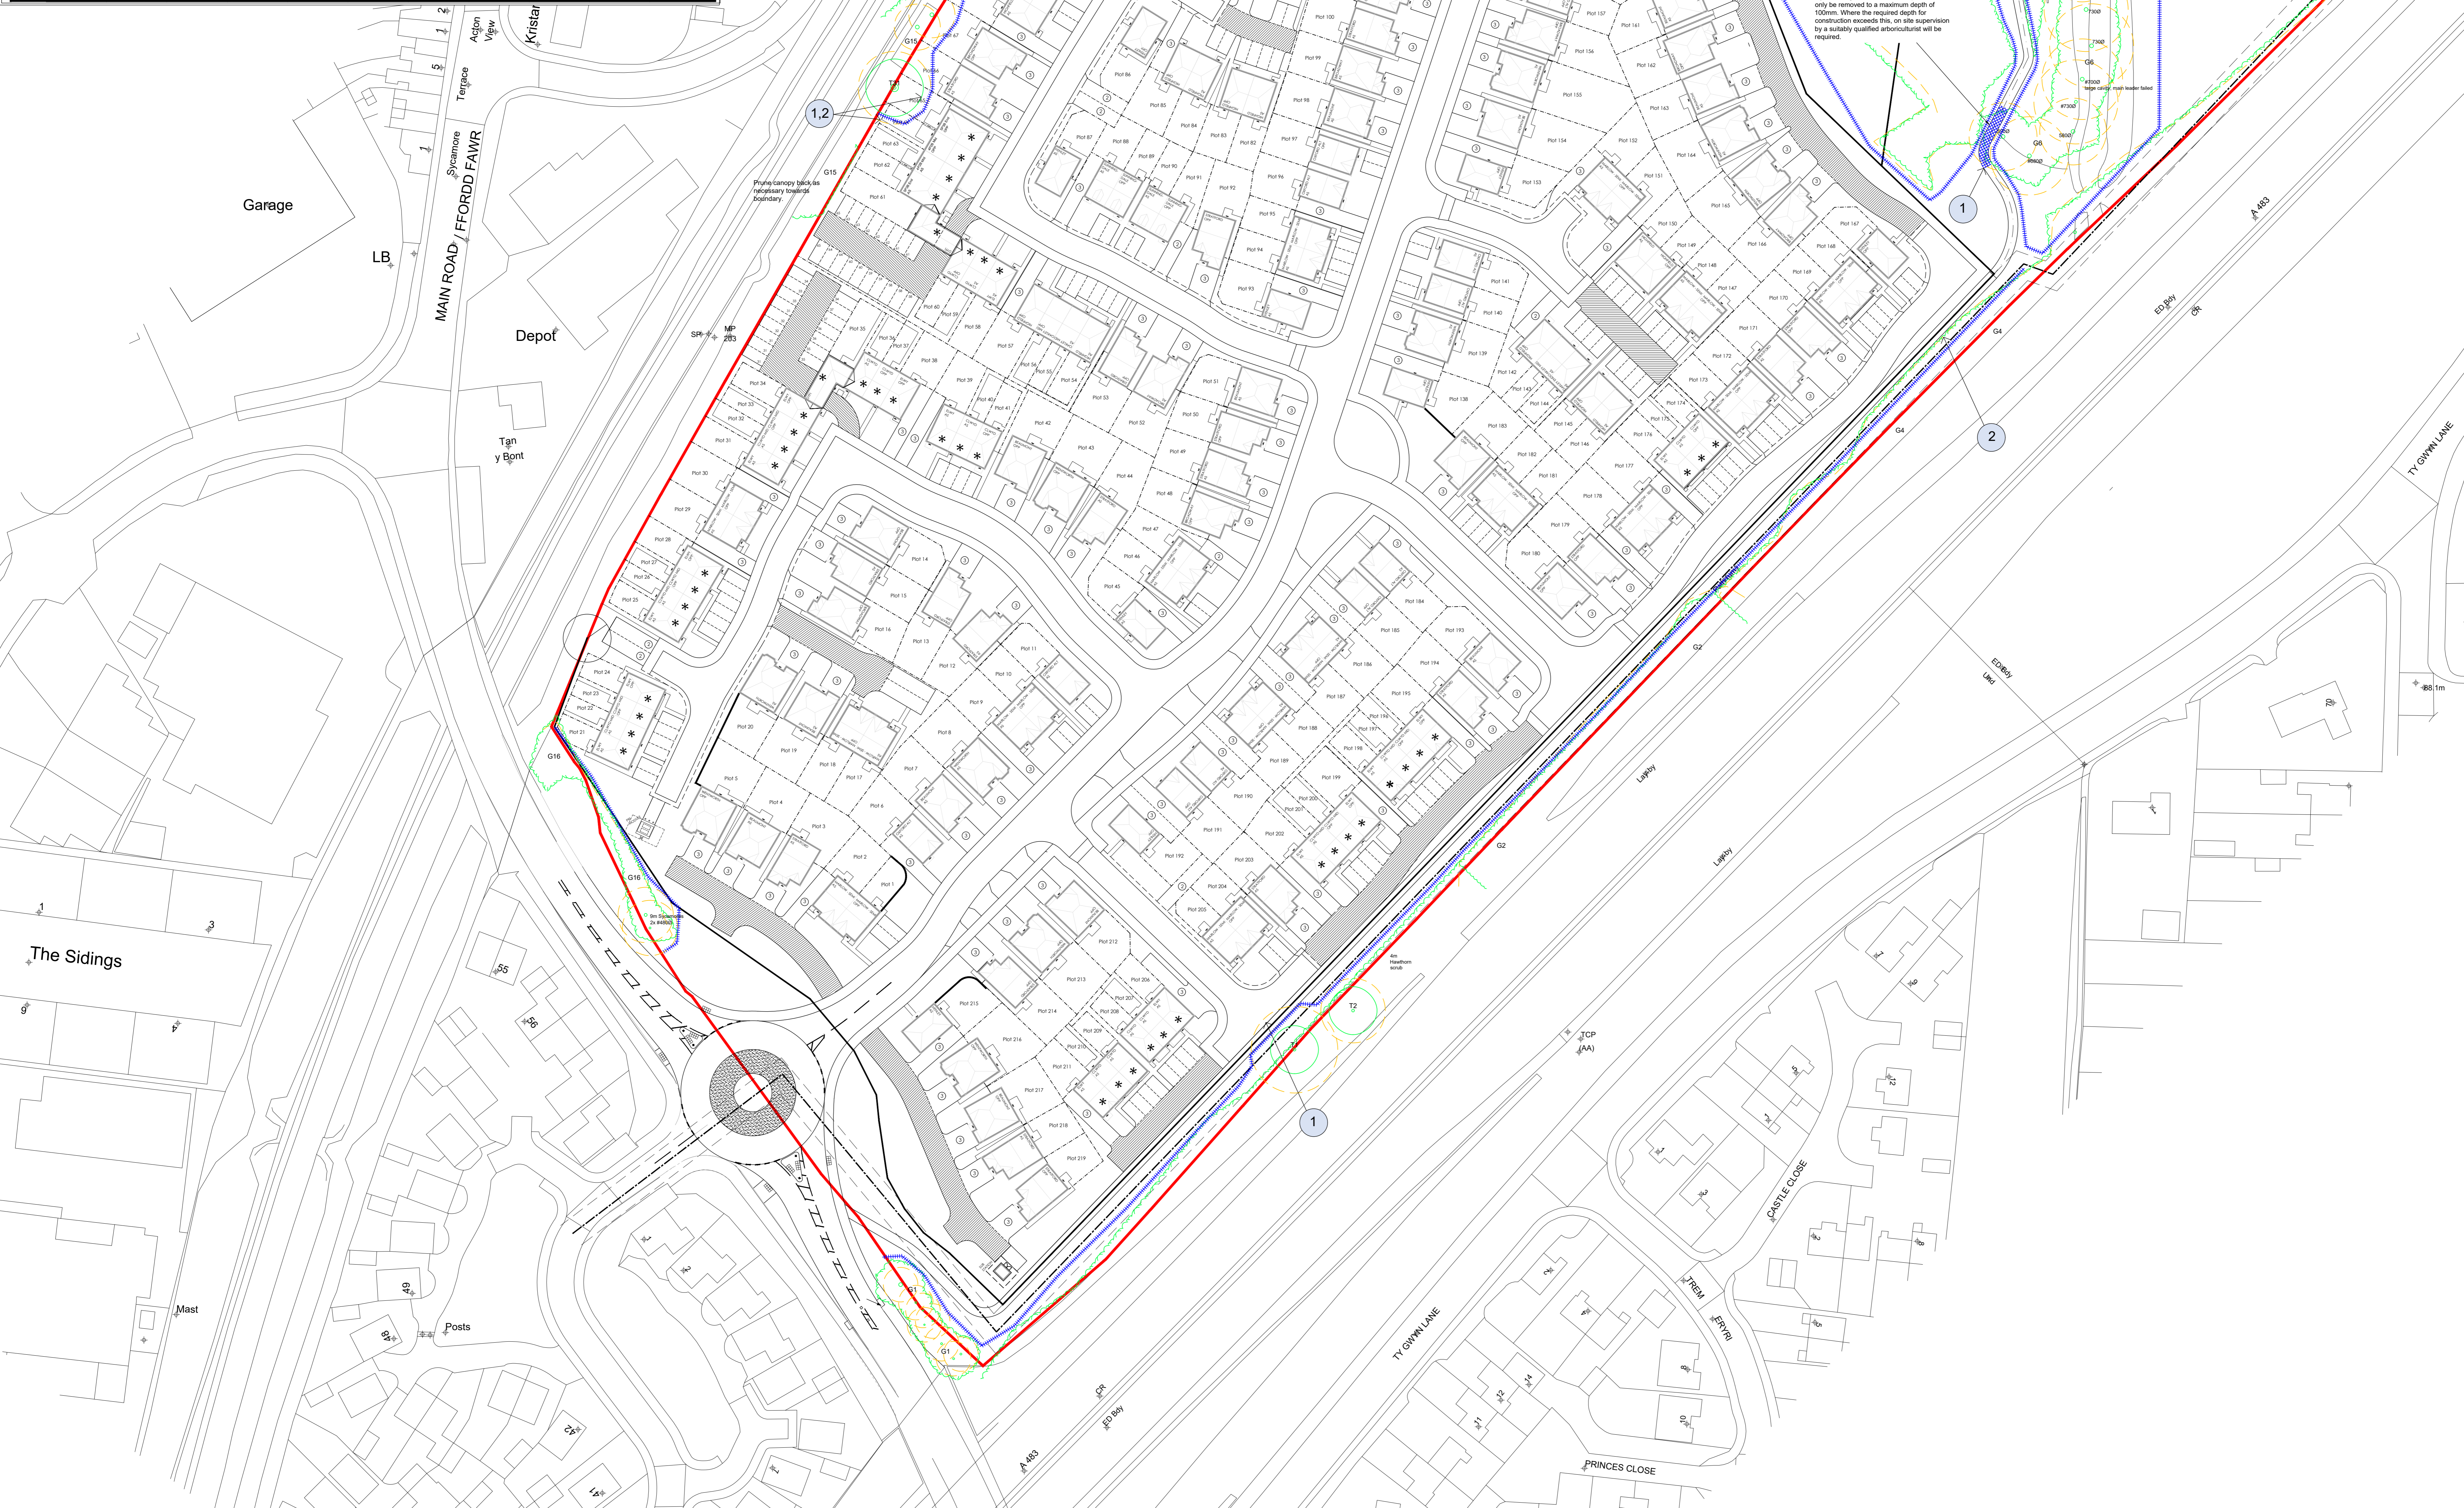
Potential Impact / Work Stage	Affecting	Protection Measure / Mitigation	Description / Specification and Procedure
<b>Construction Phase</b>			
1	Proposed areas of hard standing	T1 and T31	<ul style="list-style-type: none"> <li>Careful excavations</li> <li>Root pruning</li> </ul> <p>Machinery and plant to be located outside the root protection areas and excavations carried out slowly and progressively within and immediately adjacent root protection areas.</p> <p>Exposed roots to be pruned cleanly back to the soil surface as promptly as possible using hand tools appropriate to the task (secateurs / pruning saw).</p>
		T24, T11 and G6	<ul style="list-style-type: none"> <li>Specialised surface design/geotextiles and plastic permeable paving grid</li> </ul> <p>Surfaces to be constructed using a suitable plastic permeable paving grid where specified (Cellweb). There must be strictly no excavations beyond or deeper than the agreed / permitted extents in order to preserve as much root zone and live roots as possible.</p>

2	Canopy pruning	G4 and T31	<ul style="list-style-type: none"> <li>Pruning in accordance with British Standard</li> </ul> <p>Works to be carried out by a suitably qualified, competent tree surgeon. No large diameter, main branches to be removed. Pruning works to be carried out in accordance with BS3998:2010 Tree Work: Recommendations.</p>

2	Canopy pruning	G4 and T31	<ul style="list-style-type: none"> <li>Pruning in accordance with British Standard</li> </ul>	Works to be carried out by a suitably qualified, competent tree surgeon. No large diameter, main branches to be removed. Pruning works to be carried out in accordance with BS3998:2010 Tree Work: Recommendations.

5.2 On the basis of the above and the contents of this report, it is considered appropriate that an Arboricultural Method Statement be prepared to demonstrate how trees proposed for retention can be suitably safeguarded. The Arboricultural Method Statement can be secured by way of an appropriately worded planning condition attached to the consent for the development and should be adopted as a control document by site personnel.
