Phase II Geoenvironmental Site Assessment
Well Street, Buckley

Reference: 14-278-R2
Date: October 2020

Proposed Residential Development
Well Street
Buckley
Wales
CH7 2PQ

Prepared for:
Alan Johnston Partnership Ltd

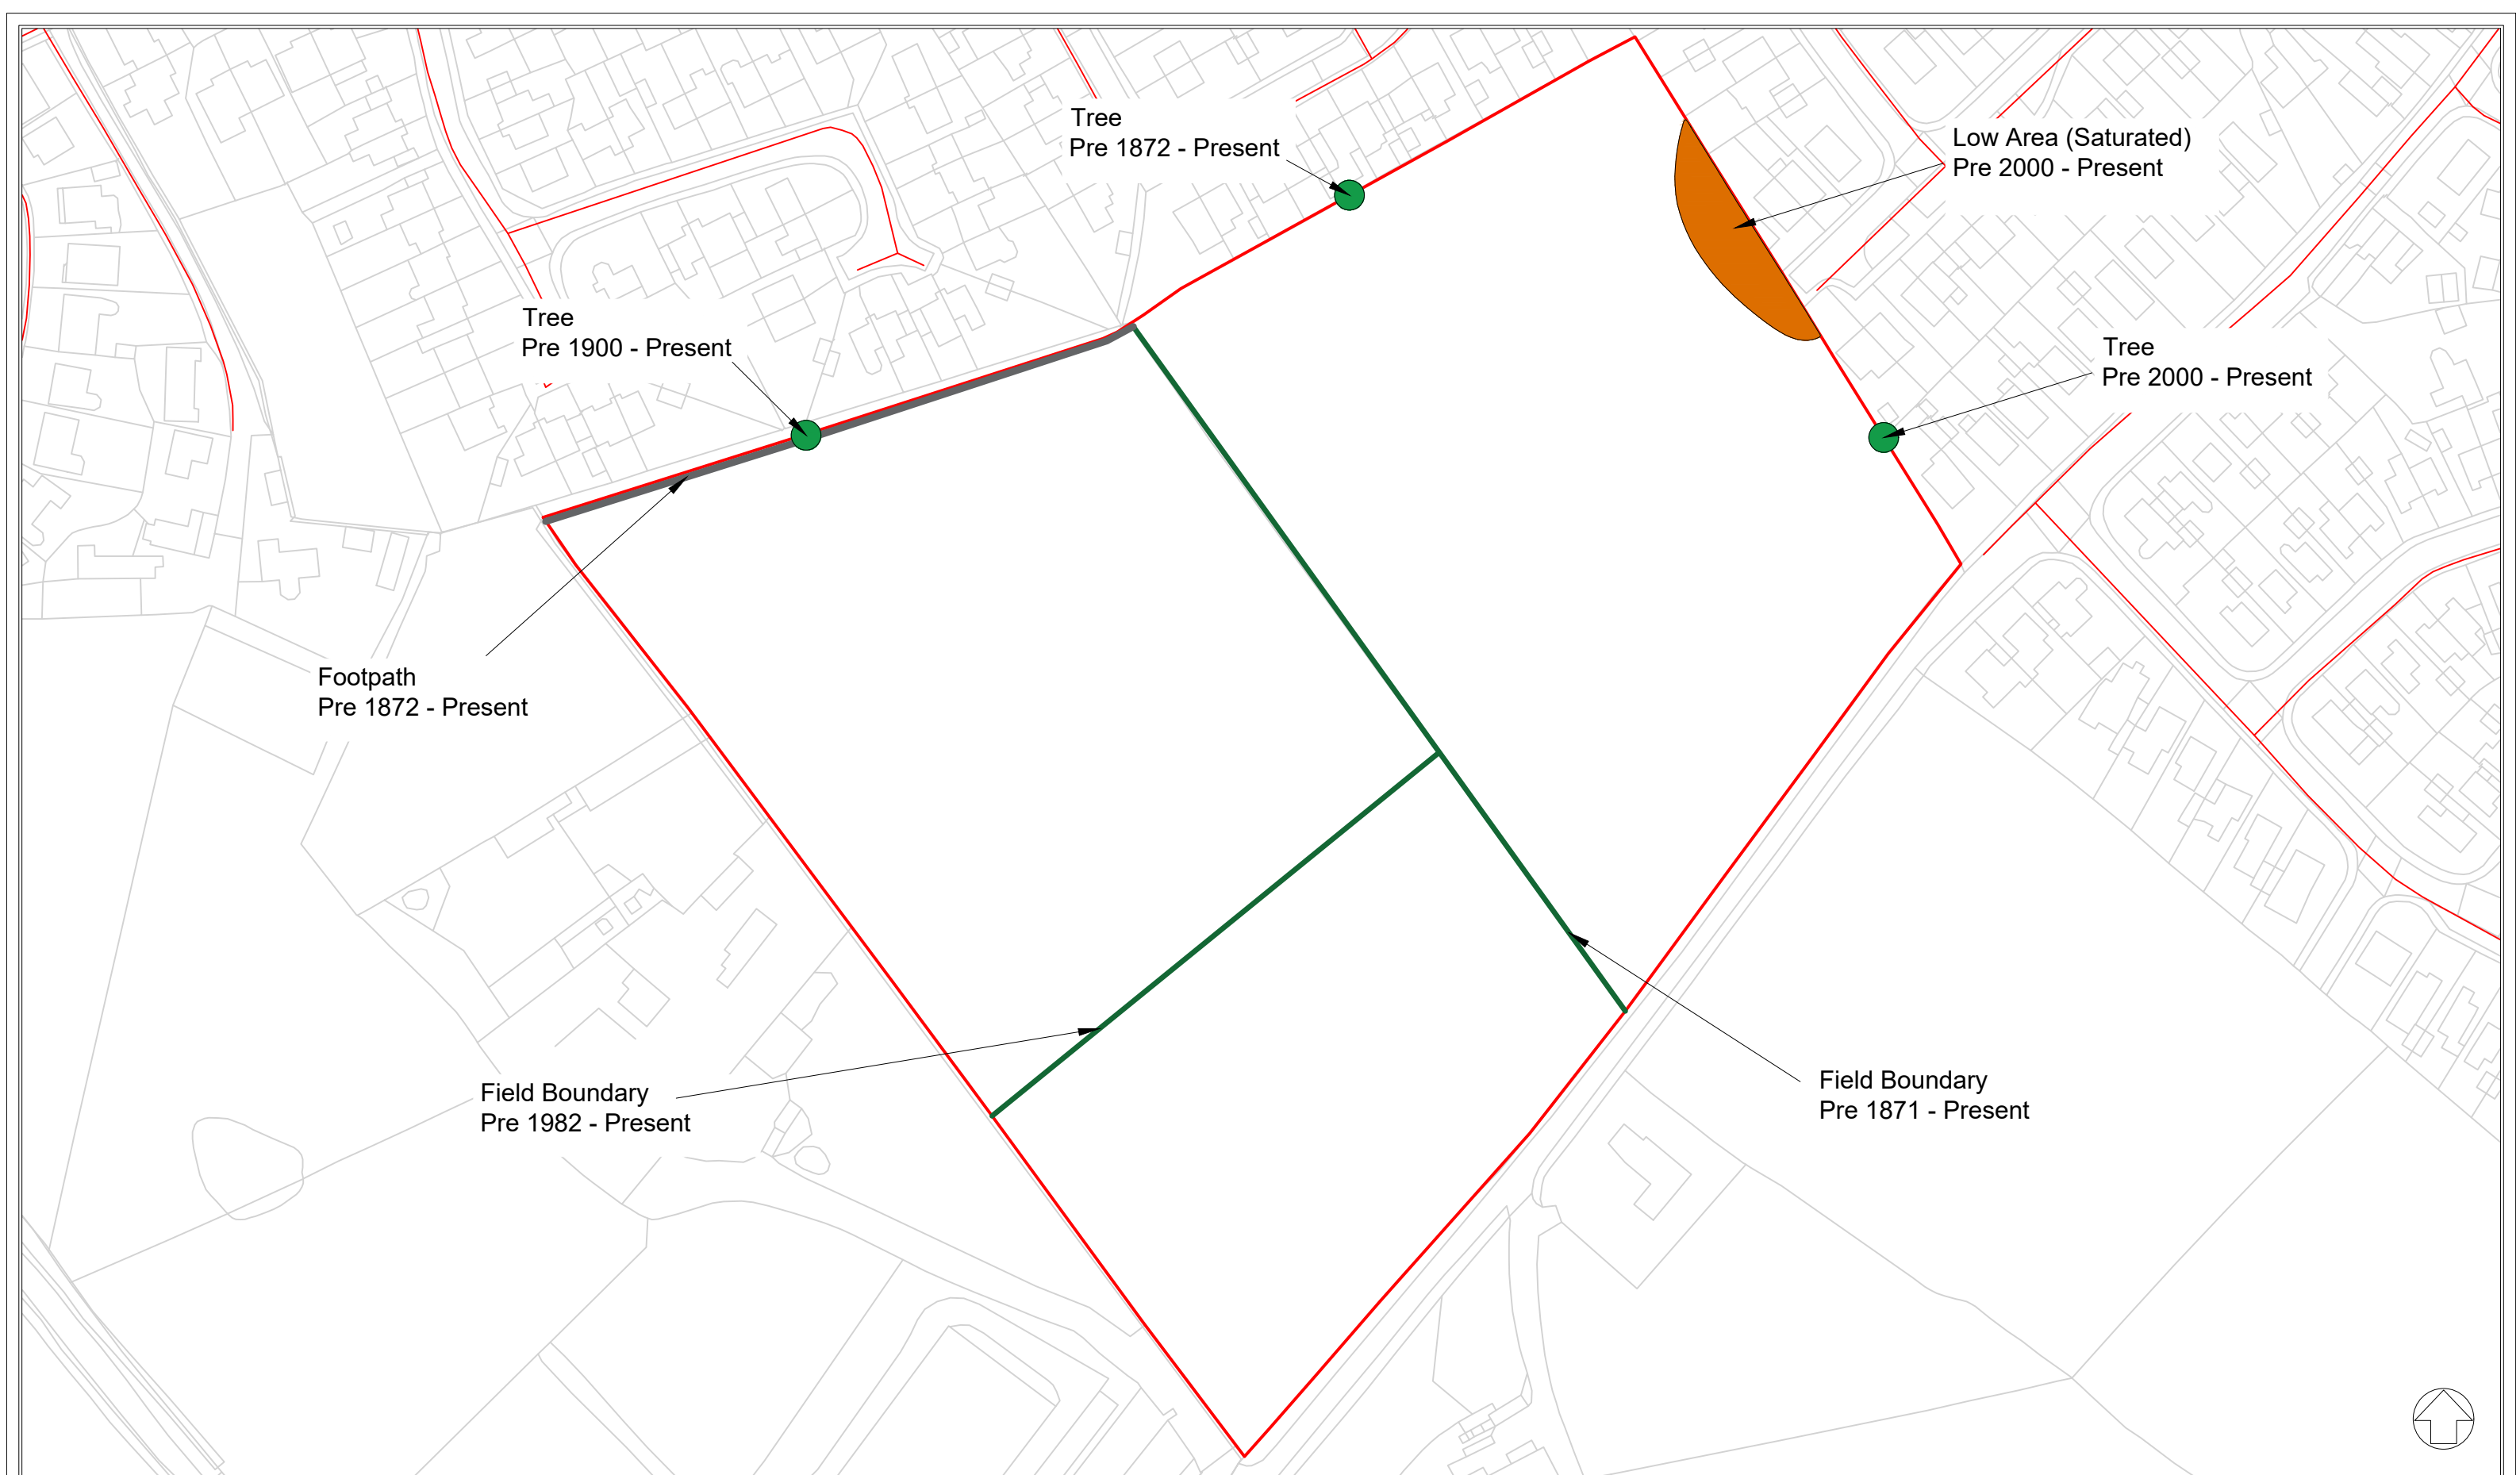
Drawing Title:
Historical Features
Plan

- Historical Features**
- Field Boundary
 - Footpath
 - Low Area
 - Trees

| | On the 1872 mapping, a pond in noted on the northern boundary however, this was infilled by 1899. | |
| | A hedgerow is noted to be present between 1982 and 1987 cutting the southern field through the centre. No changes have occurred since. | |

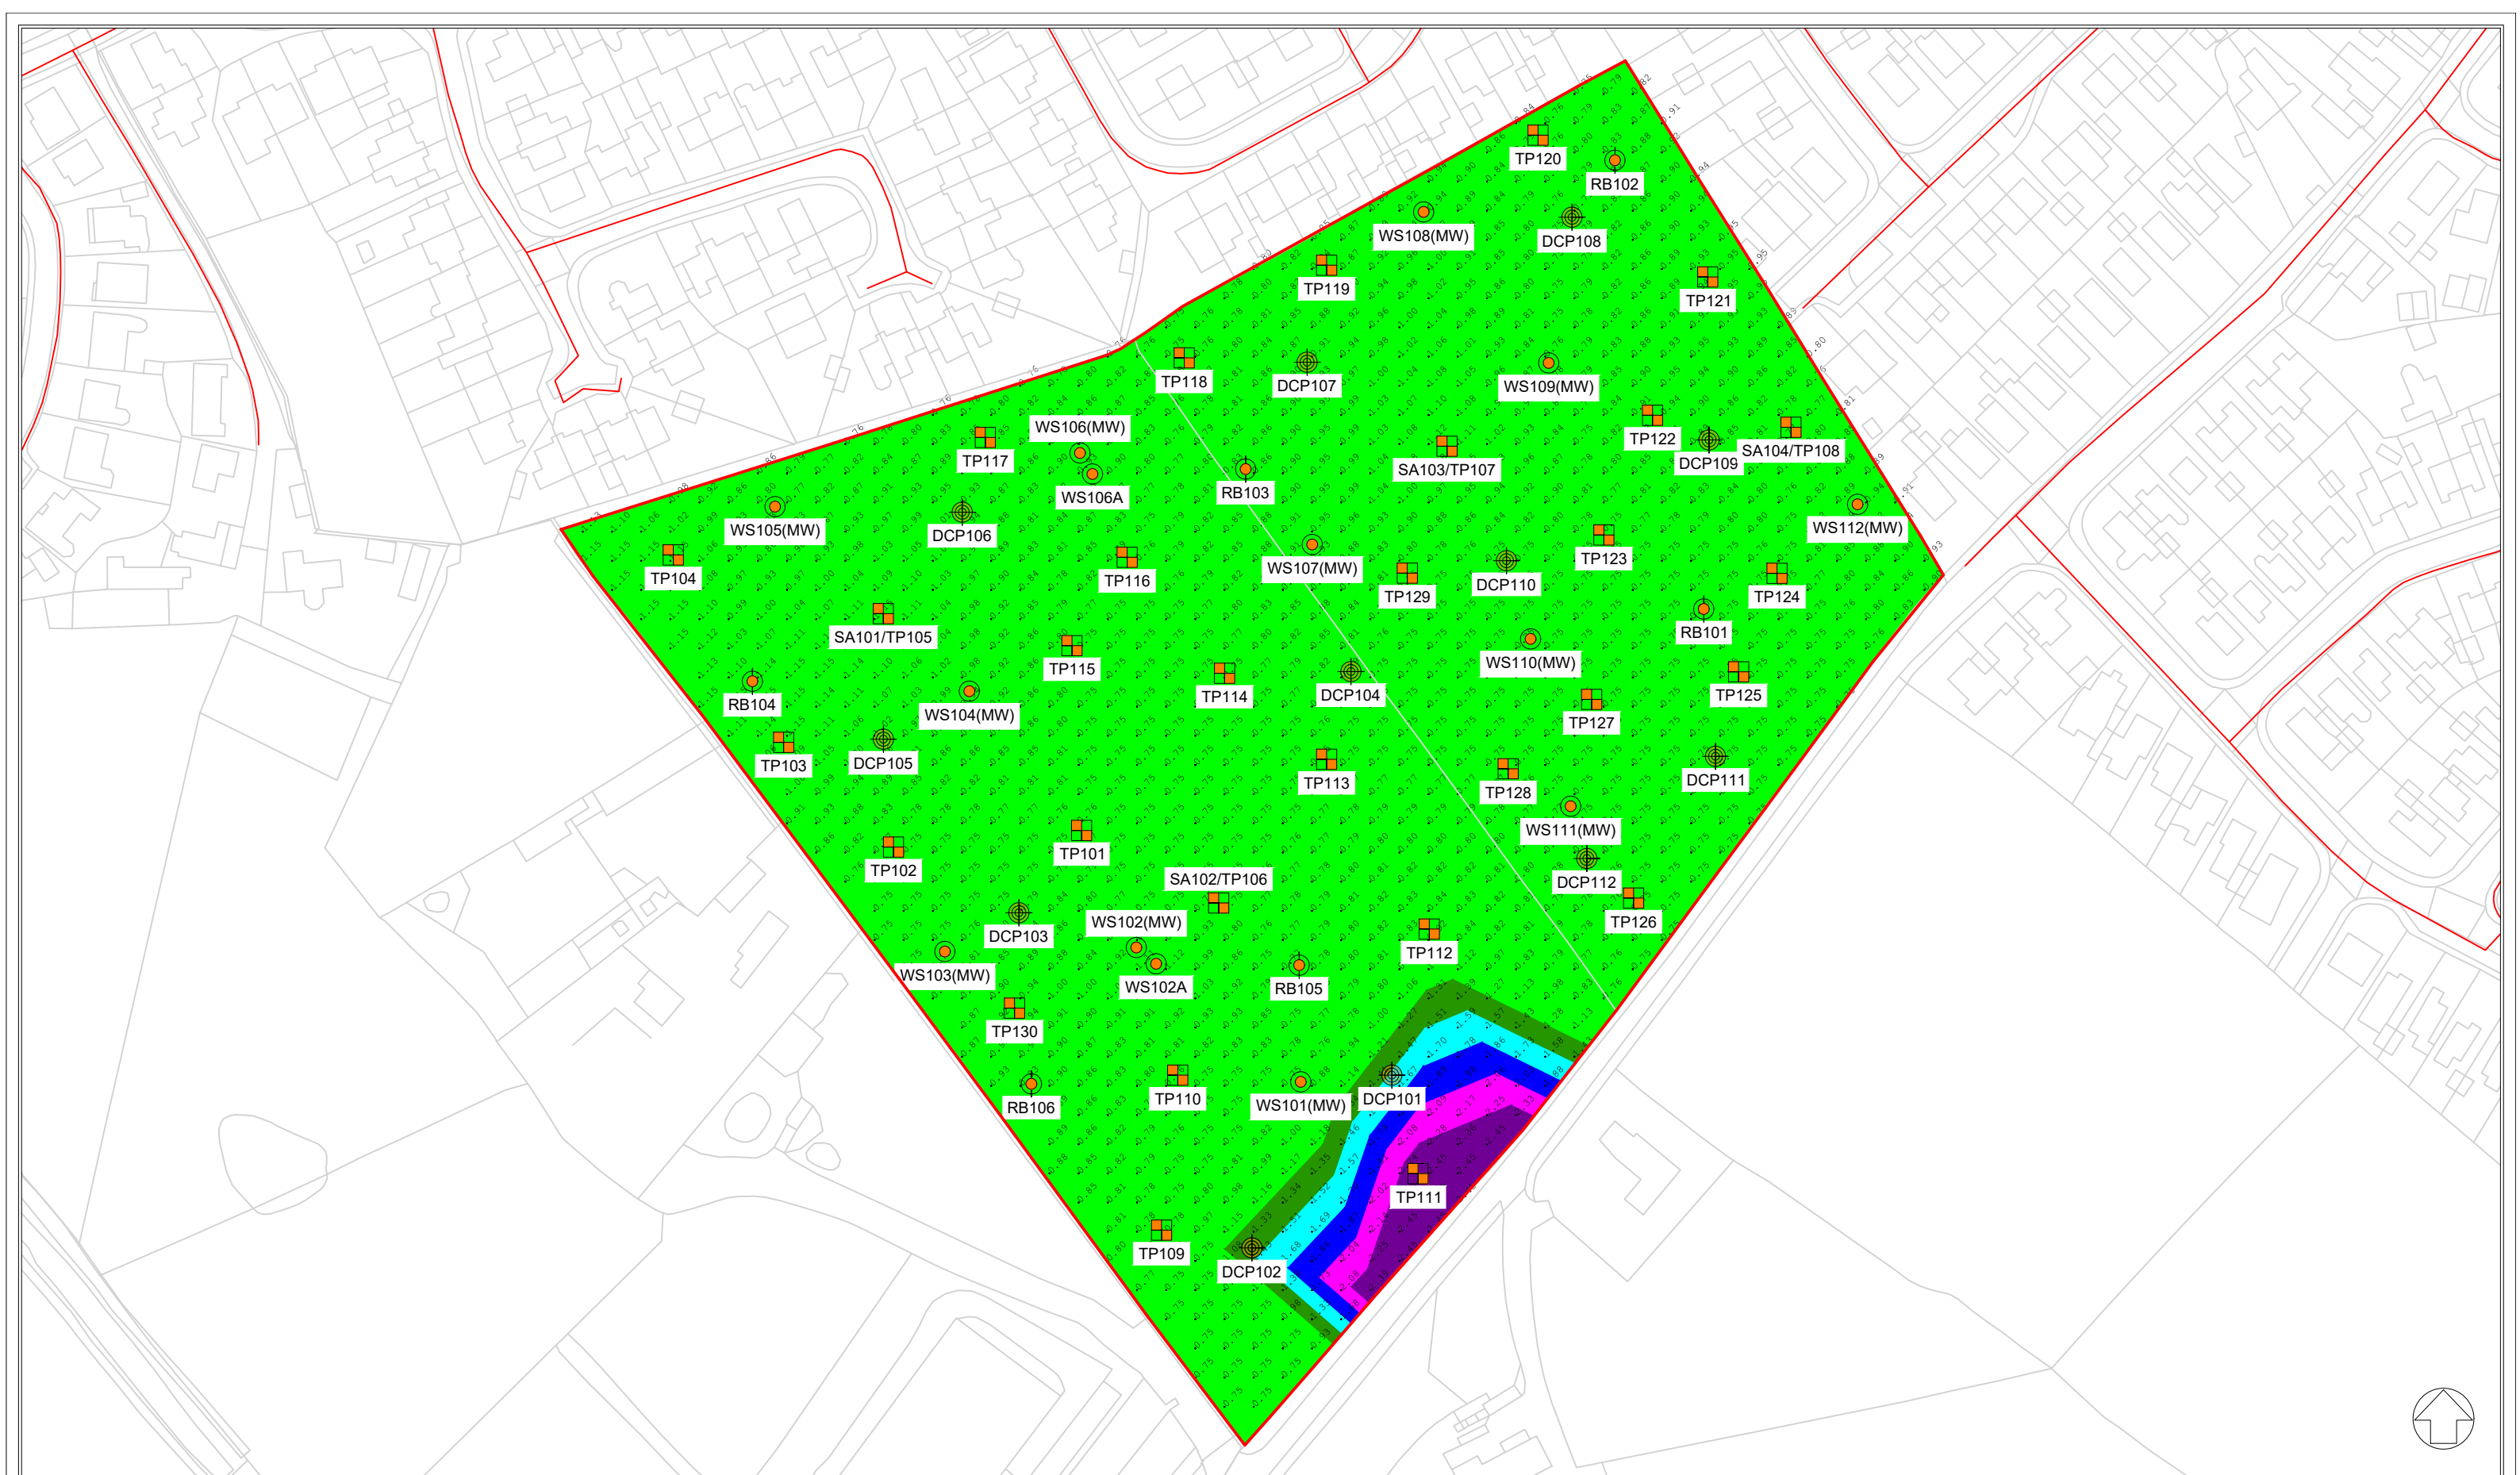
- Shallow Spread Footings**
- Depth to Founding Strata 0.00 - 1.24m
 - Depth to Founding Strata 1.25 - 1.49m
- Mass Trench Fill Footings**
- Depth to Founding Strata 1.50 - 1.74m
 - Depth to Founding Strata 1.75 - 1.99m
 - Depth to Founding Strata 2.00 - 2.24m
- Engineered Footings**
- Depth to Founding Strata 2.25 - 2.49m
 - Depth to Founding Strata >2.50m

| <p>Foundation Options</p> | <p>Due to the existing large variances in the site topography, a phase of cut-and-fill enabling works will be required in order to create a proposed development platform suitable for a residential development. This will generally comprise stepping levels through the site as the road to the south and property to the north currently tie into the site at the boundaries.</p> |

| <p>Foundation Options Continued...</p> | <p>Therefore, upon completion of these enabling works, it is likely that the most cost-effective option for the majority of the site would be to construct plots utilising a shallow strip, spread foundation or mass trench fill.</p> <p>Peat was not encountered during the E3P site investigation however, where this is recorded in previous investigation E3P identified a soft clay. As such, foundations may require deepening to a structural engineering design to tolerate risks associated with the compressibility of the materials and to tolerate total and differential settlement across the plot footprint.</p> <p>Subject to finished levels it is expected that <5% of the site may require a deep mass trench or driven pile foundation solution.</p> <p>Foundation depths within the conjectured influence of former, existing or proposed trees will need to be deepened to ensure that structural loading bears within the underlying target founding stratum, which cannot be subject to volumetric instability associated with fluctuation in moisture content.</p> |

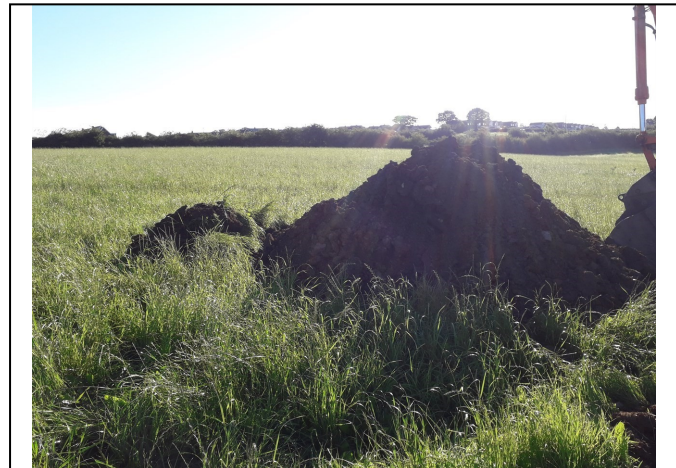
Trial Pit 101

Remarks: Complete. Unable to complete hand shear vane due to friable nature of clay.

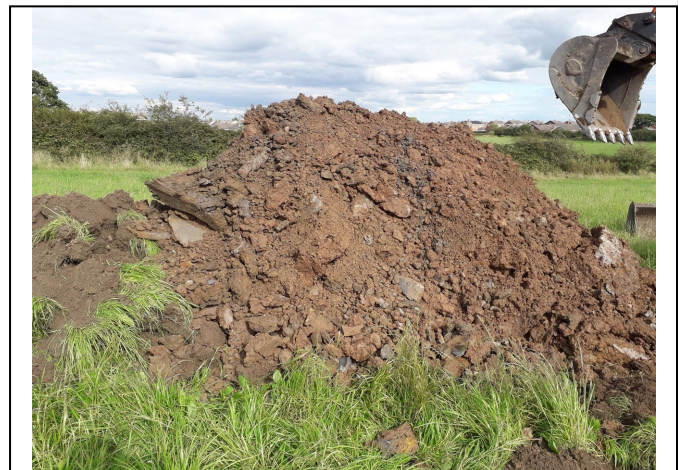
Trial Pit 116

Remarks: 1. Complete. 2. Steady water seepage encountered at 3.20 m bgl.

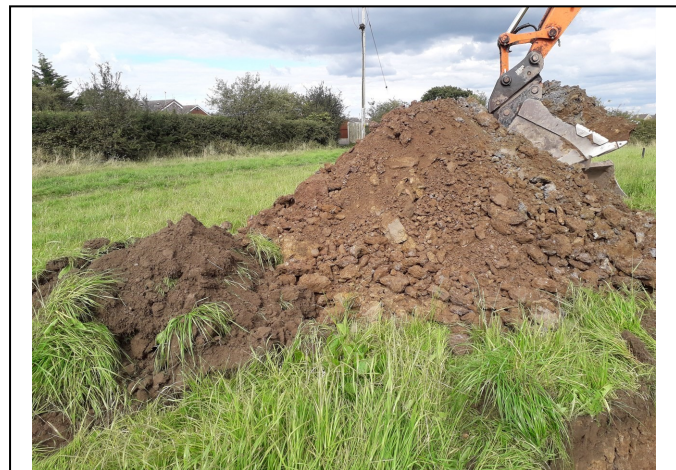
Trial Pit 117

Remarks: 1. Complete. 2. Steady water seepage encountered at 2.00 m bgl.

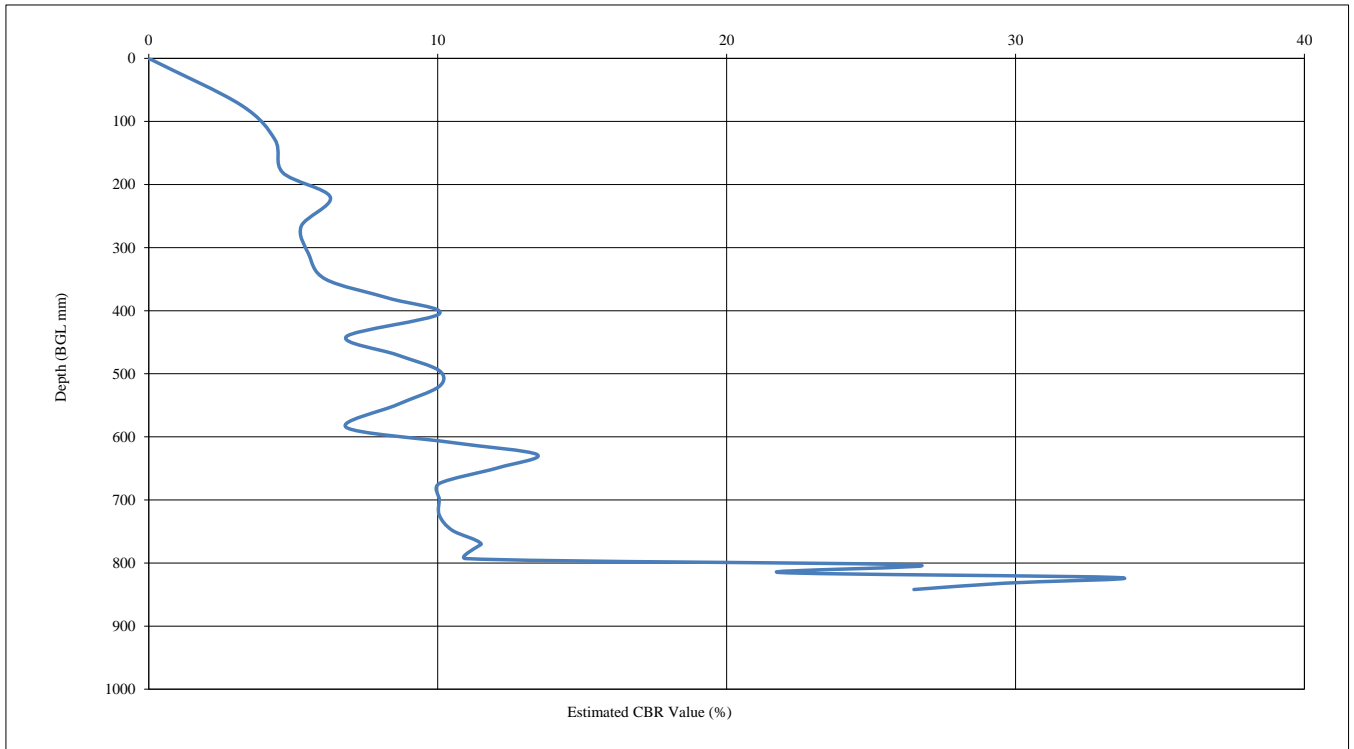
Estimated California Bearing Ratio Graph

| Start Depth (mm) BGL | Finish Depth (mm) BGL | No. of Blows | Blows Per Layer | DCP mm/Blows | Ave Estimated Layer (CBR %) |
|---|---|---|---|---|---|
| 0 | 220 | 4 | 4 | 55.00 | 4.37 |
