**BROWNFIELD
SOLUTIONS LTD**

CASTLE GREEN HOMES

Mindale Farm, Meliden

Mining Risk Assessment

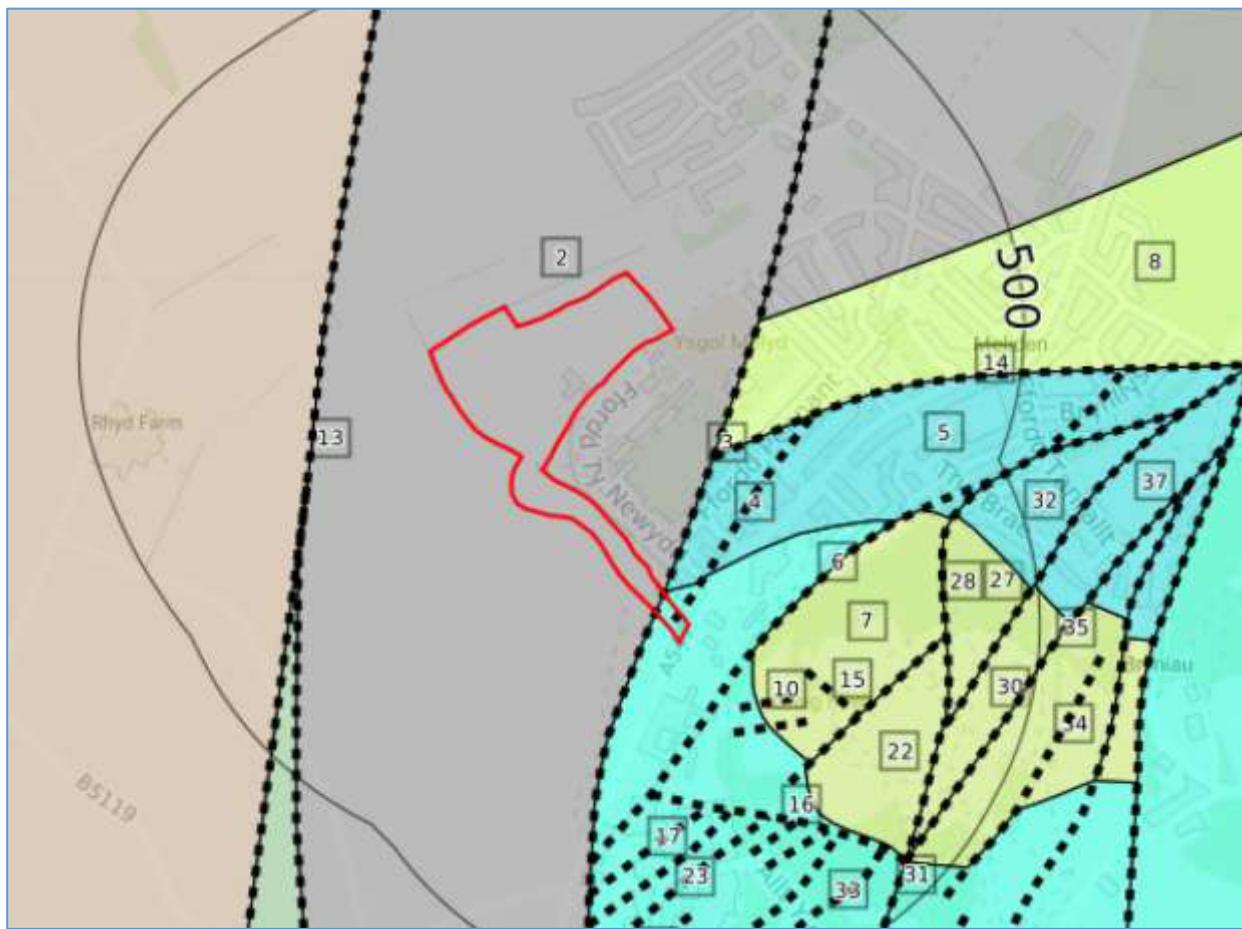
The geology of the site and the surrounding area is shown on the Geological Map Extract, Drawing No. C6347/03, and also below.

Site Boundary in red. 3: Fault. 4: Talargoch Vein. 13: Fault and Panton Vein

A fault is shown to traverse the southern part of the site in a north to south direction, downthrown to the west. However, any movements associated with this fault should now have stopped.

The site is in an area where mineral veins are abundant to the south-east of the site. Based on geological mapping, information gained from the BGS maps, geological memoir and the Mining Remediation Authority Interactive Map, the following veins are shown to subcrop and dip beneath the site at approximately 14° to the north-west.

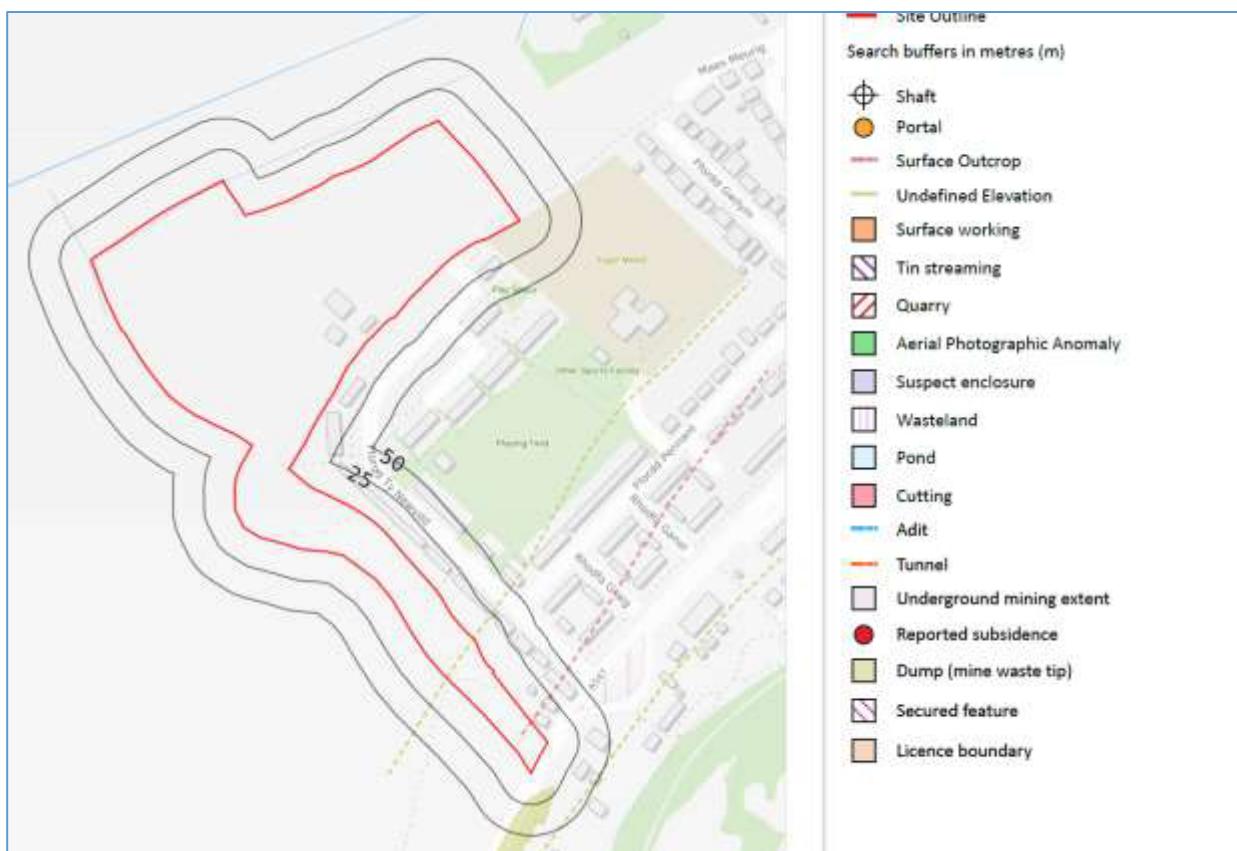
The above extract from the Groundsure report shows an additional lead vein, of an undefined elevation, sub-cropping beneath the site.

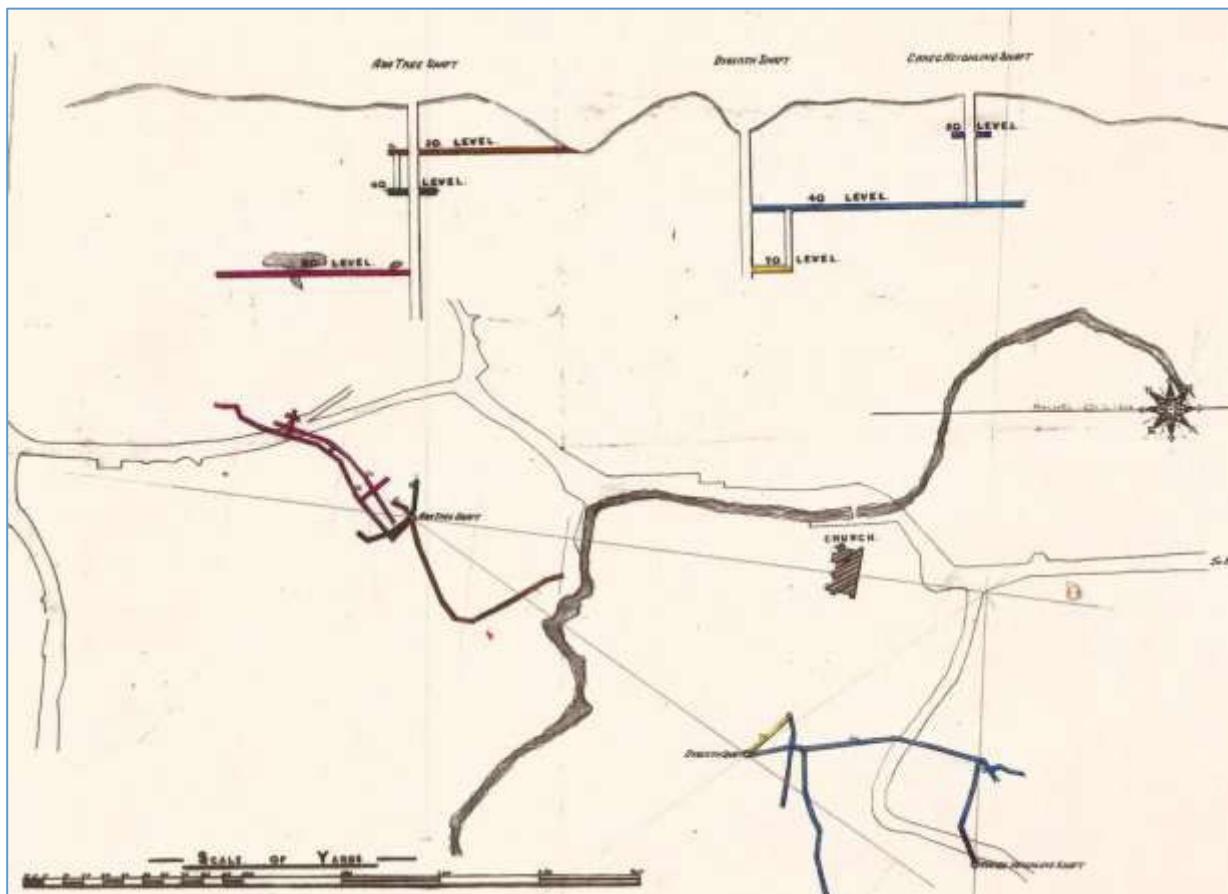
A plan and section map of the Talargoch Lead Mine at Dyerth, reference 55085E/39, shows four distinct working levels of the mineral veins, at 20ft bgl, 40ft bgl, 70ft bgl, and 80ft bgl. All four of the levels are shown to be horizontal, as shown in the extract below.

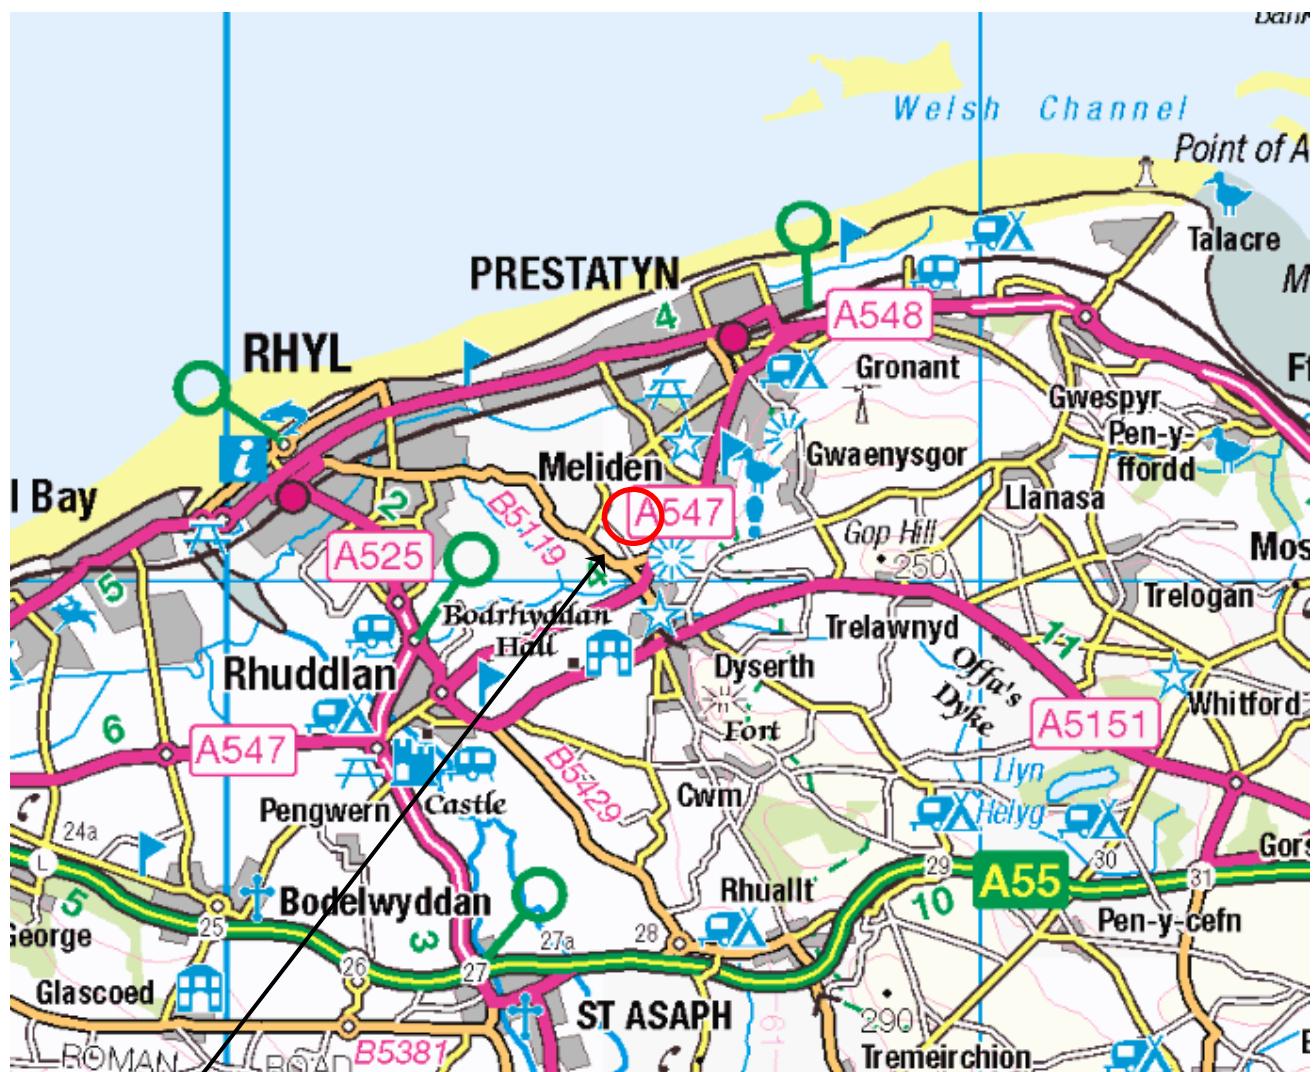
SITE LOCATION

NEAREST POSTCODE: LL19 8PG

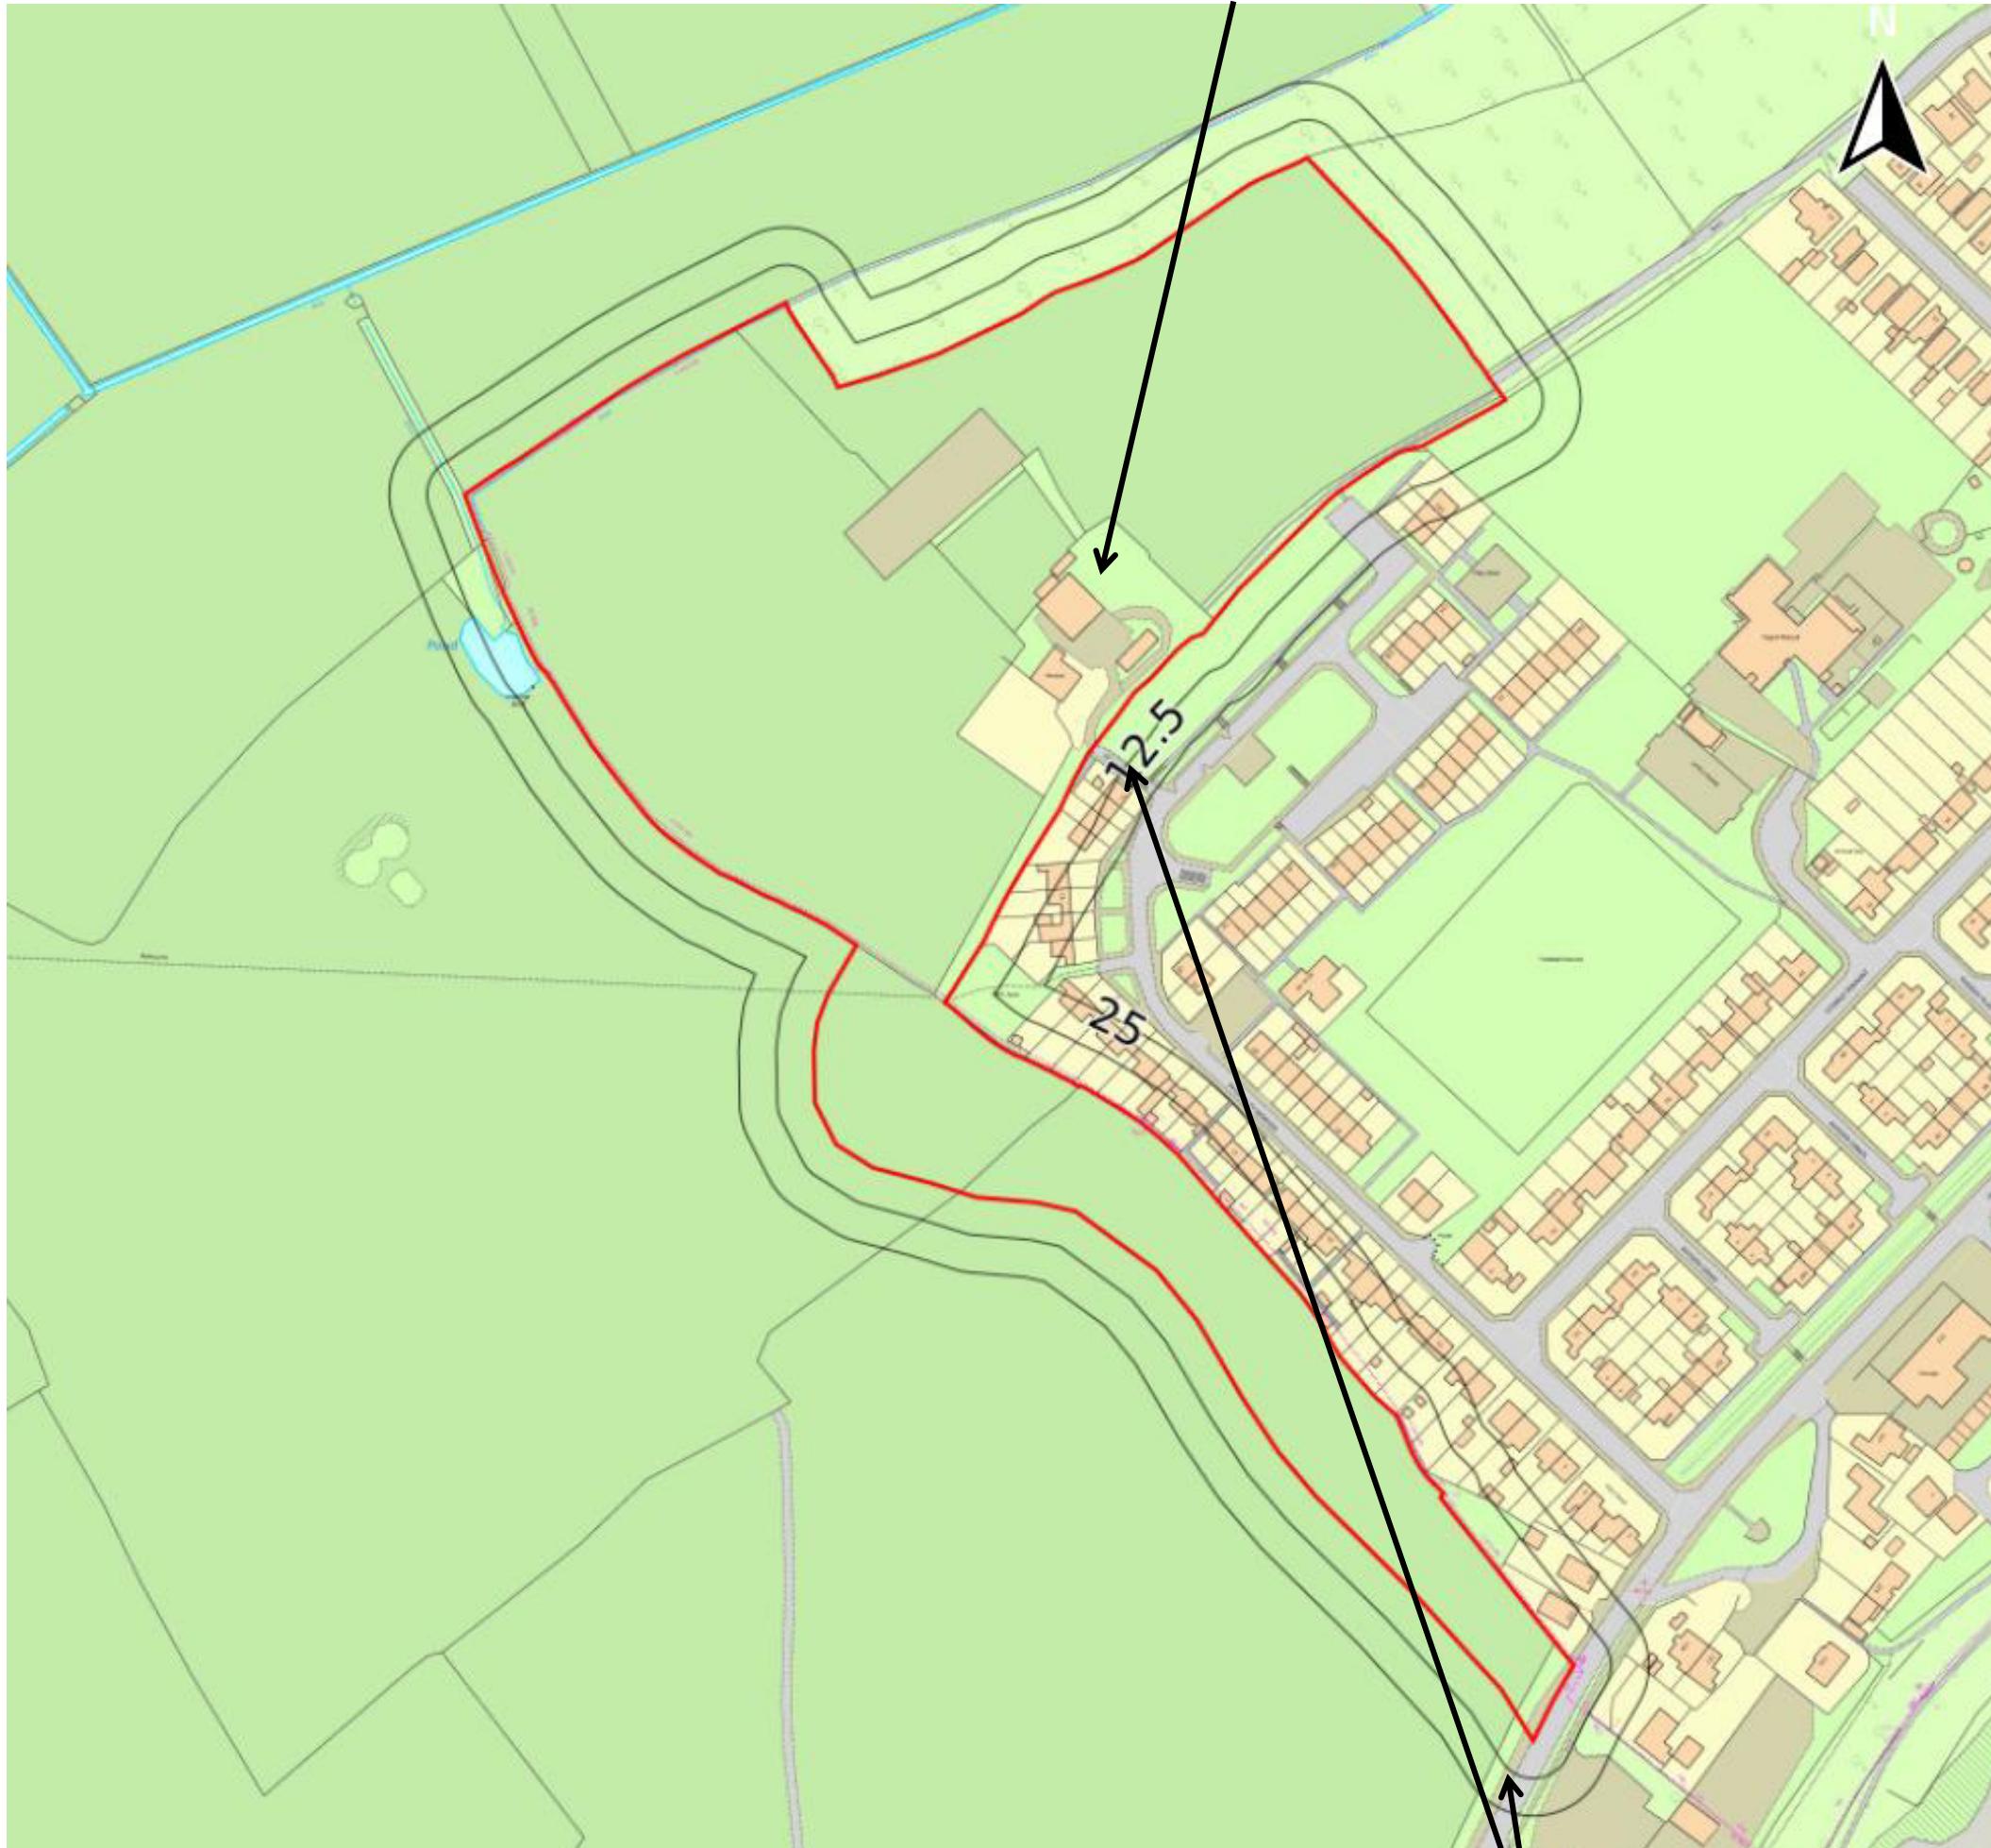
EXISTING FARM
BUILDINGS

SITE ACCESS

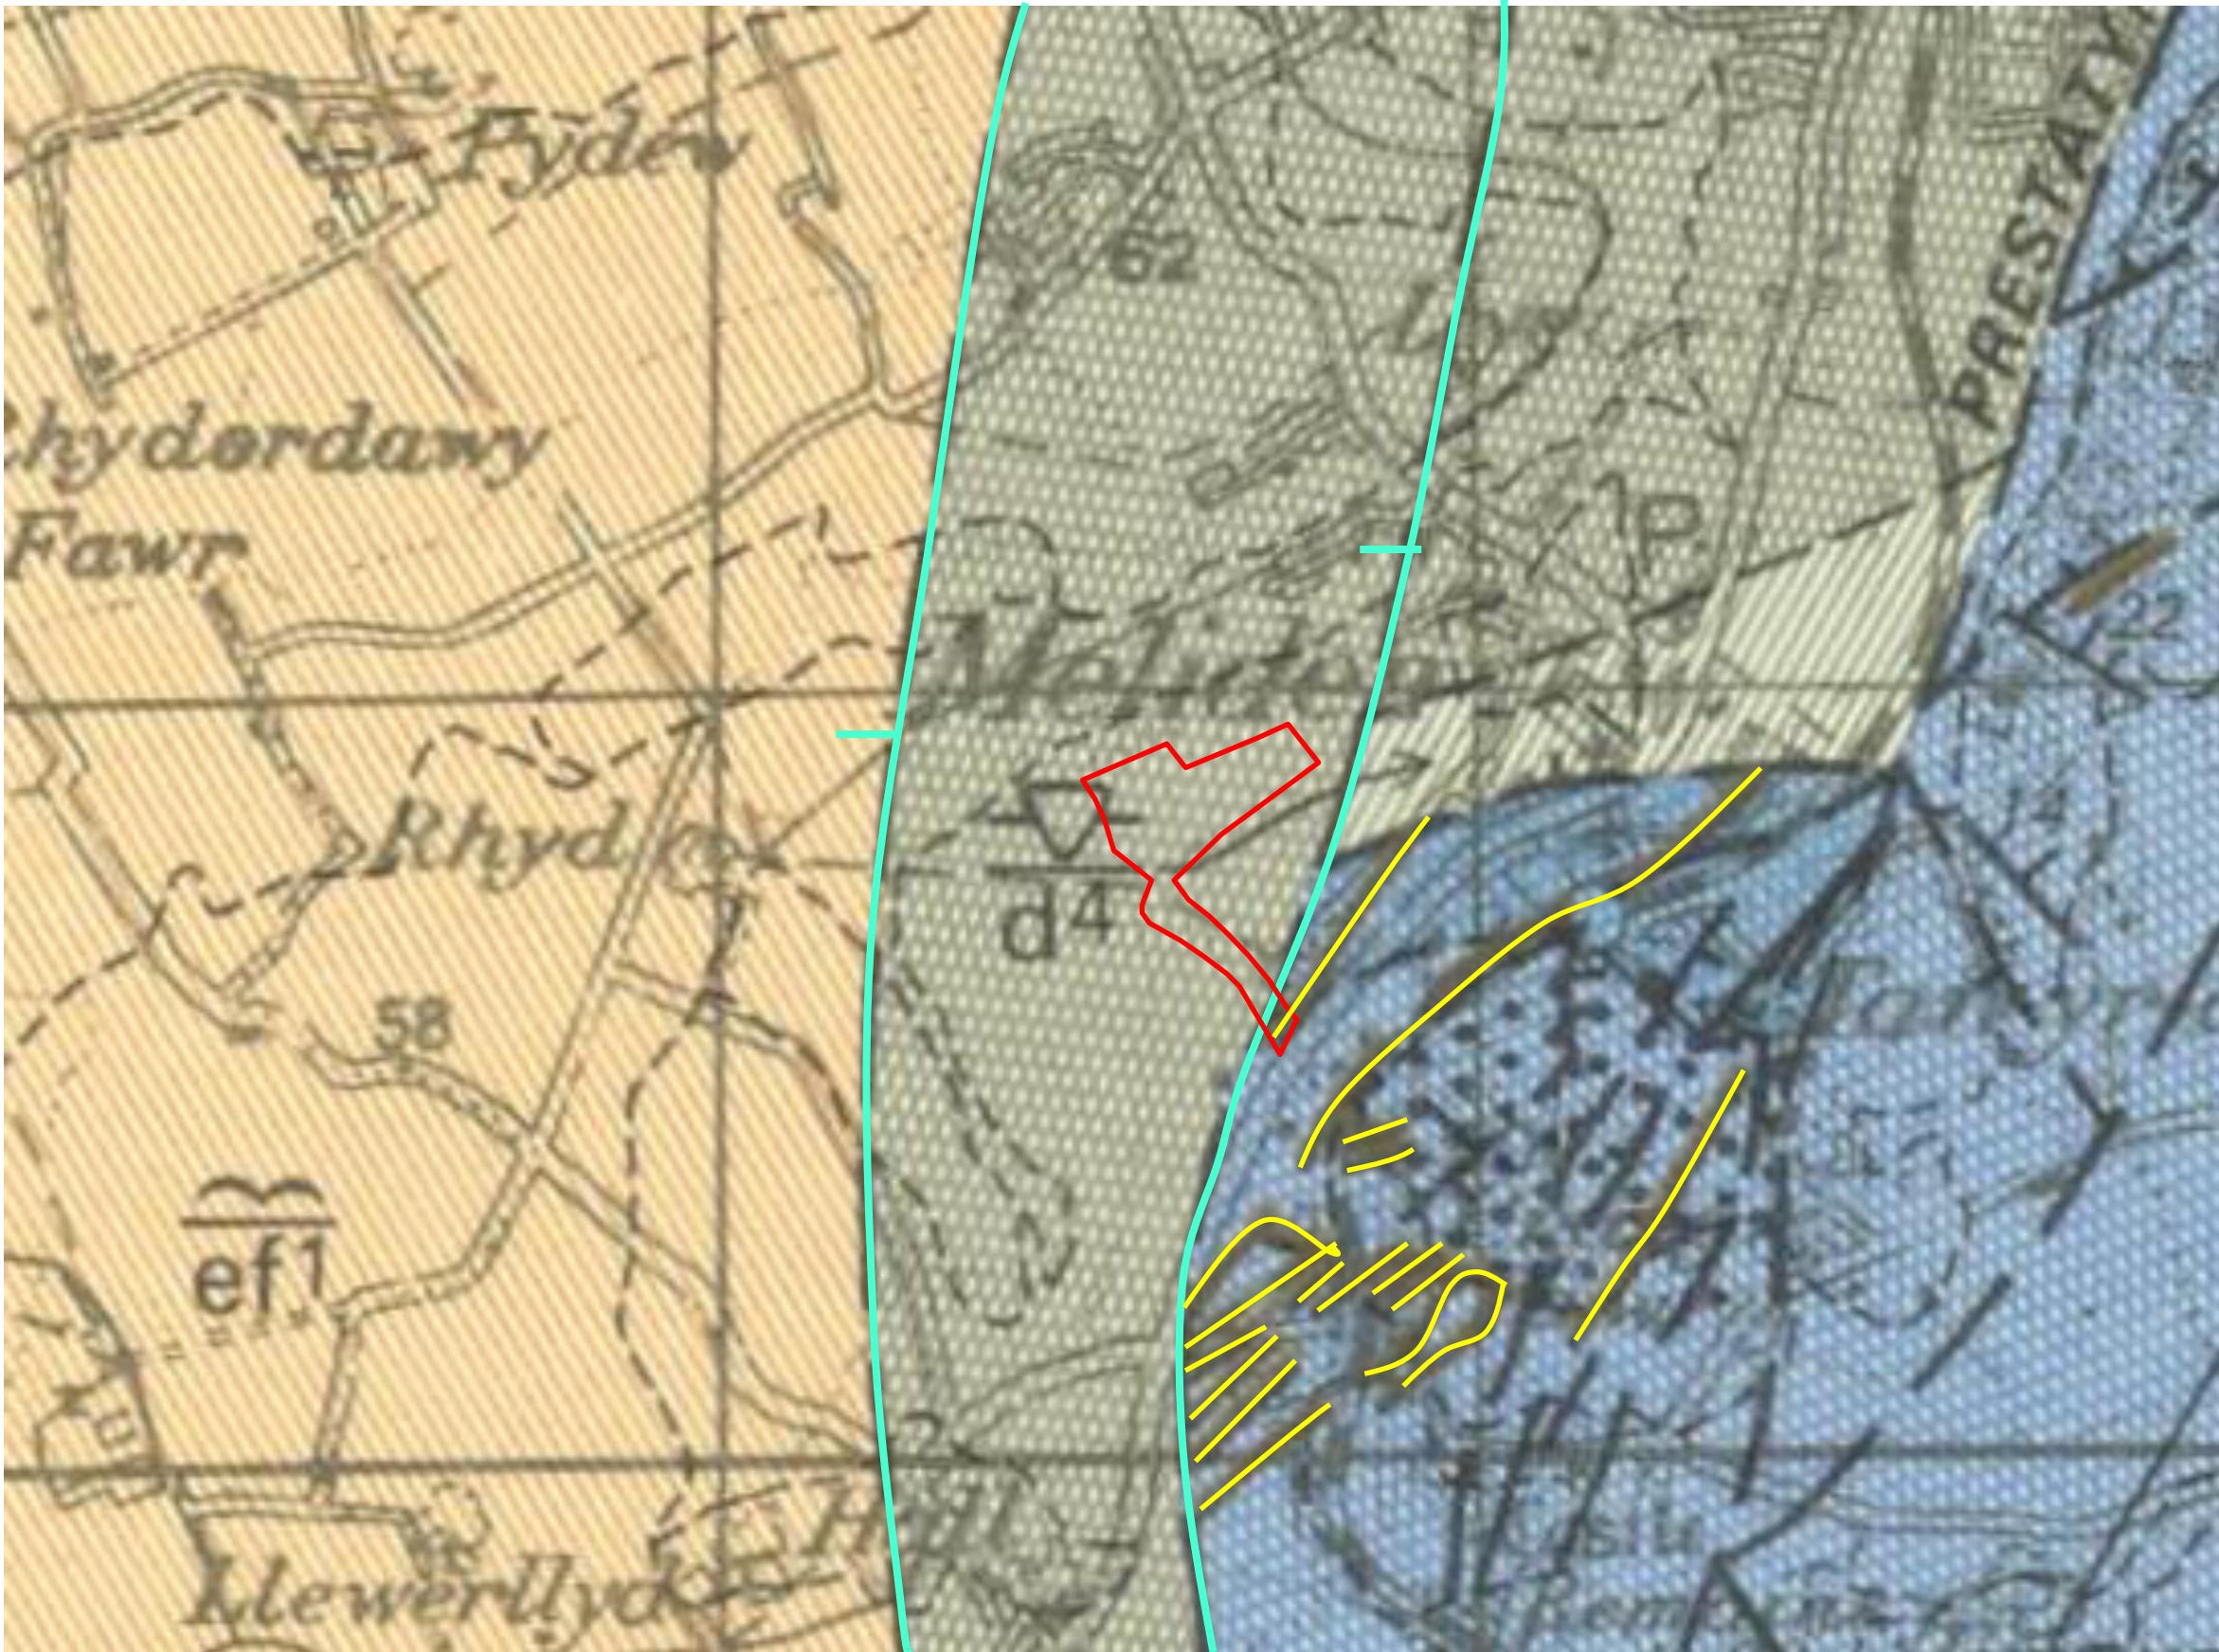
- APPROXIMATE SITE BOUNDARY
- FAULT LINE
- MINERAL VEINS

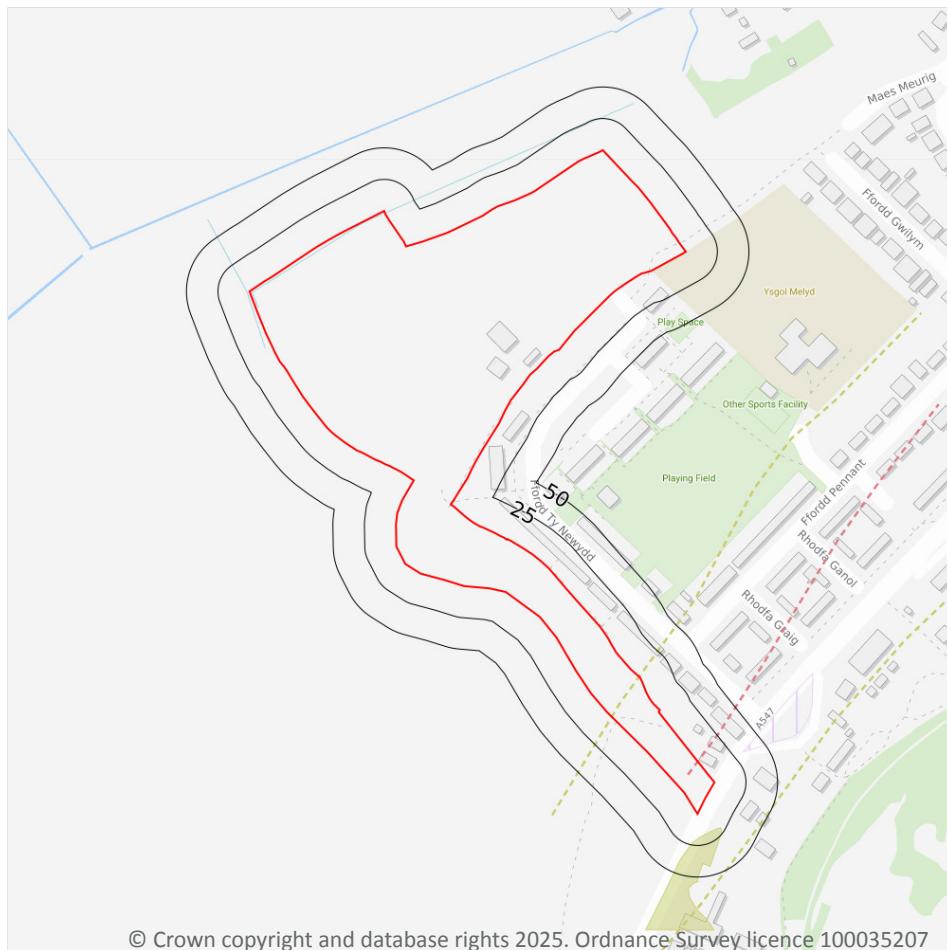
Non-coal mining / Mining features

The property has been found to be either within or in proximity to areas of potential mining identified from alternative or archival sources, including; BGS Geological paper maps, Lidar data, aerial photographs (from World War II onwards), archaeological data services, websites, Tithe maps, and various text/plans from collected books and reports. Some of this data is approximate and Groundsure have interpreted the resultant risk area and, where possible, specific areas of risk have been captured. Any such risk areas or features in the vicinity of the property are presented on the 'Mining features' map and within the detailed sections on Mine entries, Mineralised veins, Surface workings, Surface features, Underground mine workings or Mine waste tips.

The property has been found to be either within or in proximity to areas defined on Mining Record Office plans. This dataset is representative of Mining Record Office plan extents held by Groundsure and should be considered approximate. Where possible, plans have been located and any specific areas of risk they depict have been captured. Any such risk areas or features in the vicinity of the property are presented on the 'Mining features' map and within the detailed sections on Mine entries, Mineralised veins, Surface workings, Surface features, Underground mine workings or Mine waste tips.

The property has been found to be either within or in proximity to areas defined on BGS mine plans. This dataset is representative of BGS mine plan extents held by Groundsure and should be considered approximate. Where possible, plans have been located and any specific areas of risk depicted have been captured. Any such risk areas or features in the vicinity of the property are presented on the Mining features map and within detailed sections on Mine entries, Mineralised veins, Surface workings, Surface features, Underground mine workings or Mine waste tips.

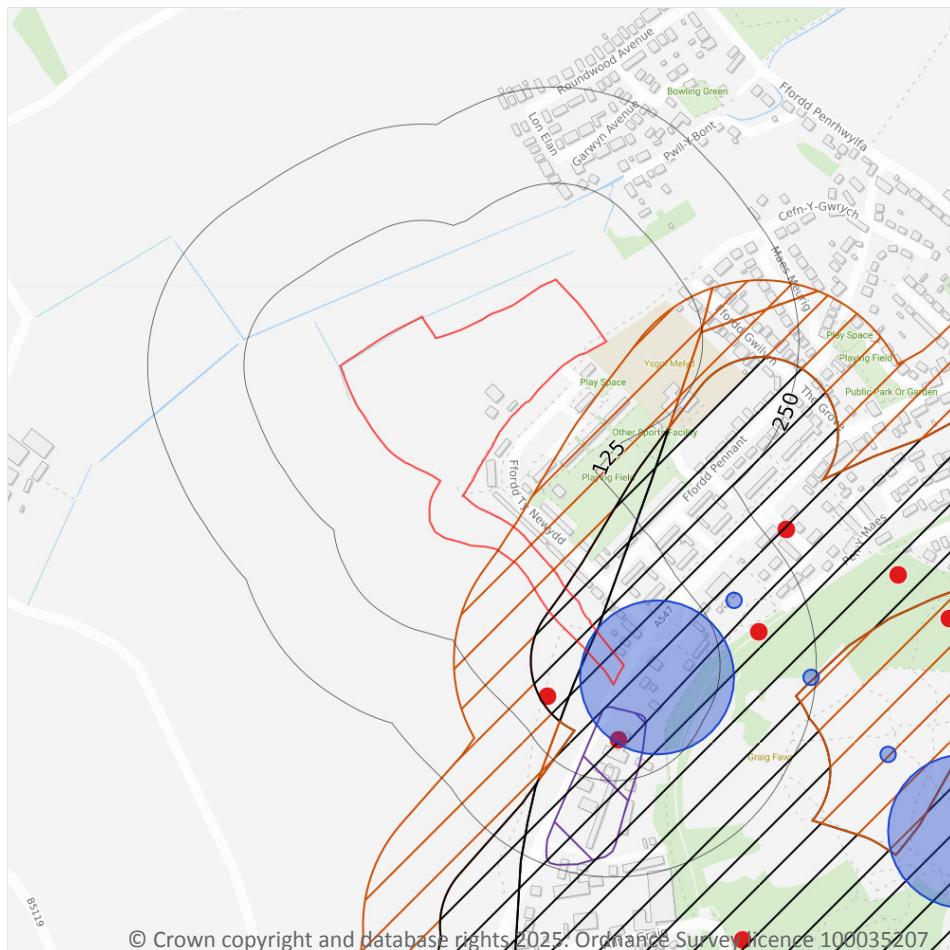
Non-coal mining / Mining records

Location	Name	Commodity	Class	Likelihood
On site	Not available	Iron Ore (Bedded)	D	Underground mining is considered likely to have occurred within or close to the area. The location, extent and nature of mining should be considered in any site investigation. Potential for difficult ground conditions should be considered.
On site	Not available	Vein Mineral	E	Underground mining is known or considered likely within or very close to the area. The location, extent and nature of mining should be considered in any site investigation. Potential for difficult ground conditions should be considered.
On site	Not available	Iron Ore (Bedded)	E	Underground mining is known or considered likely within or very close to the area. The location, extent and nature of mining should be considered in any site investigation. Potential for difficult ground conditions should be considered.

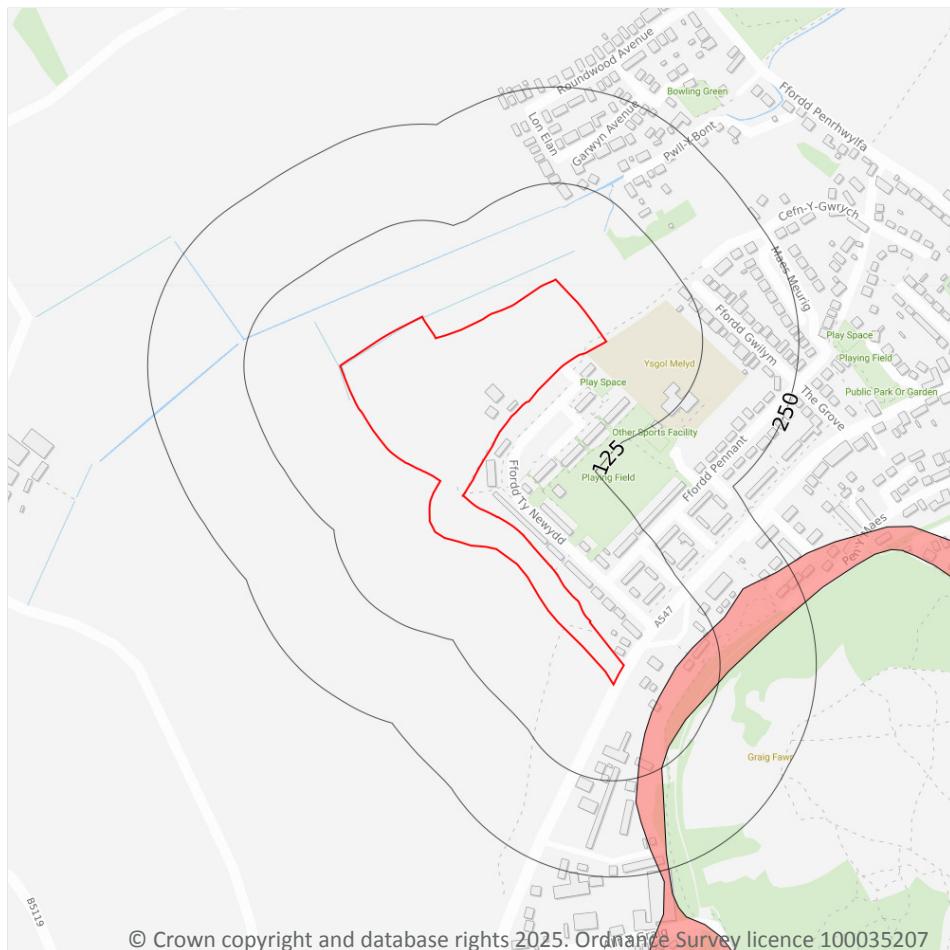
Ground stability / Landslides

Location	Hazard rating	Details
60m SE	Moderate	Slope instability problems are probably present or have occurred in the past. Land use should consider specifically the stability of the site.

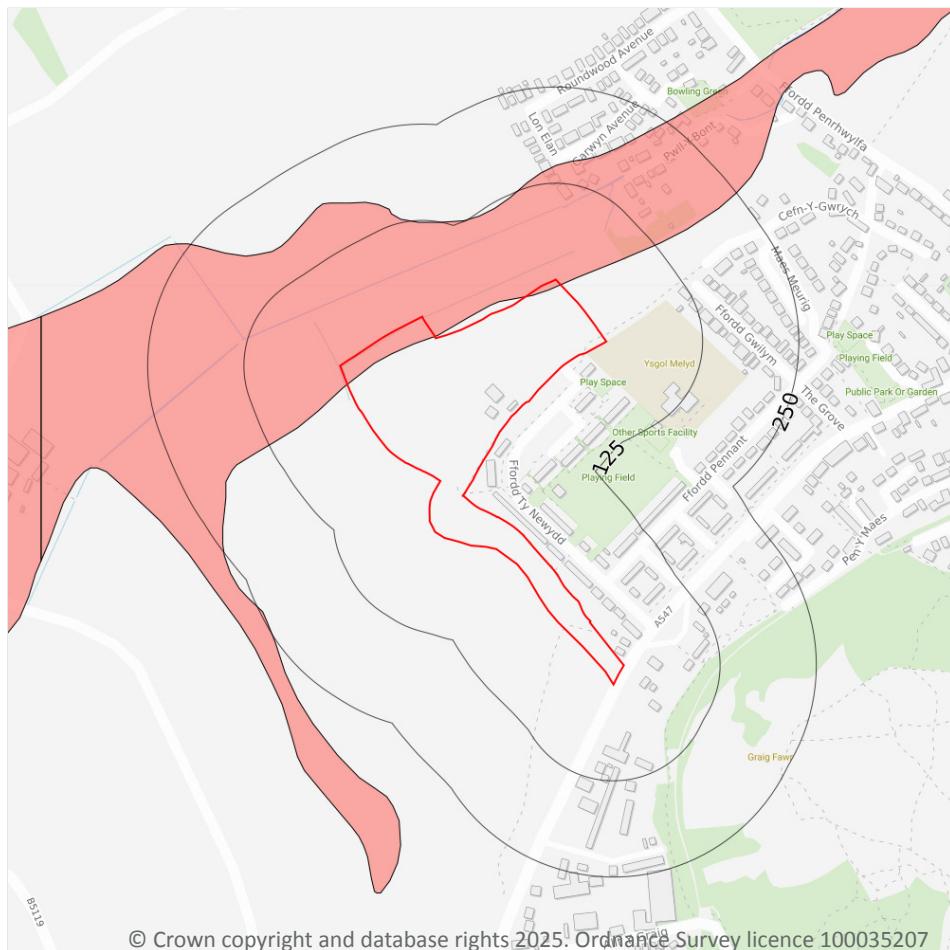
Ground stability / Compressible deposits

Location	Hazard rating	Details
On site	Moderate	Compressibility and uneven settlement hazards are probably present. Land use should consider specifically the compressibility and variability of the site.

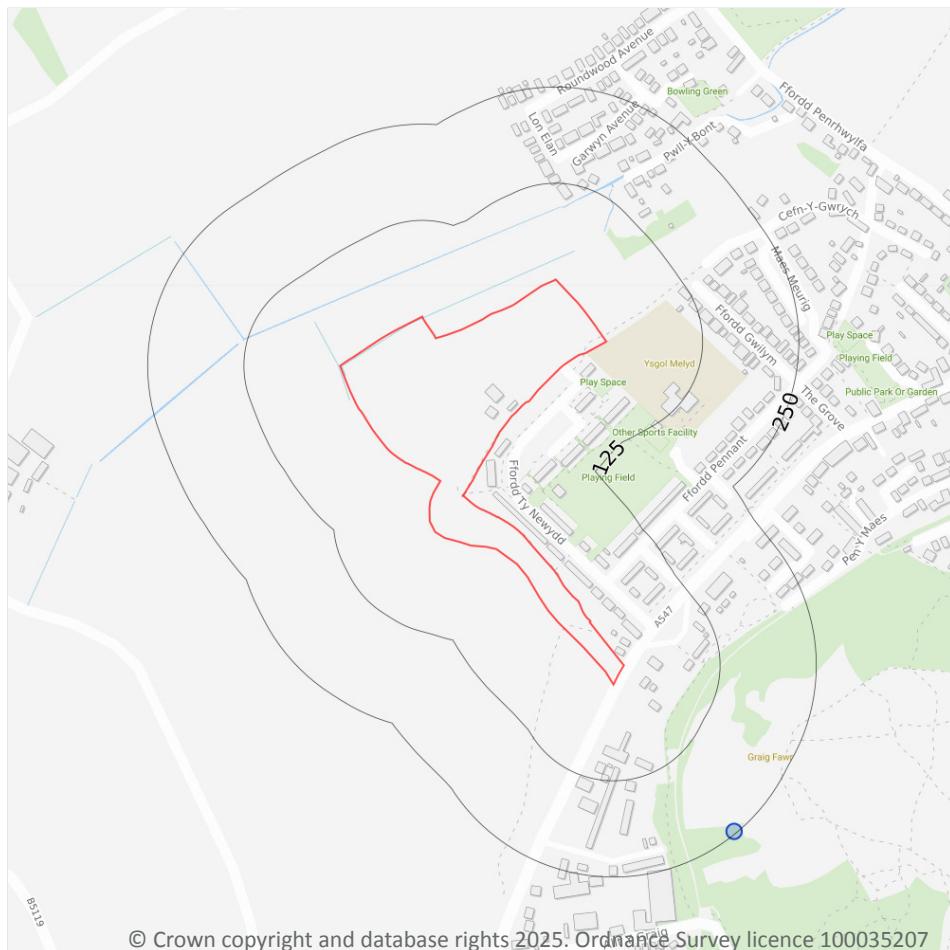
Ground stability / Natural cavities

— Site Outline
Search buffers in metres (m)

- Natural cavities (Polygon)
- Natural cavities (Line)

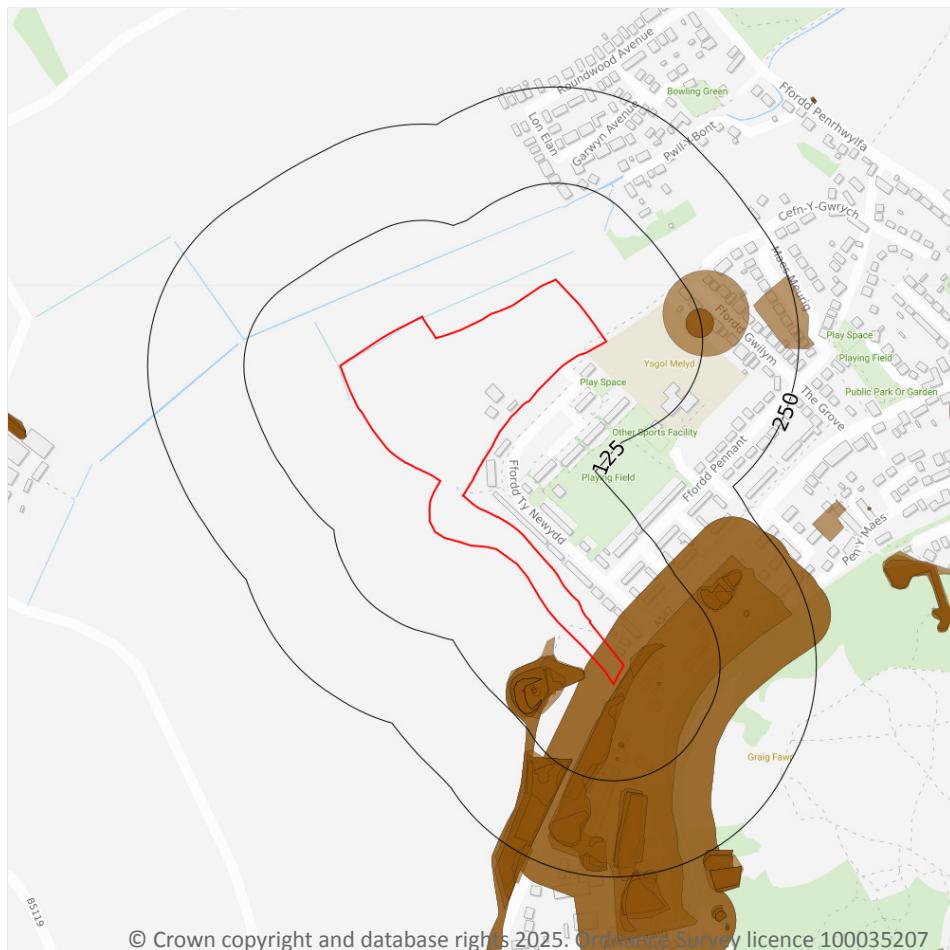
Ground stability / Infilled land

— Site Outline
Search buffers in metres (m)

- Active landfill sites
- Historical landfill (LA/mapping)
- Infilled Land
- Historic landfill sites
