Flood Consequences Assessment
and Drainage Strategy

Upper Denbigh Road

St Asaph

Flood Consequences Assessment and Drainage Strategy
for Land Off Upper Denbigh Road, St Asaph

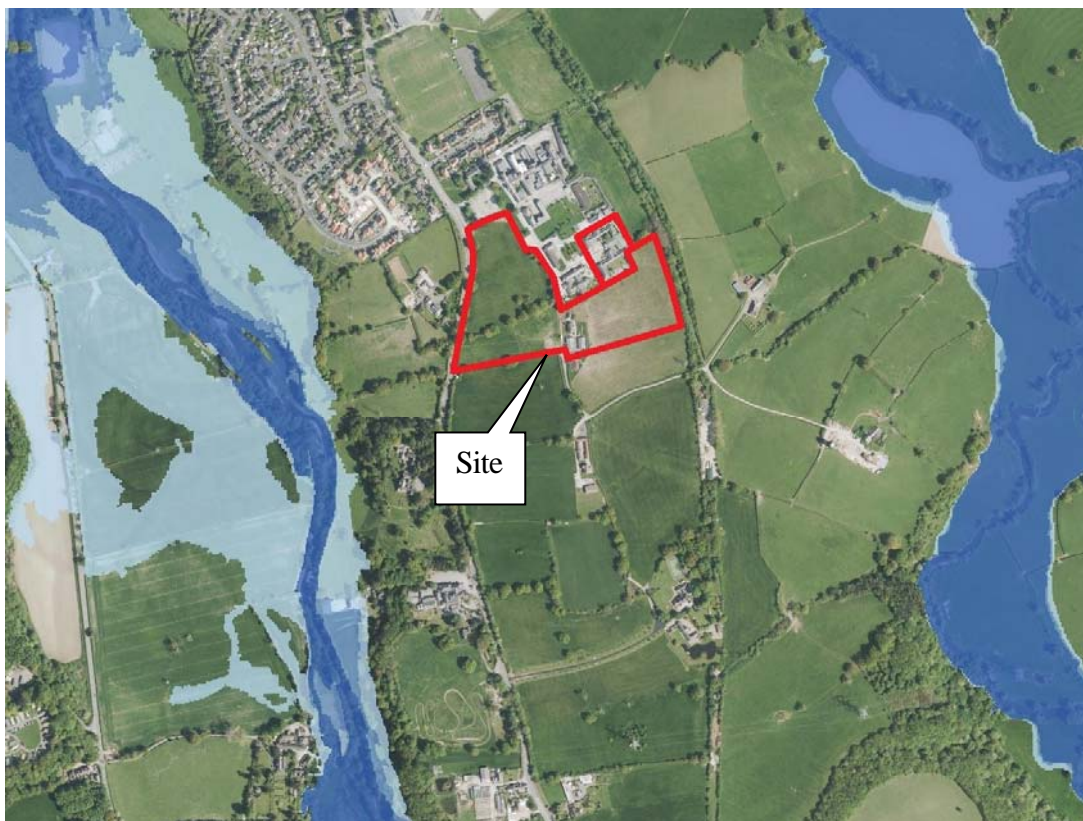
Figure 2 – Natural Resources Wales Flood Map for Planning (River and Sea)

The NRW Flood Map shows the site is located within Flood Zone 1 – an area considered to have the lowest probability of fluvial flooding. It is assessed as having a less than 0.1% annual probability of flooding in any given year.

It should be noted that the Flood Map only covers flooding from rivers and the sea. Flooding can occur at any time and in any place from sources such as rising groundwater levels, burst water mains, blocked road drains, run-off from hillsides, sewer overflows, etc.

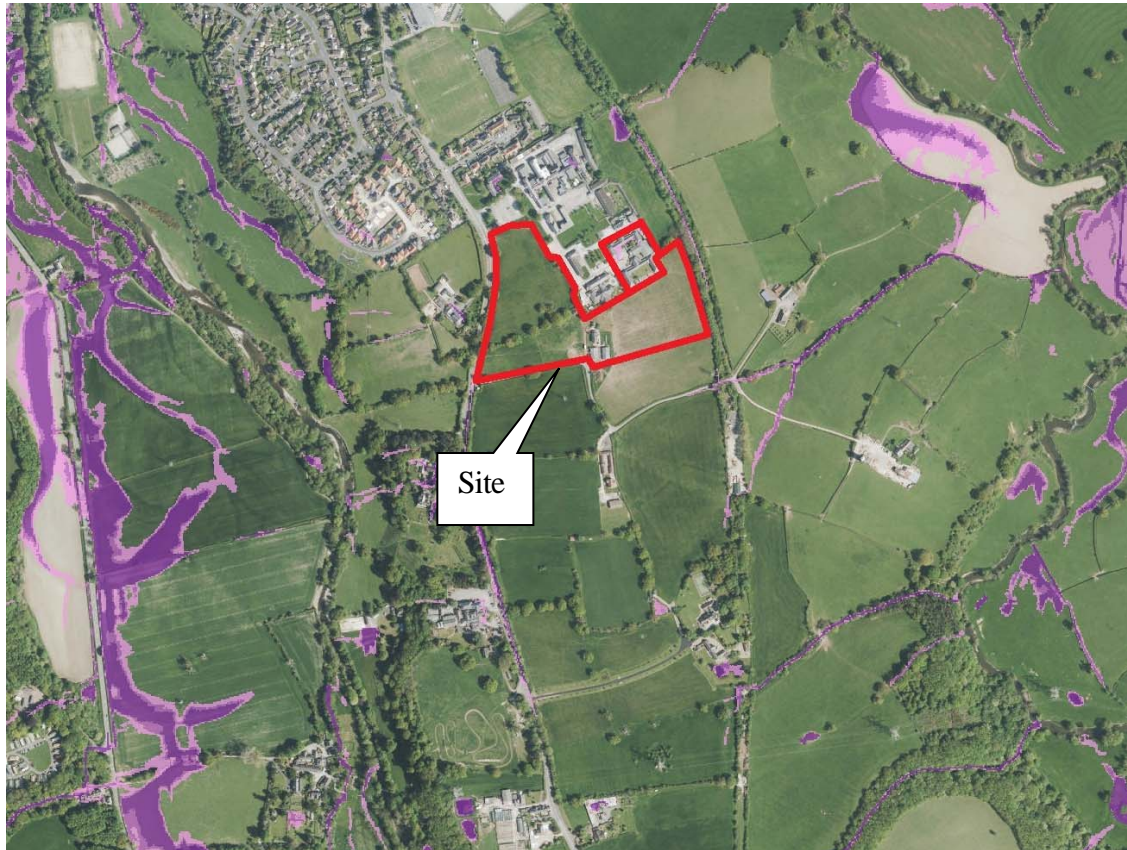
Figure 3 – Natural Resources Wales Surface Water Flooding Map

The Natural Resources Wales long term flood risk maps indicate the site has a low risk of flooding from Surface Water.

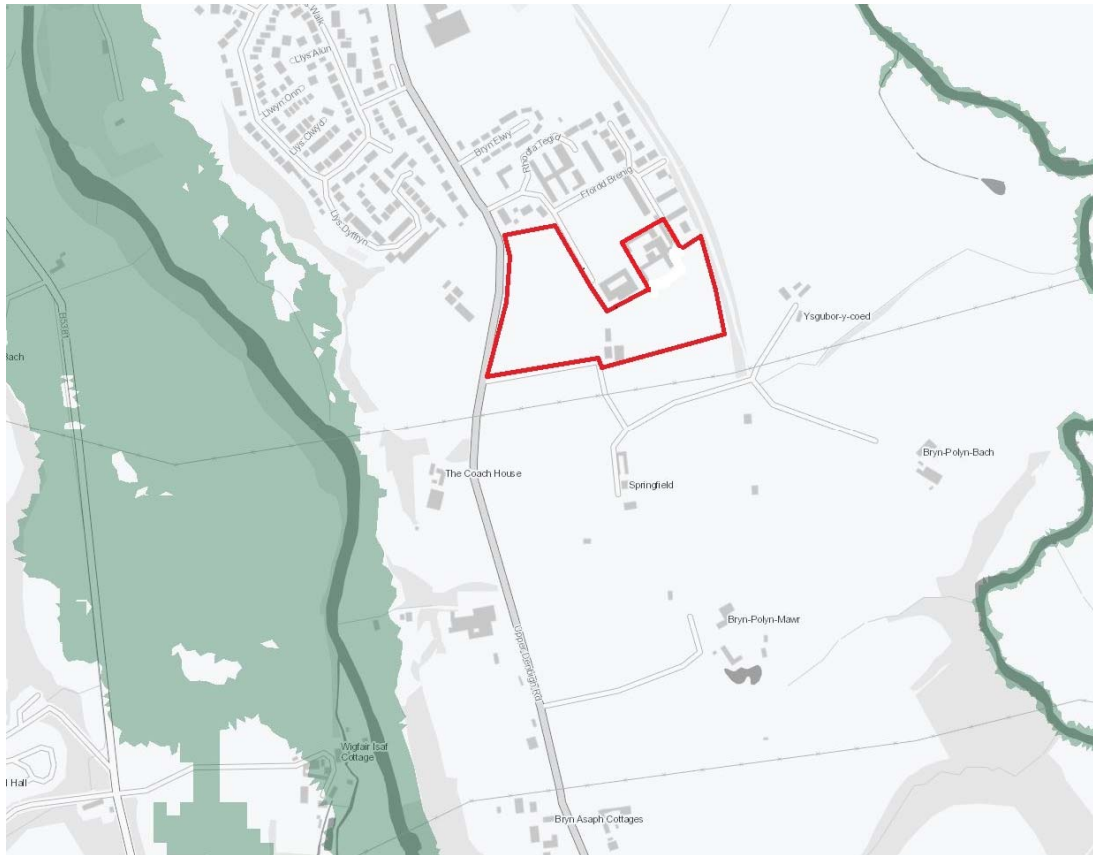
Figure 4 – Natural Resources Wales Reservoir Flooding Map

The site is not located in proximity of any reservoirs. Additionally, the NRW maps indicate the site is not at risk of flooding from reservoirs.

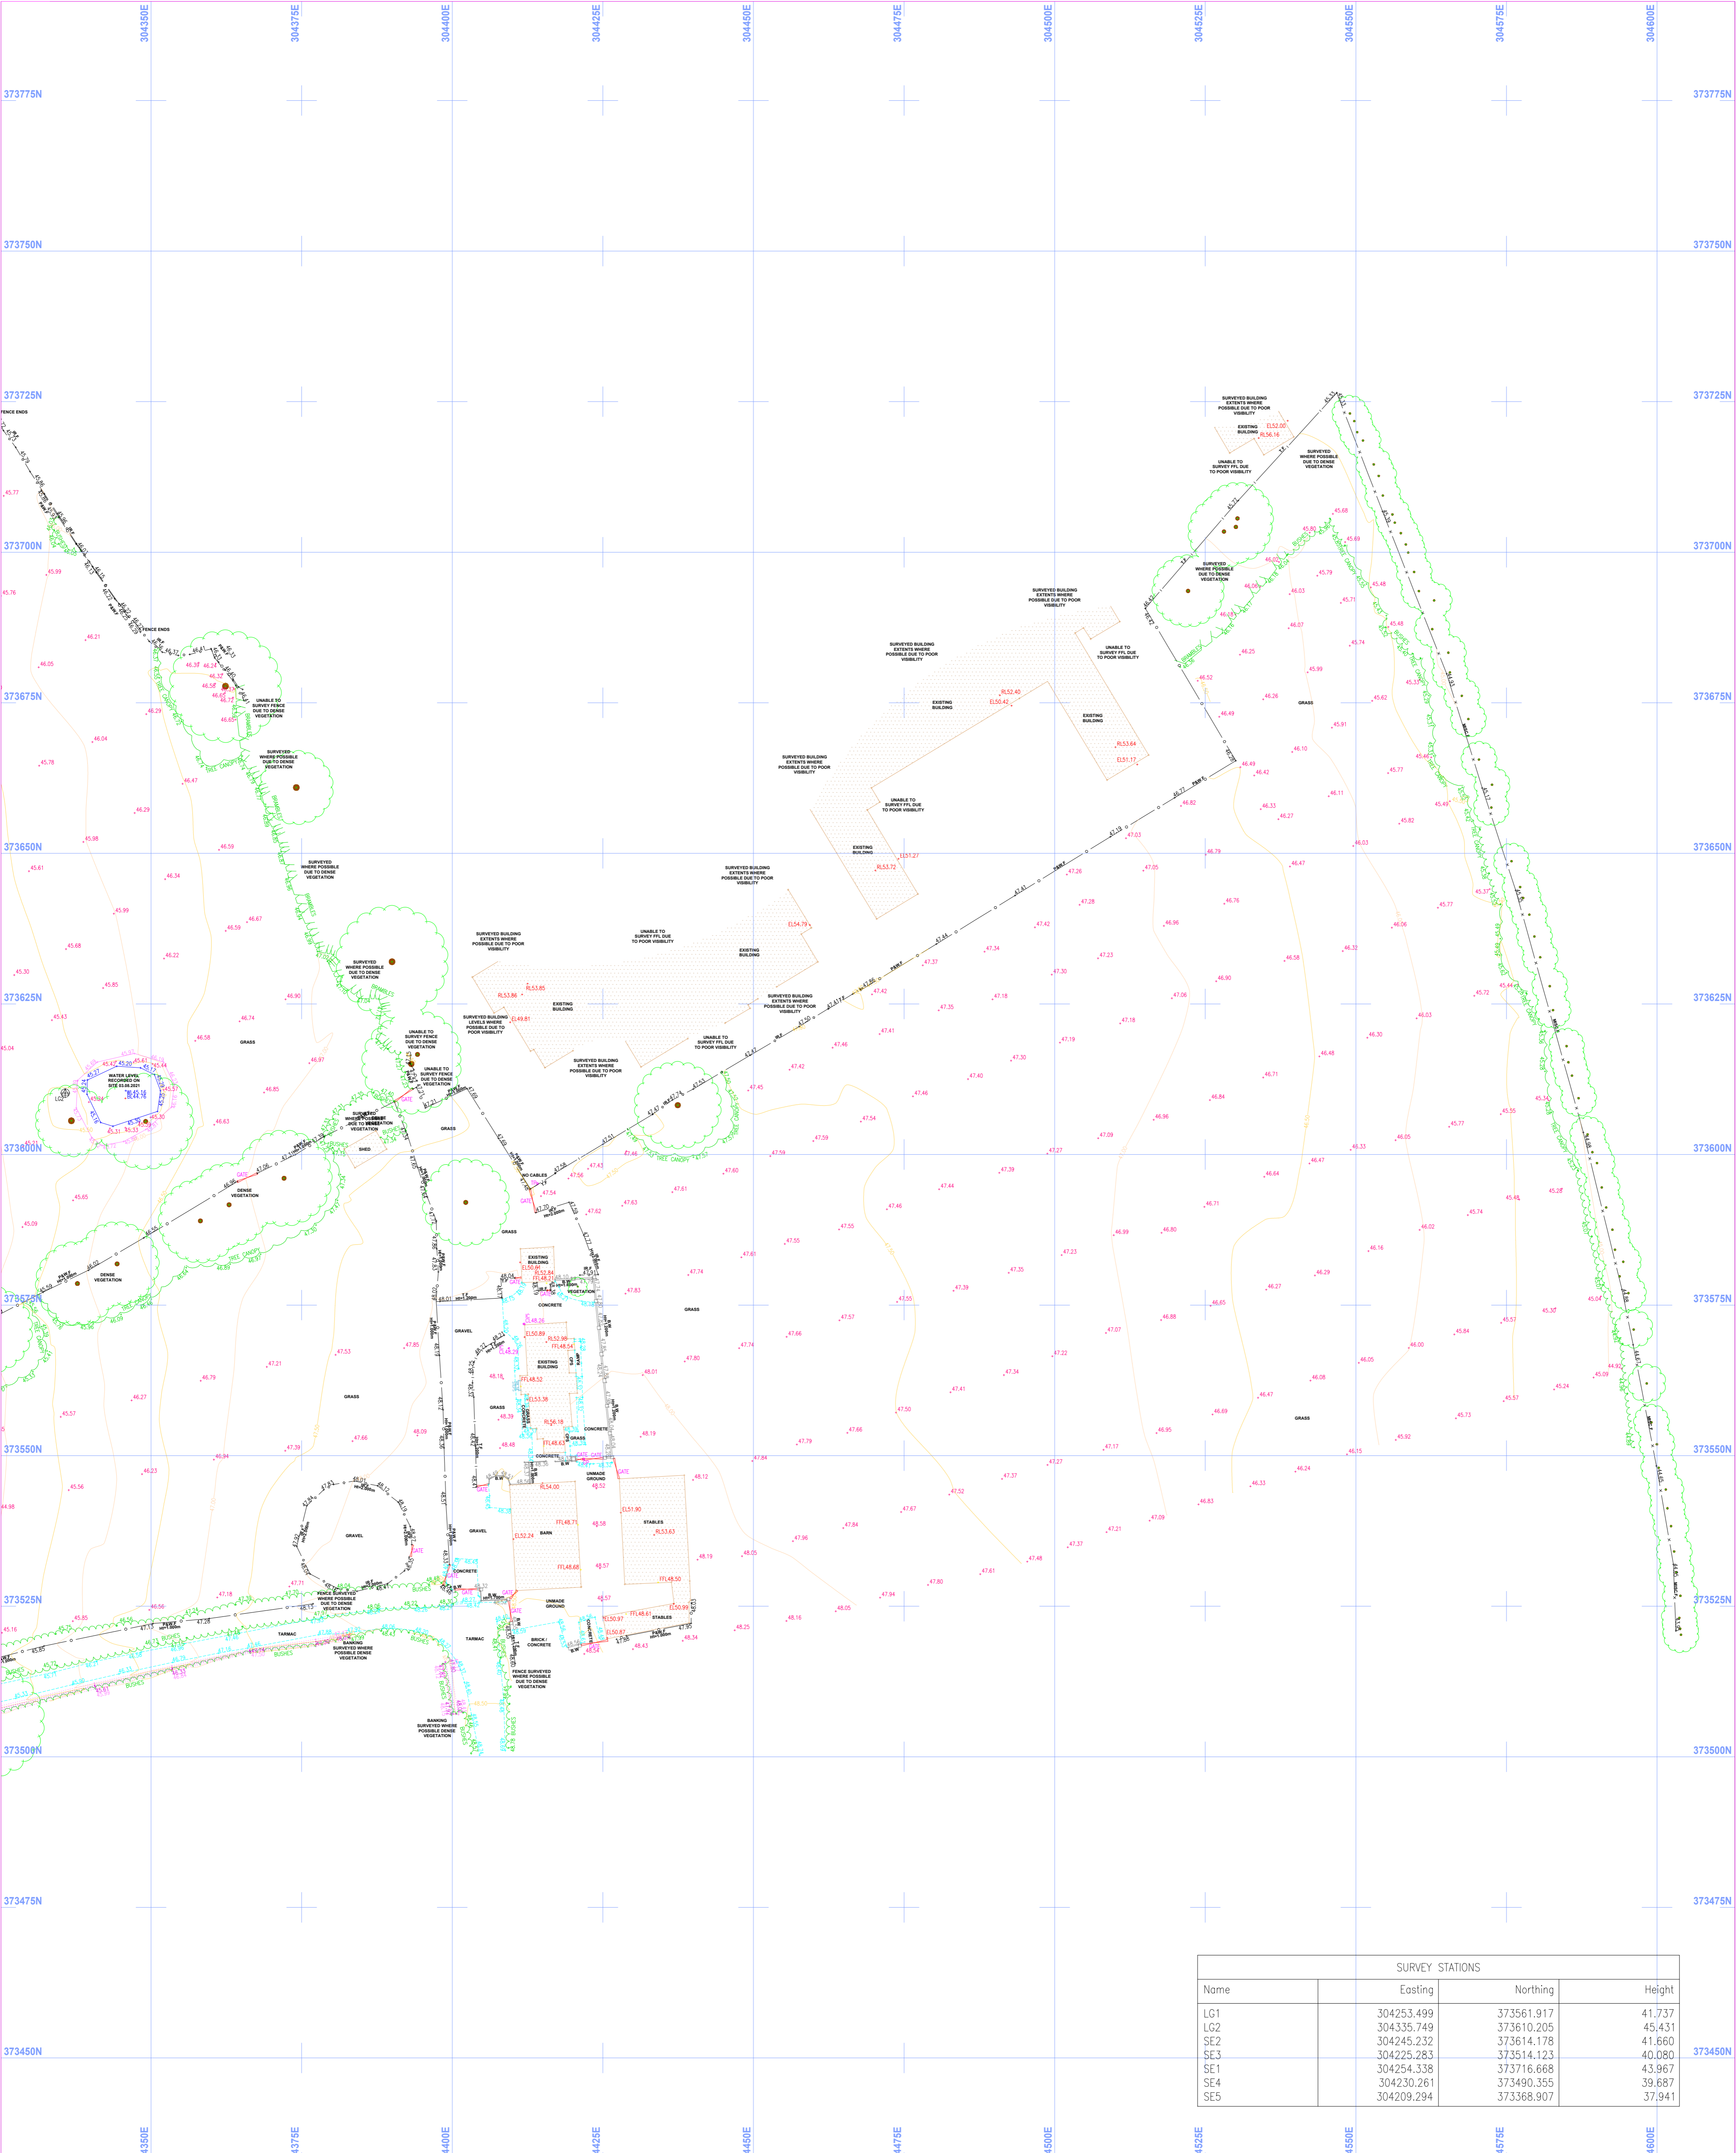
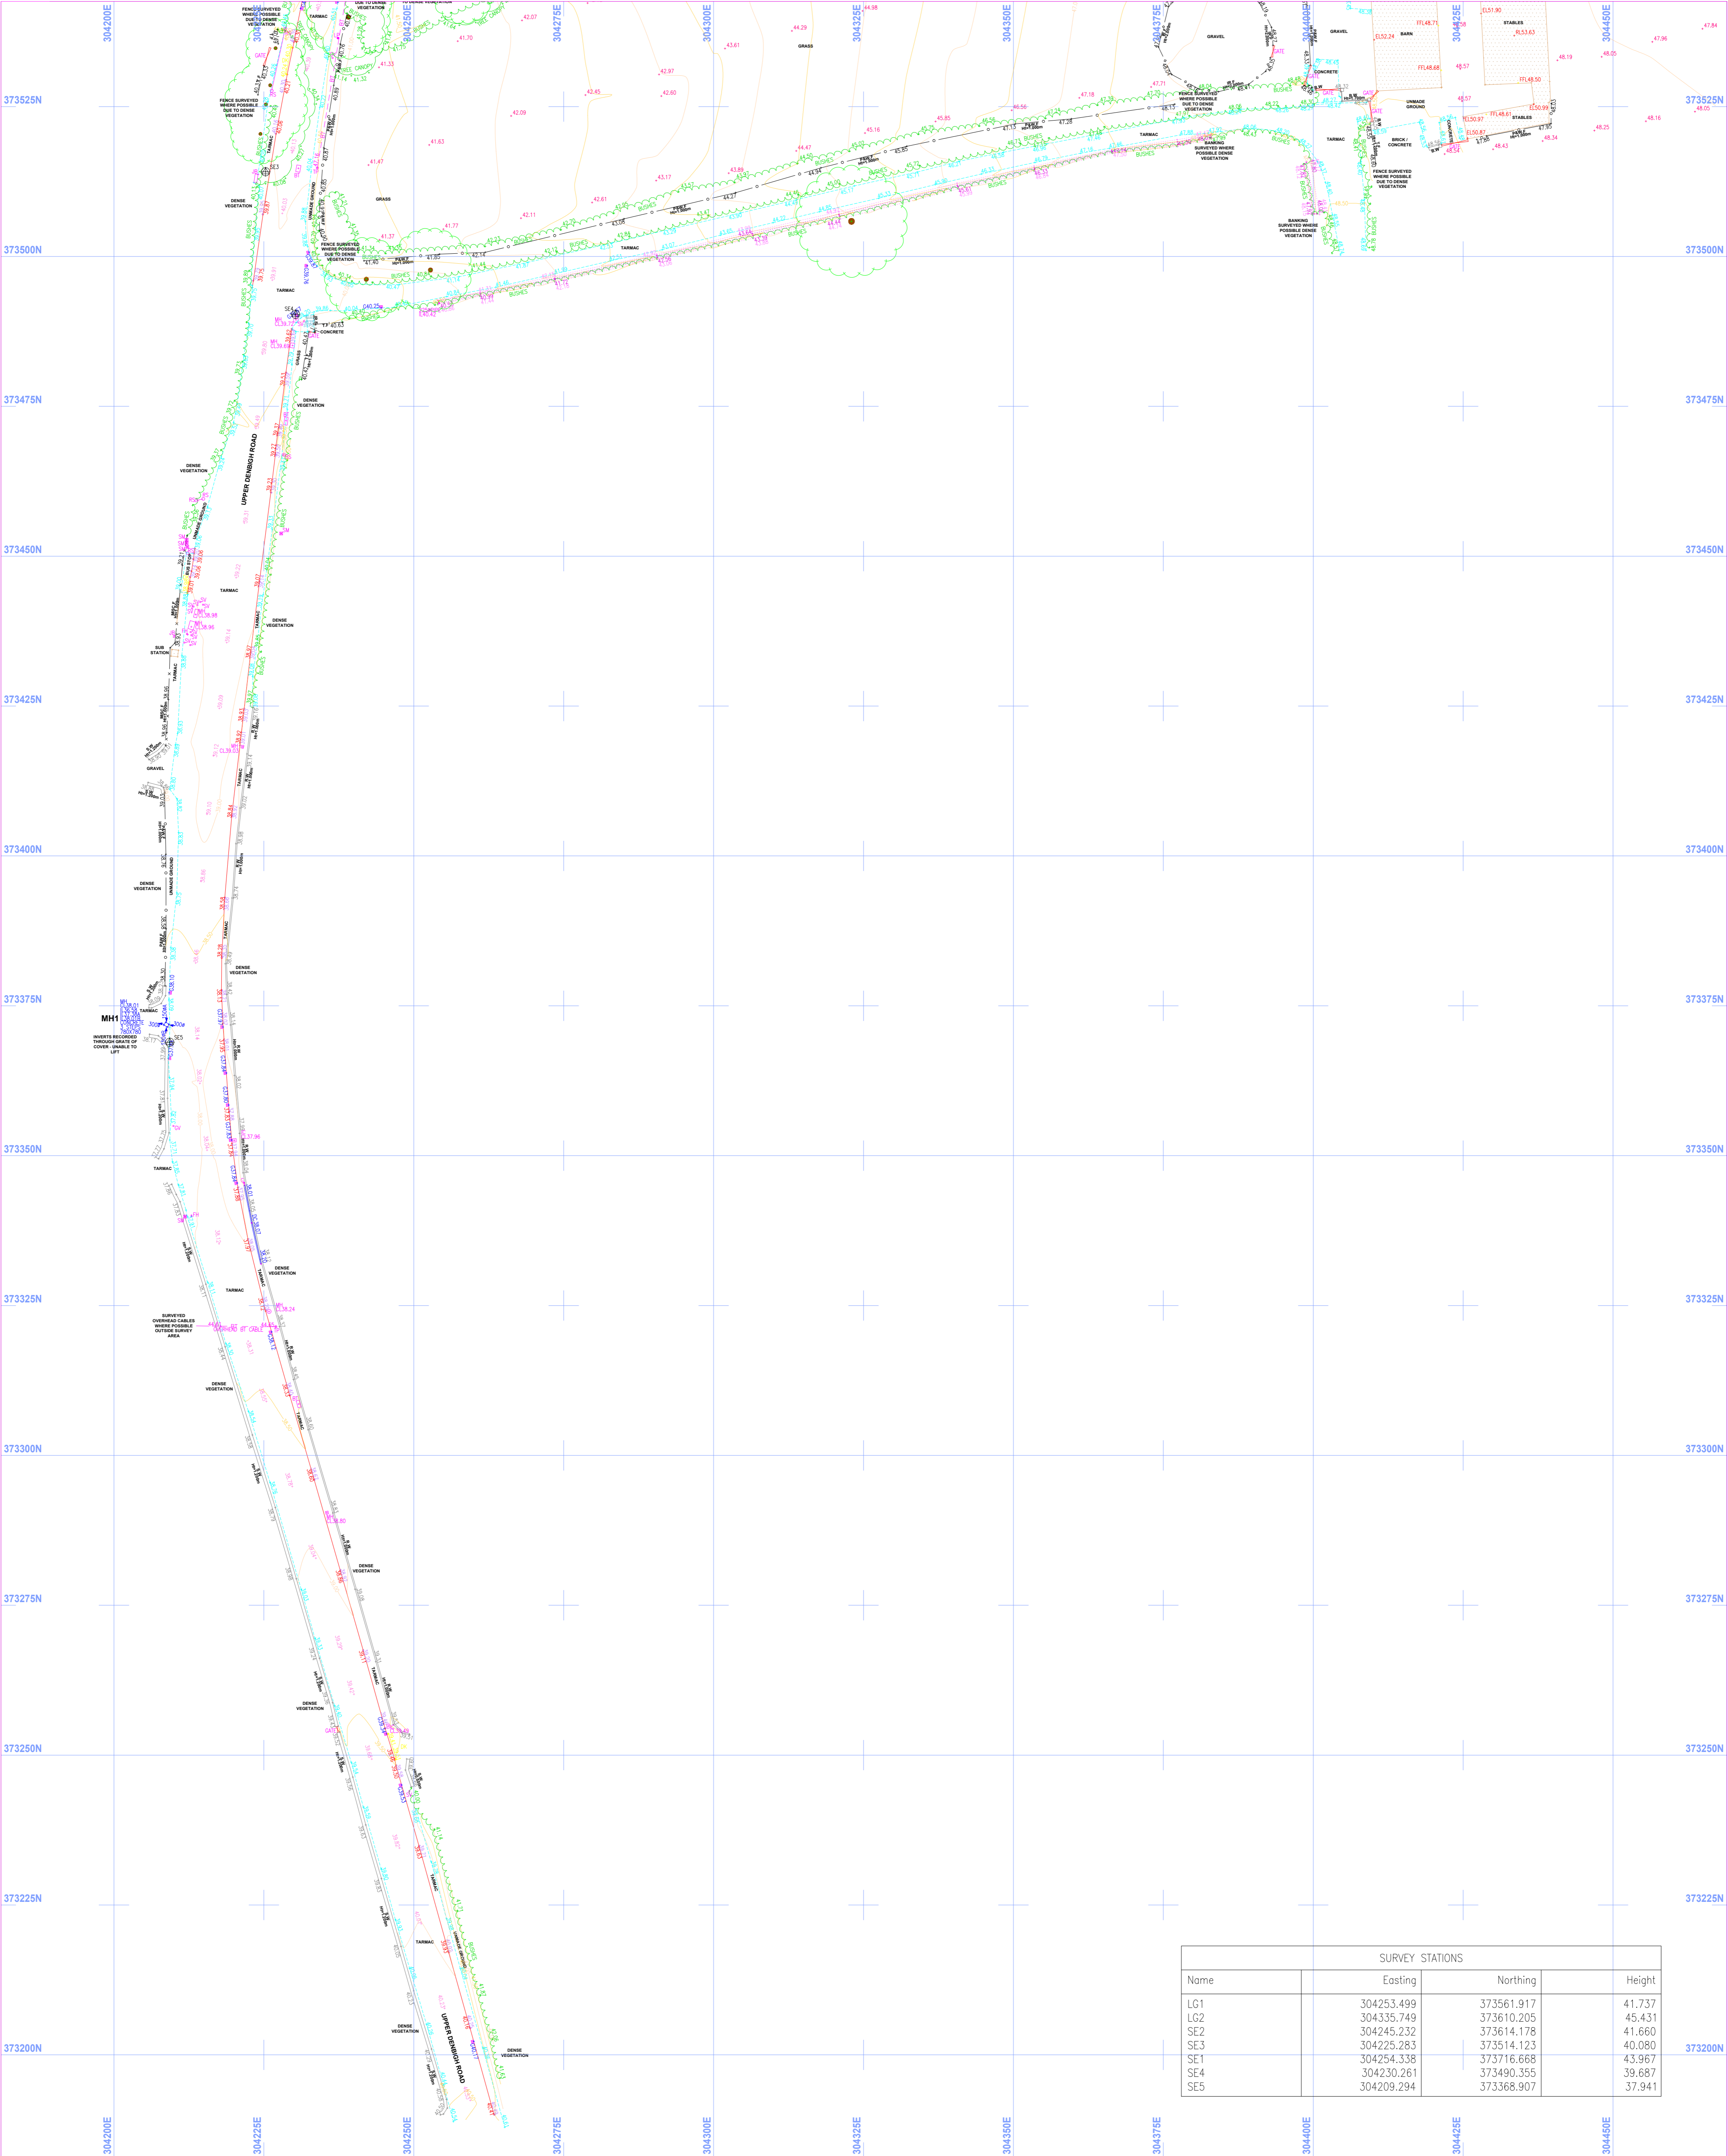
SURVEY NOTES
 ALL LEVELS ARE RELATED TO O.S DATUM (OSGB36-15)
 ESTABLISHED AT SE1 USING THE LEICA SMARTNET GPS NETWORK
