Flood Consequences Assessment
for
Mindale Farm, Ffordd Hendre,
Meliden, Prestatyn,
Denbighshire

Flood Consequences Assessment
Mindale Farm, Ffordd Hendre, Meliden, Prestatyn, Denbighshire

Project Title	Mindale Farm, Ffordd Hendre, Meliden, Prestatyn, Denbighshire
Project Number	8658
Document Title	Flood Consequences Assessment
Document Number	8658_FCA_Issue 1
This document is not to be used for contractual or engineering purposes unless the document verification sheet is signed where indicated by the approver of the document.

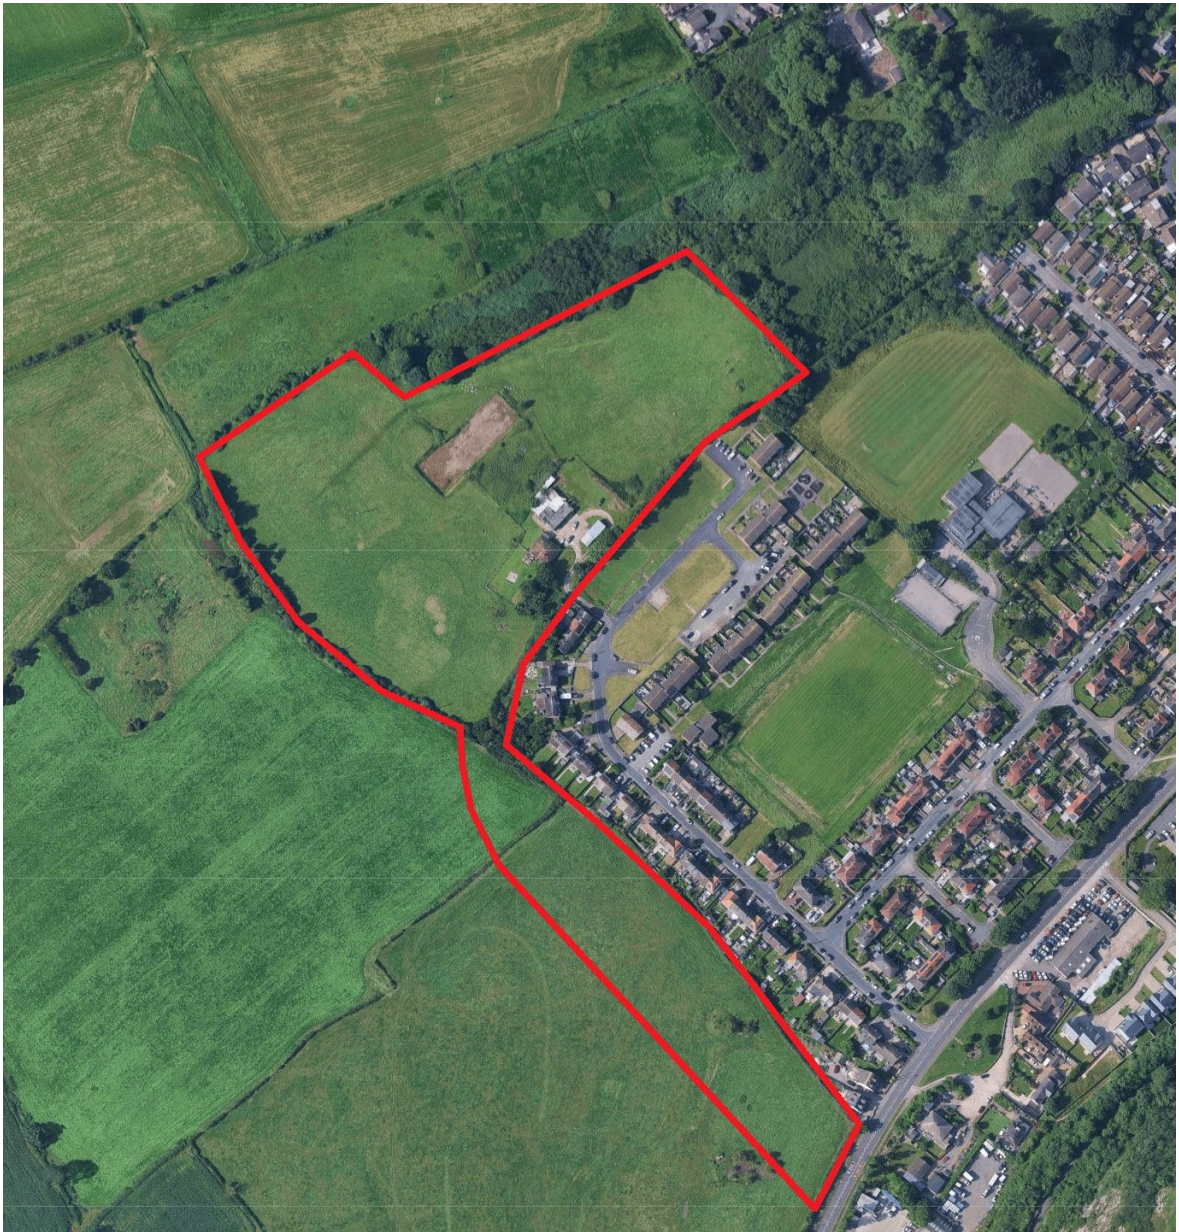
Figure 2 – Aerial View

The site is located adjacent to two existing water courses identified as main rivers on the Natural Resources Wales mapping named Meliden / Talargoch Mine Drain (northwest) and Prestatyn Gutter (north). An existing ordinary watercourse (shallow ditch) is also located along the northern site boundary which is a tributary to the Prestatyn Gutter.

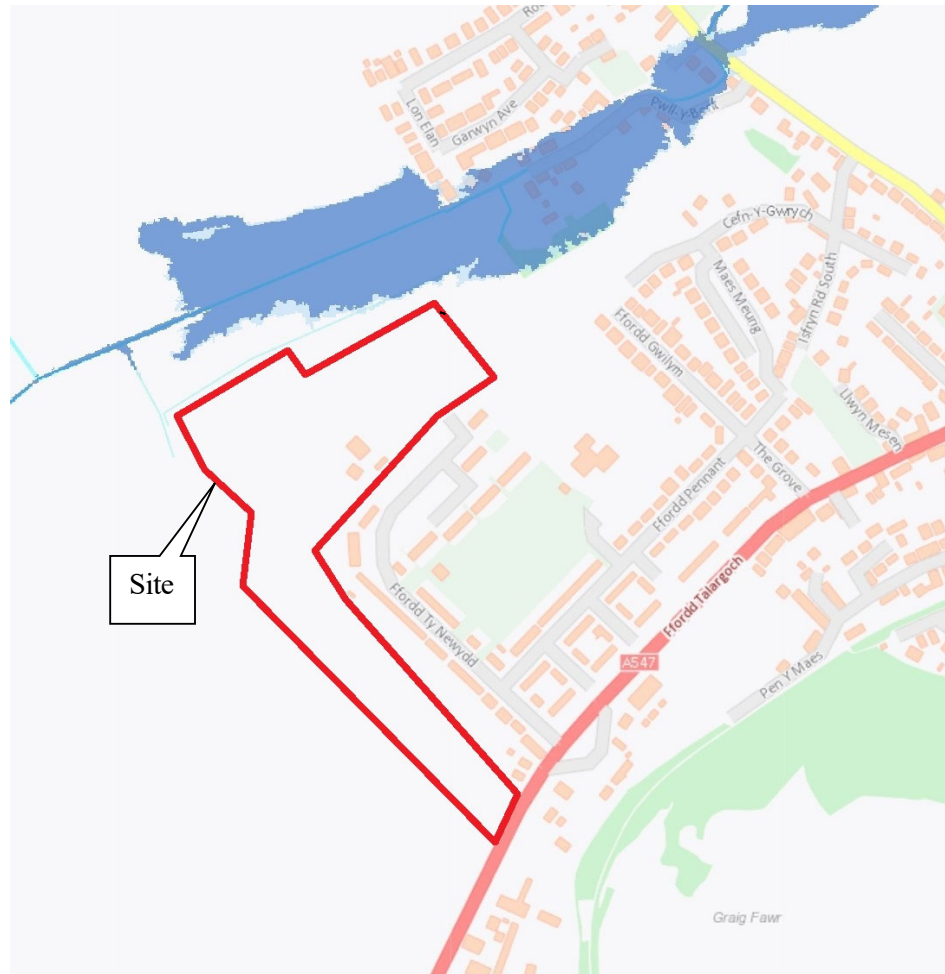
Figure 5 – Natural Resources Wales Flood Map for Planning (Sea and Rivers)

The NRW Flood Map shows the site is located within Flood Zone 1 – an area considered to have the lowest probability of fluvial flooding. It is assessed as having a less than 0.1% annual probability of flooding in any given year.

Refer to Figure 2 – NRW Flood Map for Planning (Sea and River).

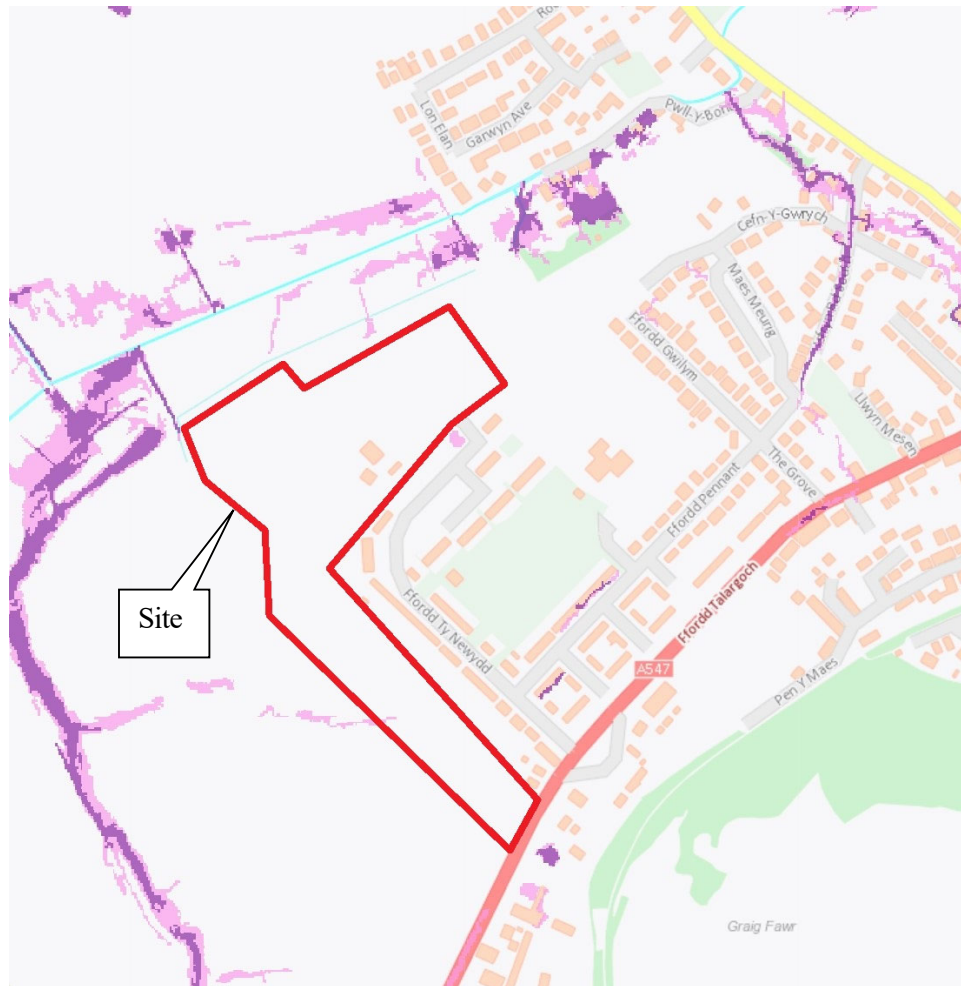
Figure 6 – Natural Resources Wales Surface Water Flooding Map

The Natural Resources Wales long term flood risk maps indicates that the majority of the site is at a very low risk of flooding from surface water.

The overall risk from surface water flooding is considered as low.

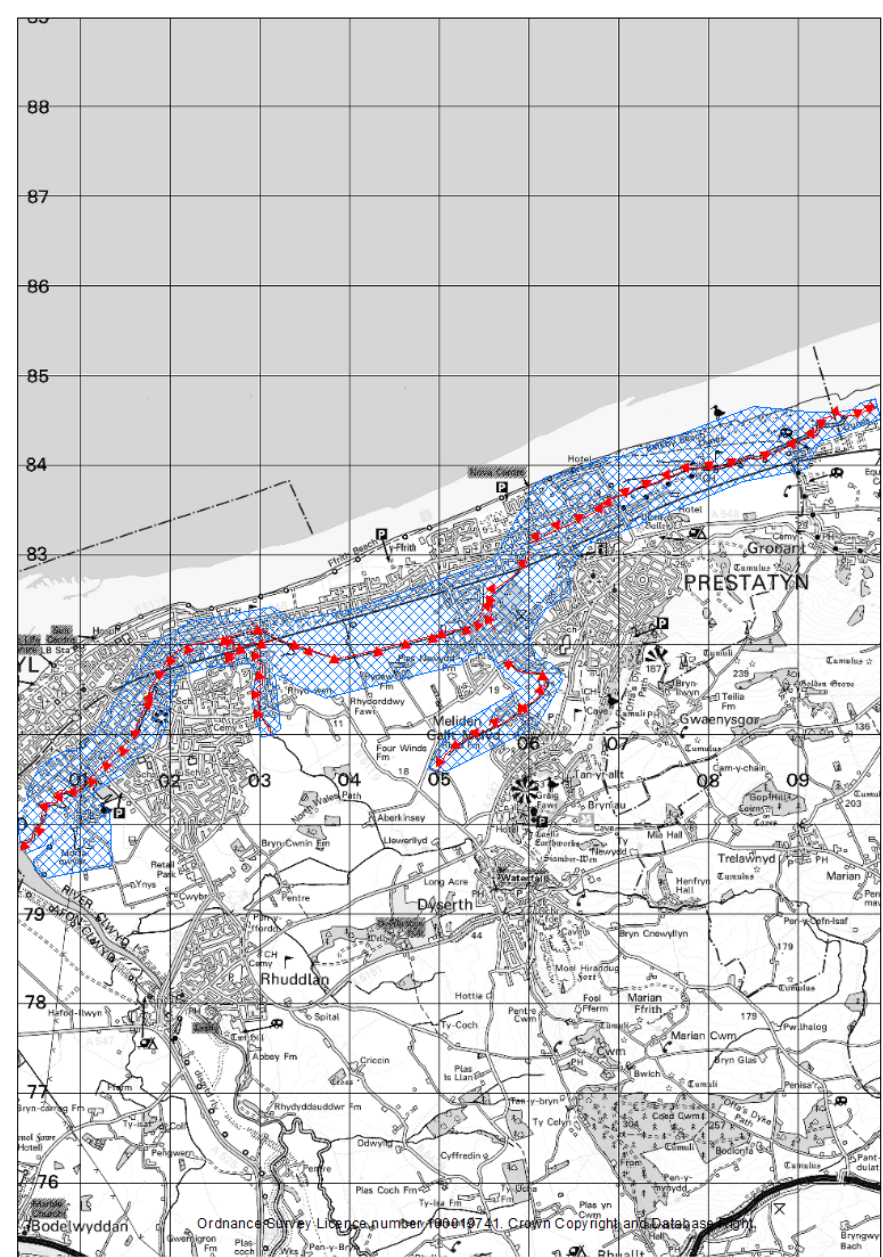
Watercourse(s)	Rhyl Cut, Prestatyn Gutter etc. Please note this may not be the complete list of watercourses modelled in this study.
Extent

<p>Model Extent (blue crosshatch), Model Centre-Line (Red triangles, where shown, indicate the extent of the river channel and/or the tidal boundary that was modelled).</p>
Model type	1D-2D

Modelling software used	FM-Tuflow
Return periods	Q30, Q30CC, Q100, Q100CC, Q1000, Q1000CC
Model Details	
Reason for study	To re-run the original RhylPrestatyn_5_V1.0_2019 model to gain extra return periods for inclusion into FRAW
Version changes (if applicable)	Removal of superfluous commands and changes to parameters to enable model to run.
Hydrology date	2018
Survey date	2019
DTM date	2011
Any model calibration carried out?	Partial
Breach runs carried out?	No
Blockage runs carried out	No
Structure failure runs carried out?	No

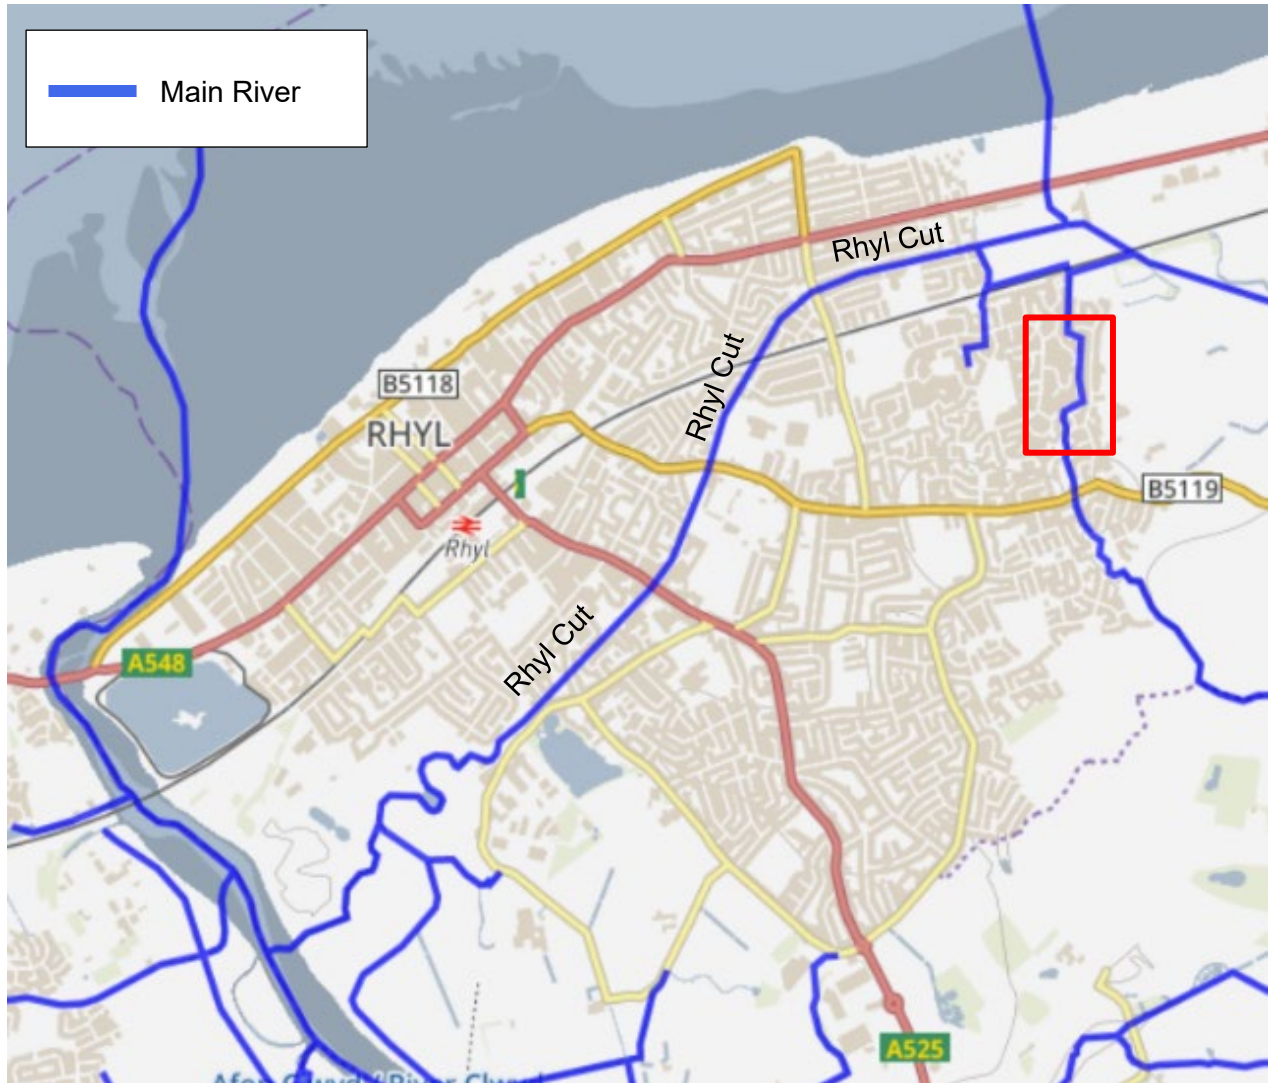
Figure 2: Main River Network for Rhyl¹

Figure 2 shows the location of the Cut, as well as other Main River drains feeding into it, such as the Maes Gwilym Drain, shown within the red rectangle.

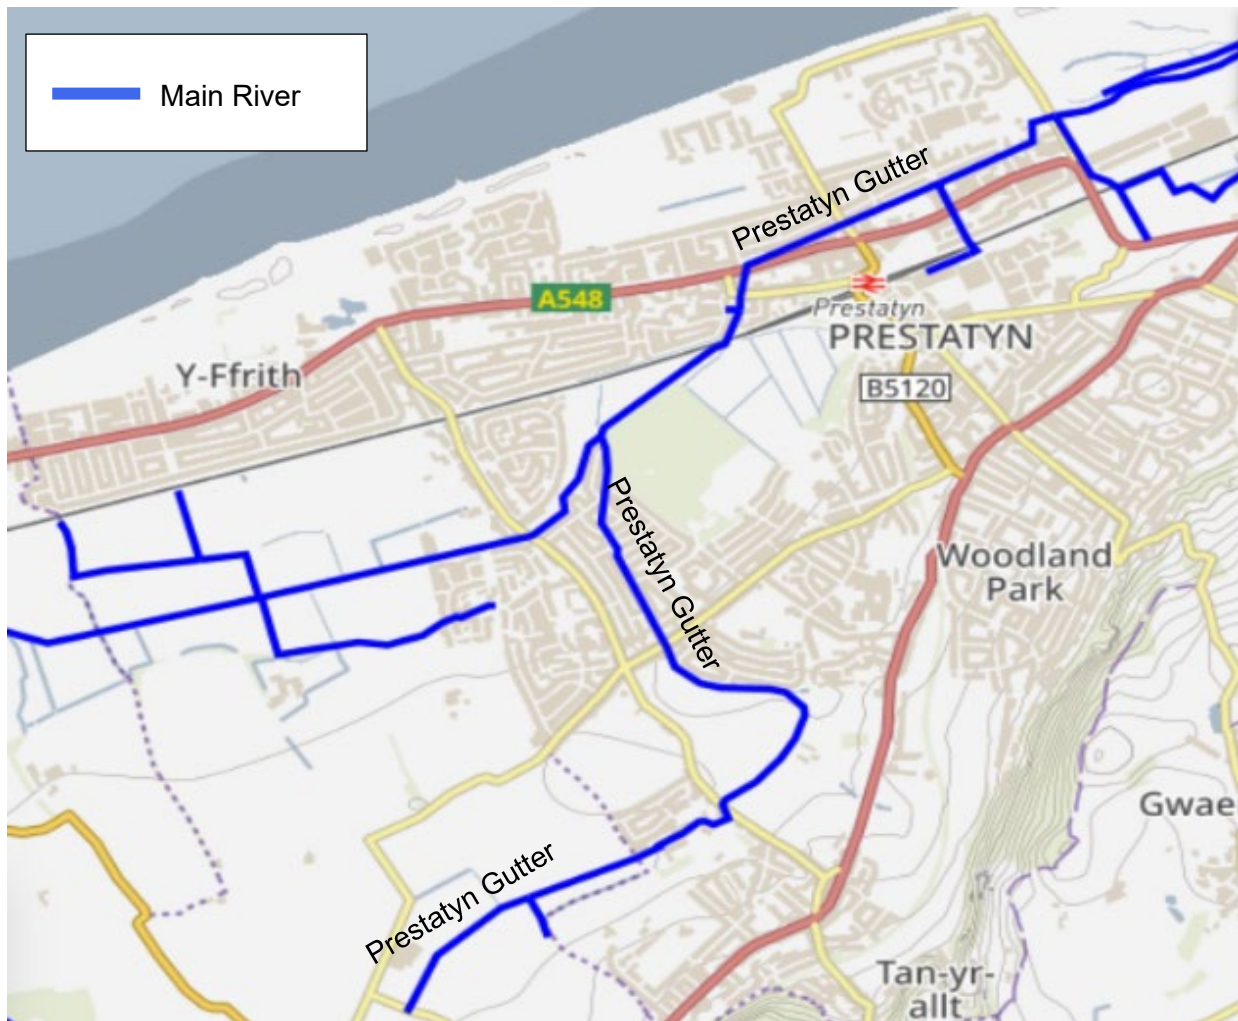
Figure 3 Main River Network for Prestatyn and Meliden¹

Figure 3 below shows the location of the Prestatyn Gutter, from its origins south of Meliden, to where it interacts with the urban areas of Prestatyn Town.

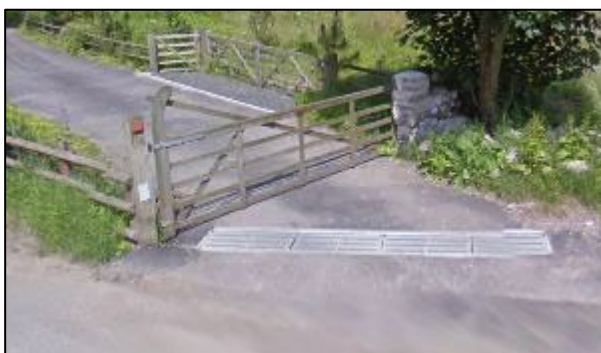
Photo 1: Bespoke highway drainage at Llanarmon Yn Ial flood investigation area

For the Property at Llanarmon Yn Ial, historically surface water highway drainage has caused issues, so much so that in 2007 DCC undertook work to install bespoke highway drains in front of the Property, as shown in photo 1.

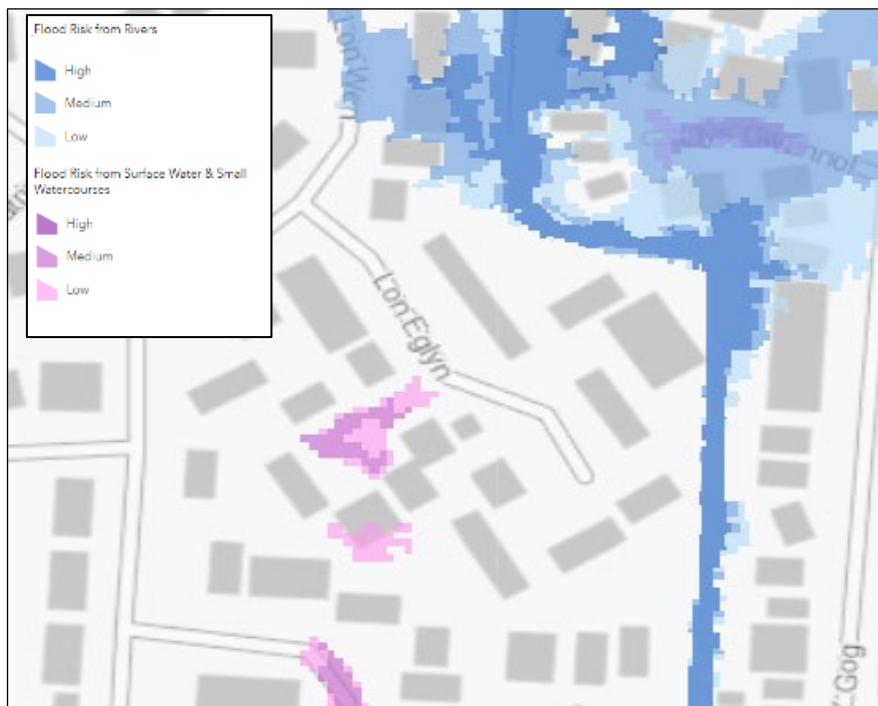
Figure 30: The NRW Flood and Coastal Erosion Risk Maps for Rivers and surface water showing Lon Eglyn

For Lon Eglyn, figure 30 shows that the Risk Maps for rivers and surface water flooding does not currently have the effected houses as being at risk of flooding from these two flood sources. Hence, it is difficult to say how likely the scale of flooding from Storm Babet will happen again, but there is a potential contributing factor to flood risk through surface water, most notably the on-going housing development upstream of Maes Y Gog, which was granted planning permission prior to the statutory implementation of sustainable drainage (SuDS) for all new developments over 100 square metres.

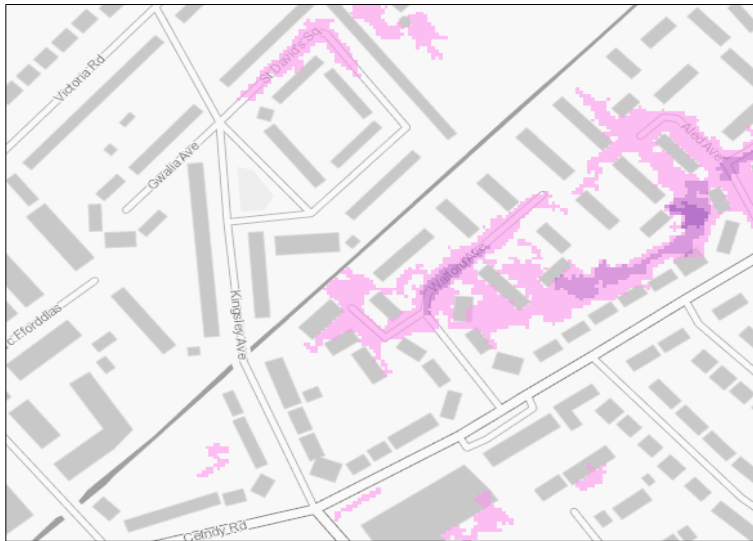
Figure 32: Surface Water Flood Map at Plas Cyril and the Dance Studio

For Plas Cyril and the Dance Studio, the chances of surface water flooding occurring again is at low to medium risk as shown in figure 32 below, which was taken from NRW's Flood and Coastal Risk Maps.

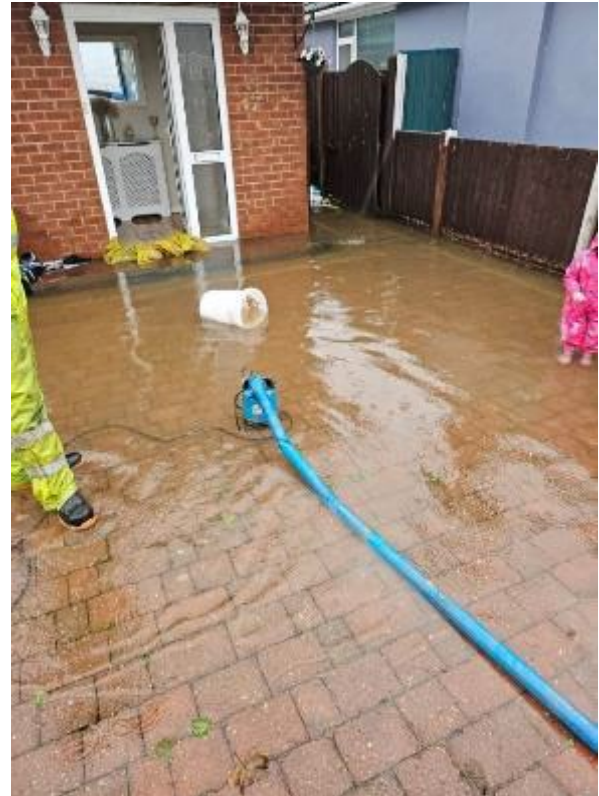
Photo 6 – Flooding at No 1 Winchester Drive

Residents of Property number 1 were visited to discuss the flooding, which had caused severe internal damage to the Property. Photos 5 and 6 below show the extent of the flood at this Property.

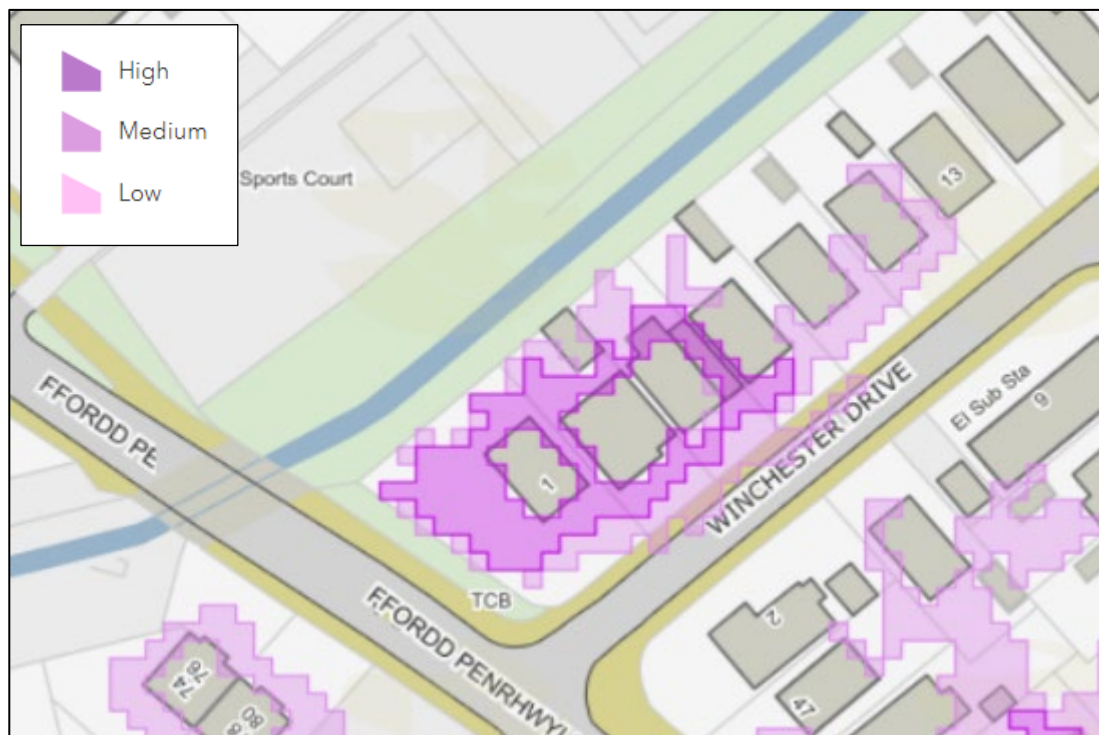
Figure 36: : NRW Flood and Coastal erosion Risk Maps for Surface Water at Winchester Drive

On the other hand, for surface water, the NRW Risk Maps in figure 36 show a low to medium risk of surface water flooding occurring for properties 1 to 7 on Winchester Drive.

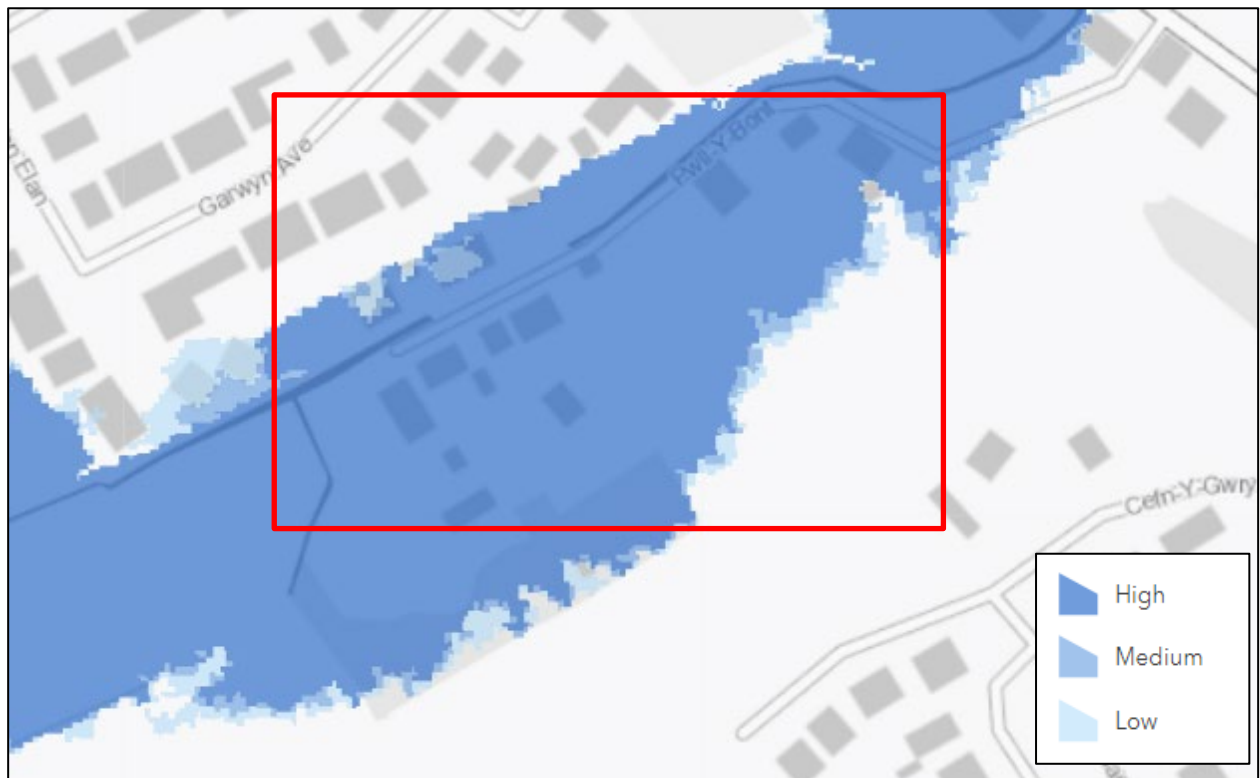
Figure 40: NRW Flood Risk from Rivers at the Pwll y Bont Investigation area

Figure 40 below shows the Fluvial flood extent at Pwll Y Bont taken from the NRW Flood Risk Maps for Rivers.

Approximately 9 properties along Pwll y Bont are within the fluvial flood extent

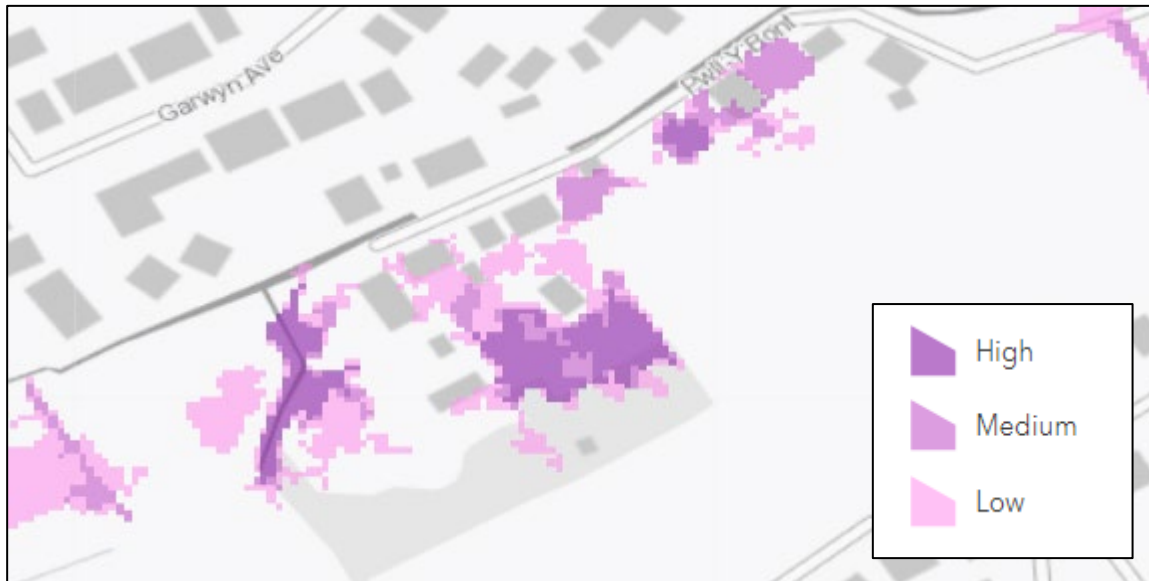
Figure 41: Flood risk from surface water at Pwll Y Bont, taken from the NRW flood risk Maps

With regard to the flood risk extent from surface water at Pwll Y Bont, there is a low to medium risk of such flooding occurring for 4 of the properties within the investigation area, as shown in figure 41 below.

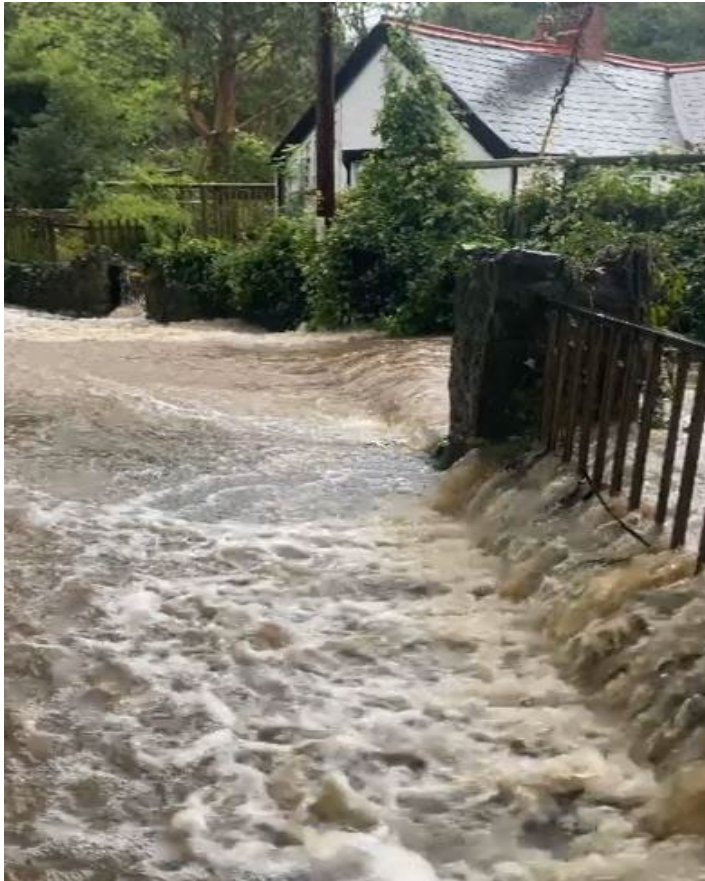
Photo 9: Flooding from the Afon Ffyddion at Glan y Afon Cottage

Glan y Afon Cottage on Pandy lane suffered internal flooding due to the Afon Ffyddion overtopping as a result of the storm conditions, as shown in photo 9

The floodwater flowed out of the river bank and made its way around Glan y Afon Cottage before being impounded by the garden wall, which may have caused the flood water to back-up and increase the depth of flooding. This however will need further investigation via modelling to confirm the flood outlines.

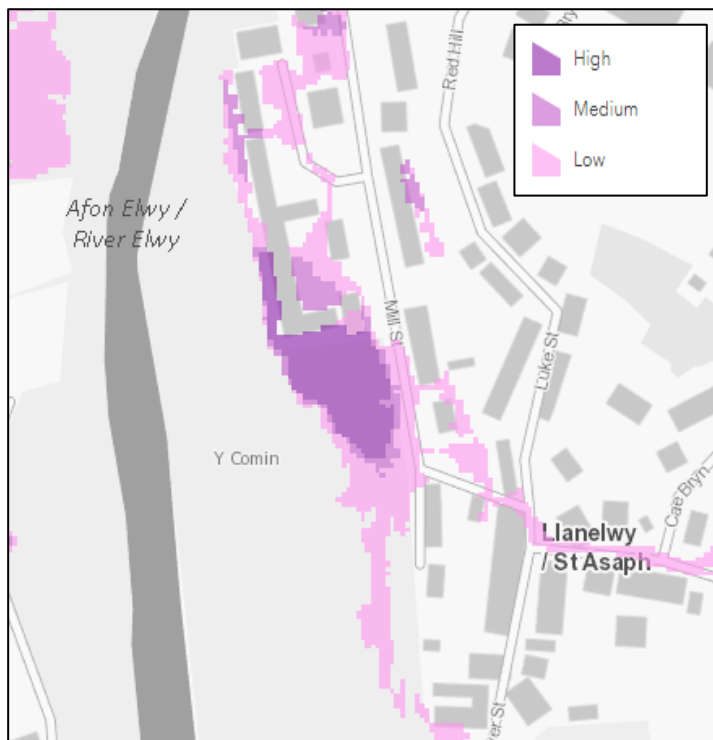
Figure 45: NRW Flood and Coastal Risk Maps for Llys y Felin showing risk of flooding from surface water and small watercourses.

Flooding to Llys y Felin also occurred in 2021 following Storm Christophe. Figures 45 and 46 from The NRW Flood and Coastal Risk Maps show that for Llys y Felin it has a high

risk of flooding from surface water and small watercourses, whereas for for flooding from rivers, it is low risk.

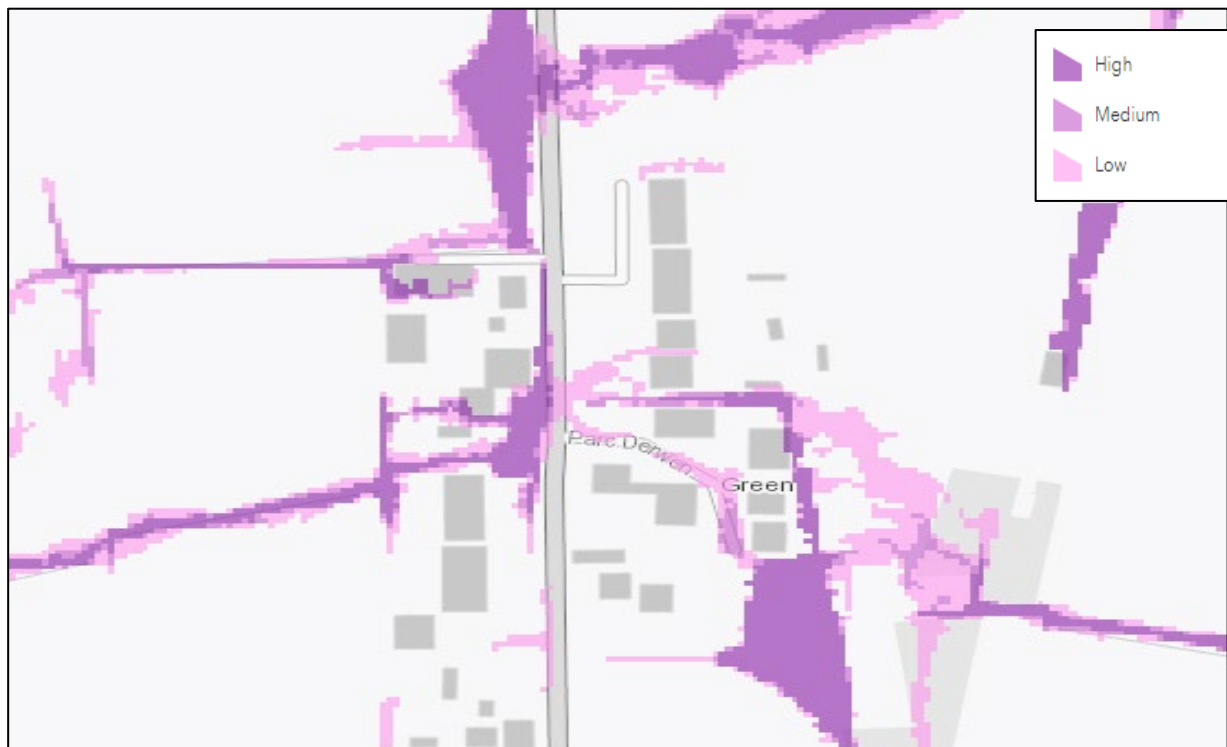
Figure 48: NRW Flood Risk Maps showing flood risk from surface water and small watercourses at Denbigh Green

Figure 48 below from the NRW Risk Maps has the effected properties in close proximity to being at high risk from surface water and small watercourse flooding.

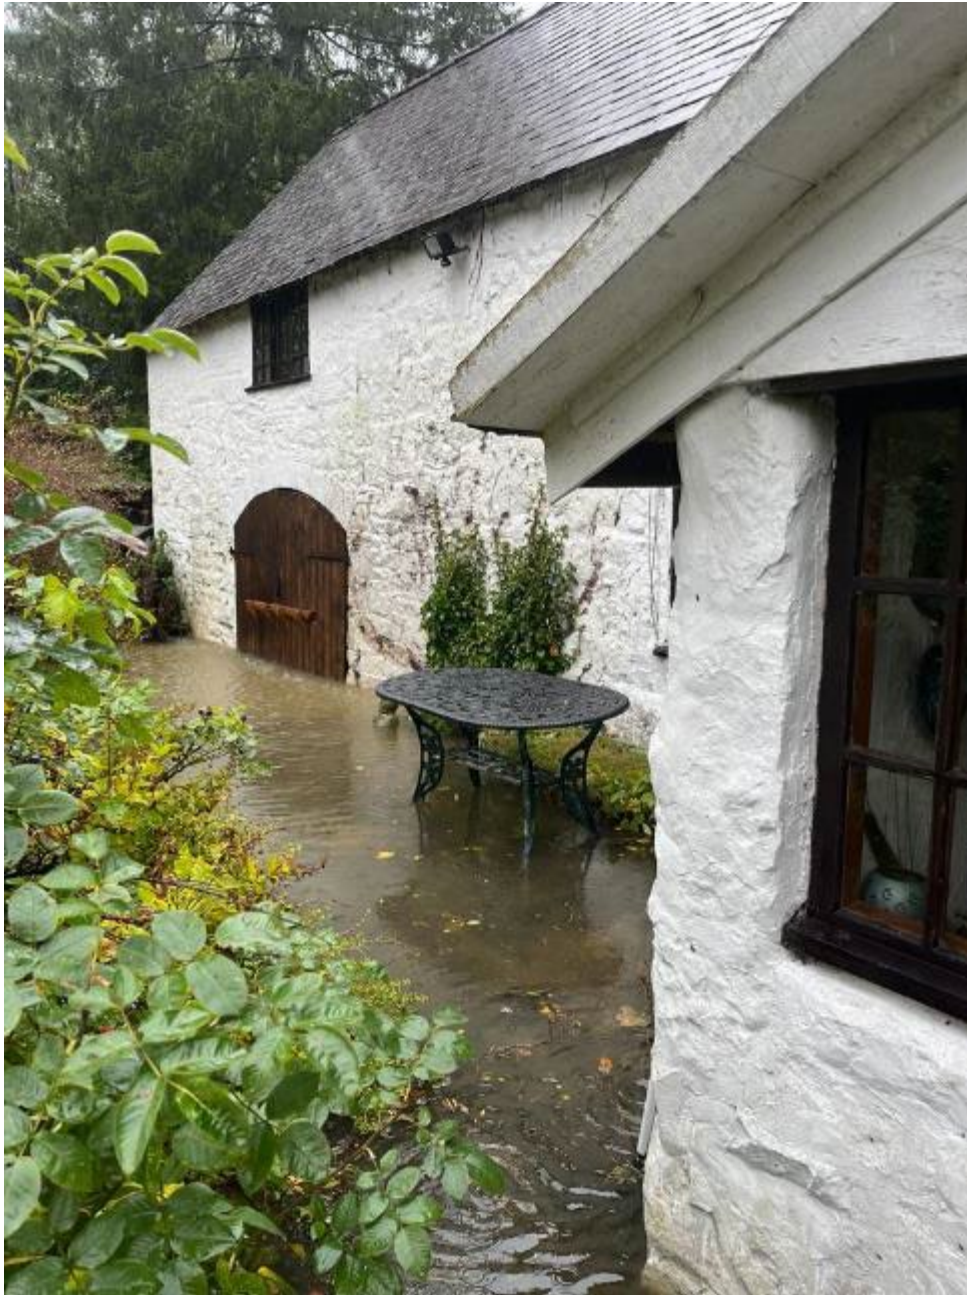
Photo 11 showing flood waters at the front door of Plas Isaf

Flood water entered the Property from the front via a low sitting floor, as shown in photo 11 below

Flooding occurred as a consequence of both high flow levels in the River Alyn (Main River) and significant surface water flows coming off the highway being conveyed to an individual property known as Plas Isaf via its access track. Measures previously constructed by DCC (see photo 1 in section 4.6.2) to help reduce the risk of the water coming off the highway were overwhelmed, but predominately, the main source of flooding was the River flowing around a private wall structure.

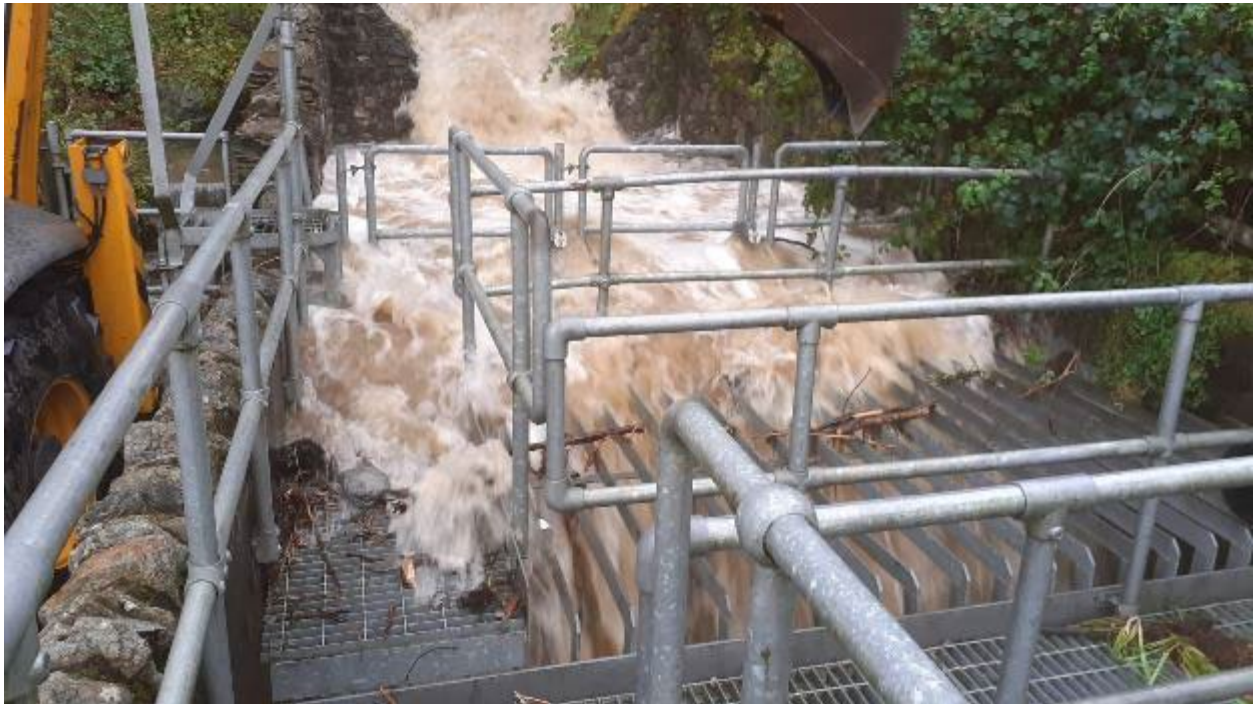
Photo 12: Flood Alleviation Culvert below Pen y Pigyn at Corwen during Storm Babet

A crew had to continually clear out the flood alleviation culvert below Pen y Pigyn for a number of hours on the morning of Storm Babet. Without this level of maintenance, a large proportion of Corwen Town would have been flooded by water over-topping the culvert. Photo 12 below shows the intensity of the water almost over-topping the flood alleviation culvert.

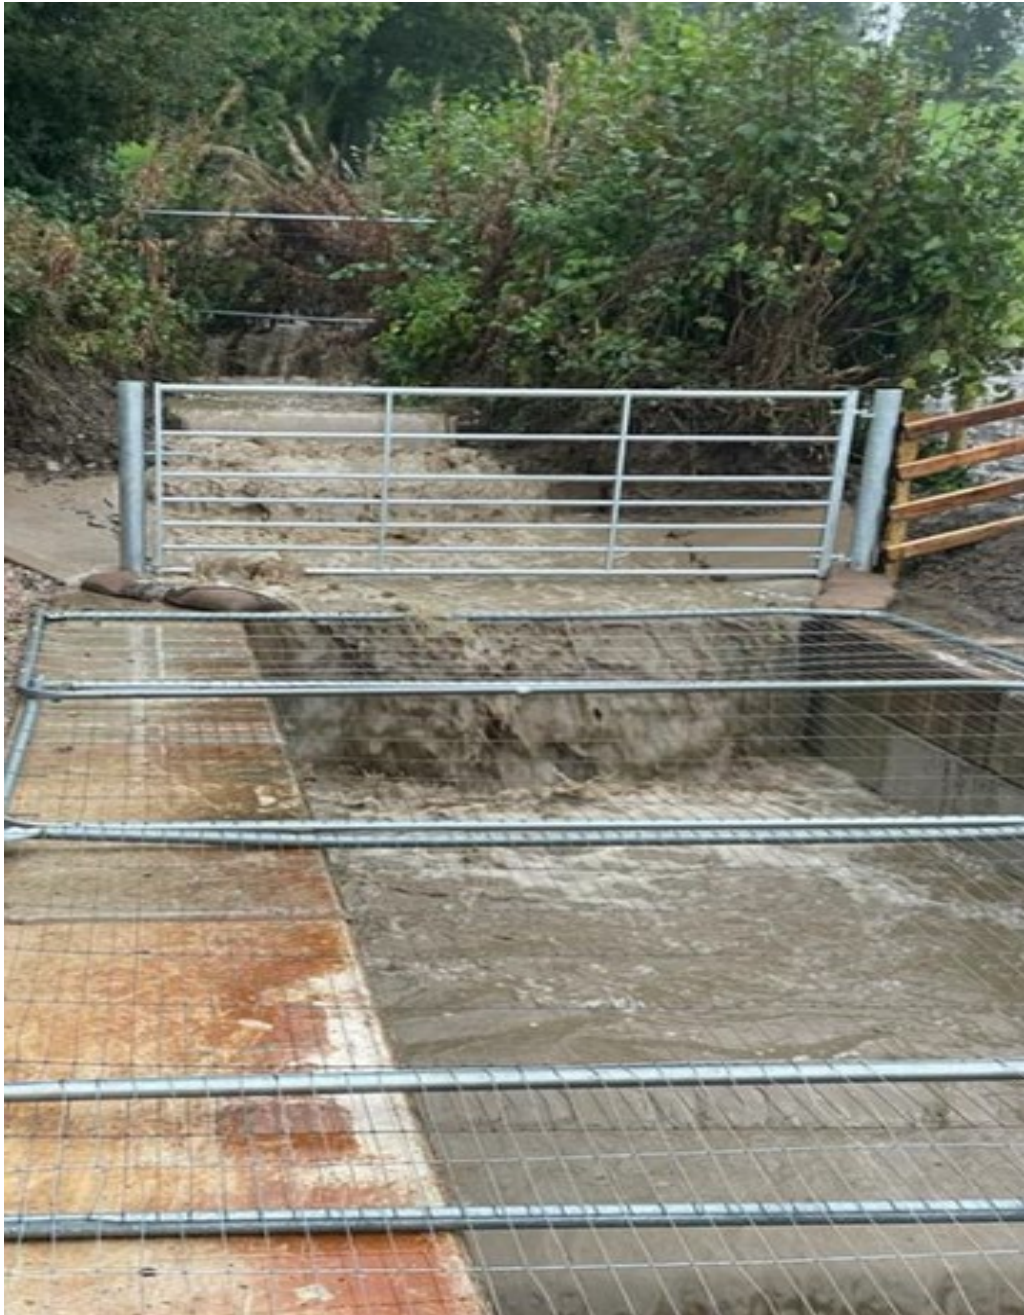
Photo 13: New culvert structure at Nantglyn Village during Storm Babet

The highway culvert within the Village, which historically overtops during storm events, flooding properties in the process, had just been replaced prior to Storm Babet. Its replacement came on the back of a recommendation in the Section 19 report for Storm Christophe in 2021, which caused flooding to a couple of properties within the Village. The new structure coped well during Storm Babet despite the torrential amount of water entering the inlet, as shown by photo 13 below.

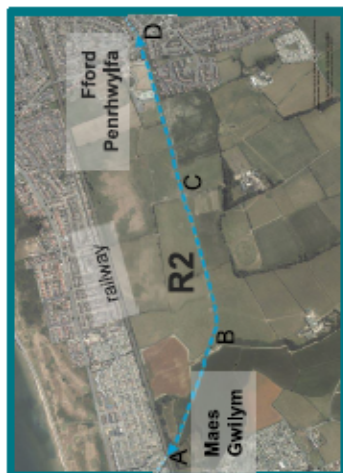
Ffordd Penrhwyffa to Maes Gwilym

Main River Flood Risk Summary	There is no significant flood risk to properties from Rhyl Cut but there is flooding of farmland, in particular to the south of the cut. Properties around Maes-Y-Gog and Lon Hedyn are at risk of flooding from Maes Gwilym (MG) drain.
Current River Condition	Rhyl Cut is currently in good (if unnatural) condition with channel clearance undertaken relatively frequently. There can be substantial invasive weed growth. There could be significant benefits if the river was restored to a more natural state. Maes Gwilym drain is currently in reasonably good condition, except for a culvert under the railway which is partially collapsed (see impact below).
Maintenance Impacts	Maintaining the Rhyl Cut in this reach has no significant impact on property flooding from the main river. Reducing maintenance will lead to some additional flooding of farmland to the south and north of the cut. Drainage could be affected by silt levels. Maes Gwilym drain channel vegetation and raised bed levels increase flood risk. Maes Gwilym drain railway culvert increases flood risk downstream and will therefore not be maintained.

No long section available for Maes Gwilym drain. Max bed level to minimise reduction in capacity of culverts and other crossings.

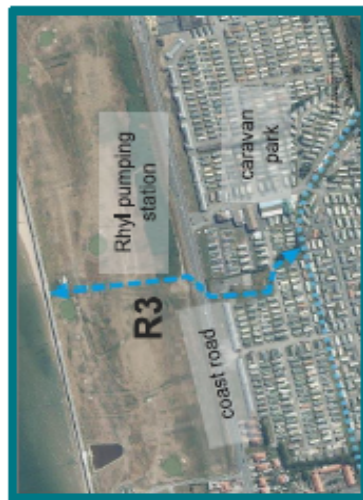
Rhyl Cut R3

Rhyl Pumping Station leg

Main River Flood Risk Summary	There is no significant risk of flooding from Rhyl Cut in this reach but high water levels could affect properties in reach R4. A few caravans are at risk of flooding during infrequent floods (above approximately 1 in 30 annual chance).
Current River Condition	The river is currently in good condition with channel clearance undertaken relatively frequently. The left hand bore of the Ash Grove culvert upstream is partially blocked but the culvert has spare capacity.
Maintenance Impacts	Rhyl Pumping Station will continue to be operated and maintained (subject to pumping station review and impact of set-back sea defences), as it reduces flood risk to a large area and lots of properties. Maintaining the river channel in this reach has minimal impact on main river flooding but some clearance is required for Rhyl pumping station to operate effectively. Drainage could also be affected by silt levels.

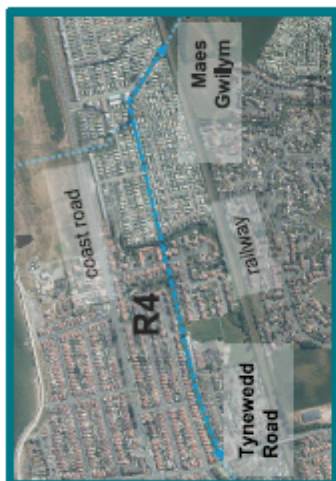
Maes Gwilym to Tynwedd Road

Main River Flood Risk Summary	The highest point of Rhyl Cut is near Brynheddydd Road and can therefore flow in both directions along this reach. Properties near Brynheddydd Road and Edgbaston Road and some caravans are at risk of flooding during infrequent floods (above approximately 1 in 30 annual chance) from both Rhyl Cut and Fron Hall drain.
Current River Condition	This reach of Rhyl Cut and Fron Hall drain are in fair condition but there has been siltation between Tynwedd Road and Brynheddydd Road which requires clearance. Maintenance is difficult due to poor access in some locations along both watercourses.
Maintenance Impacts	Maintaining conveyance along this reach of Rhyl Cut slightly reduces the extent of flooding and reduces peak water levels, which may benefit incoming drainage; drainage could also be affected by silt levels. Channel vegetation and raised bed levels along Fron Hall drain increases flood risk.
